“High Alarm” from Plastic Scintillation Fiber monitor (PSF monitor) monitoring the wharf drainage channel at the Fukushima Daiichi Nuclear Power Station (Continued report)

【Overview】

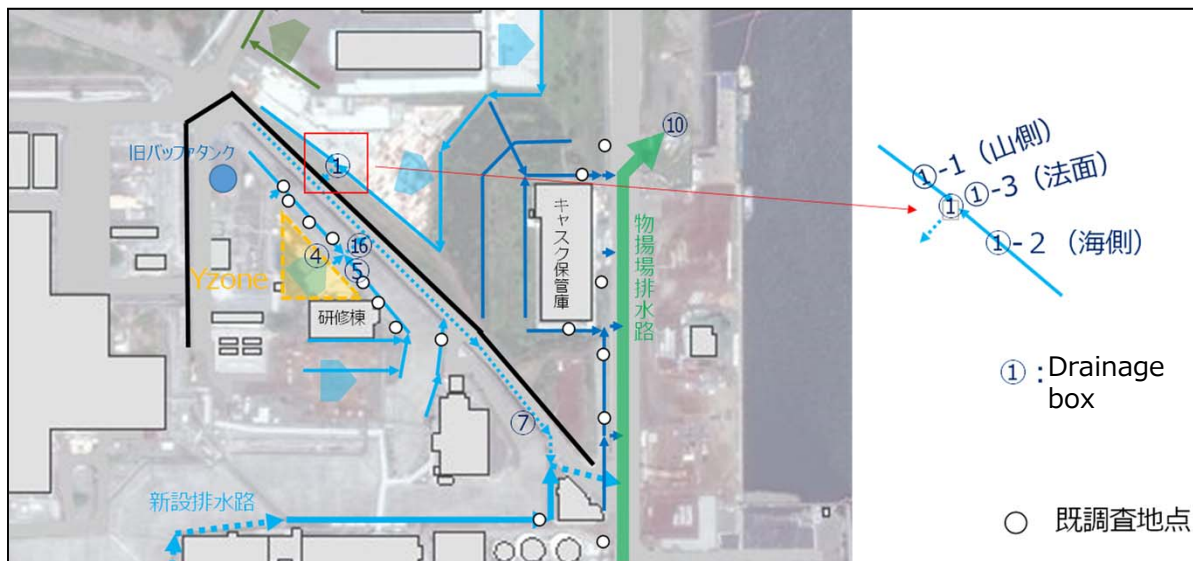
【Reference】 Drainage ditch rainwater analysis results (Sampled on March 29)

- ✓ Gross beta values for drainage water from temporary storage area W2 at point ④ was 1,100Bq/liter
- ✓ β/γ radioactivity concentration ratio: Approx. 26 times greater

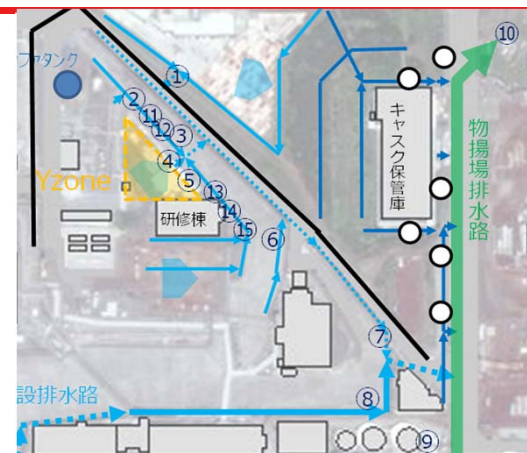
【Reference】 Drainage ditch rainwater analysis results (Sampled on March 21)

- ✓ Gross beta values for drainage water from temporary storage area W2 at point ④ was 1,700Bq/liter
- ✓ β/γ radioactivity concentration ratio: Approx. 300 times greater
- ✓ Surface surveys conducted on temporary storage area W2, which is the source of drainage water

No water at points ⑪, ⑬~⑮
Units: Bq/L
