Status of Visual Inspections of Containers Stored in the Temporary Storage Areas at the Fukushima Daiichi Nuclear Power Station

<Reference material>
July 1, 2021
Tokyo Electric Power Company Holdings, Inc.
Fukushima Daiichi D&D Engineering Company

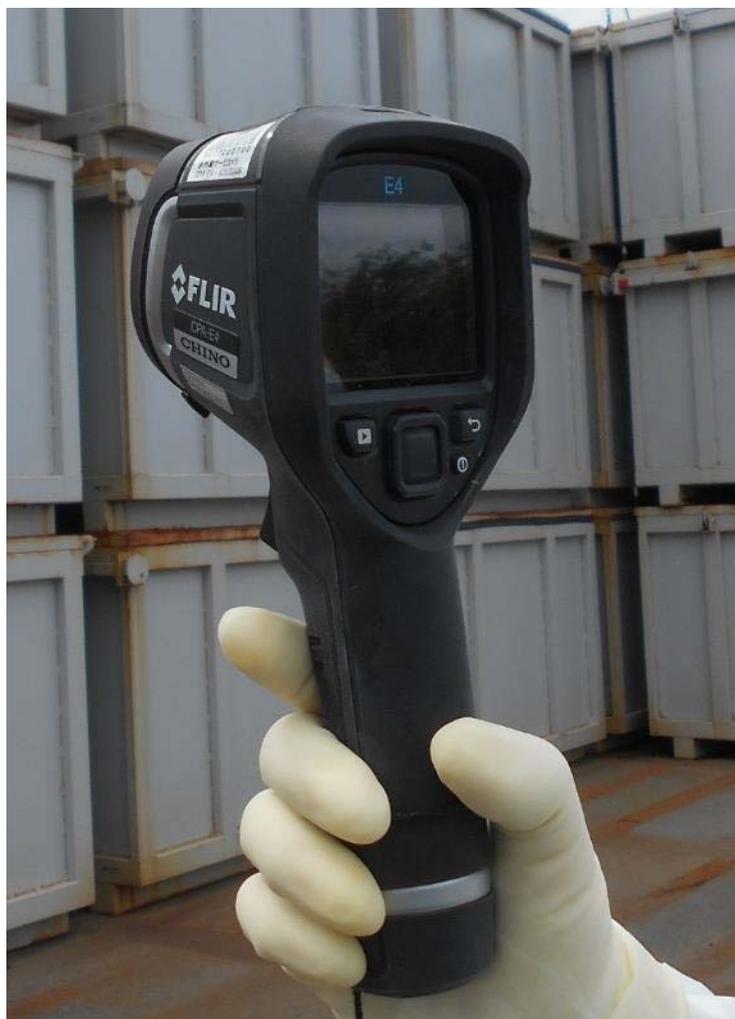
Thermographic camera

- ① Thermographic cameras are used to check for the presence of water inside the containers from the outside prior to moving the containers for the visual inspections.
