Fukushima Daiichi Nuclear Power Station Results of Station-wide High Integrity Container Exhaust Filter Damage Inspection

< Reference material >
October 8, 2021
Tokyo Electric Power Company Holdings, Inc.
Fukushima Daiichi D&D Engineering Company

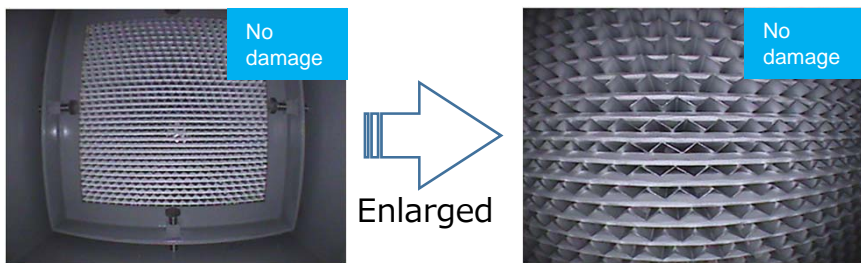
Unit 5/6 hot lab used water receiving tank exhaust filter (photographed on October 5)

- ※An ④ inspection of actual filters will be implemented for exhaust filters for which integrity was not confirmed through inspections ①～③
- The integrity of 100 of the 102 exhaust filters was confirmed through inspections ①～③
Inspections of the remaining two filters (Unit 5/6 hot lab used water receiving tank exhaust filter, subdrain purification equipment RO concentrated saline processing relay tank exhaust filter) were conducted on October 5th and 6th since these filters had not been subjected to regular inspection or status monitoring, and no damage was found.
Going forward, the maintenance-management methods of these two filters will be examined and revised.

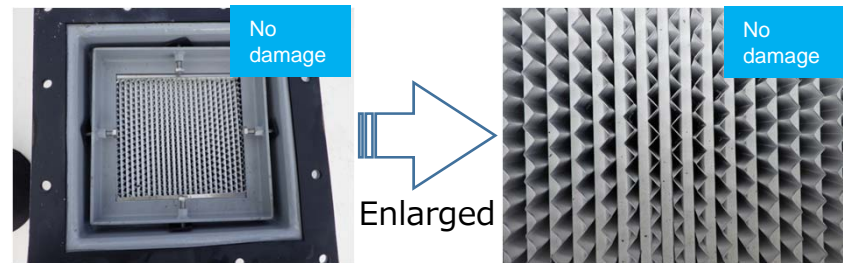
Subdrain, etc. purification equipment RO condensed water treatment water relay tank exhaust filter (photographed on October 6)
