## Progress status of the investigation into the causes of nonconformities discovered during preparations for the Unit 1 PCV internal investigation at the Fukushima Daiichi Nuclear Power Station (Update 4)

< Reference Material >  
February 7, 2022

Tokyo Electric Power Company Holdings, Inc.  
Fukushima Daiichi D&D Engineering Company

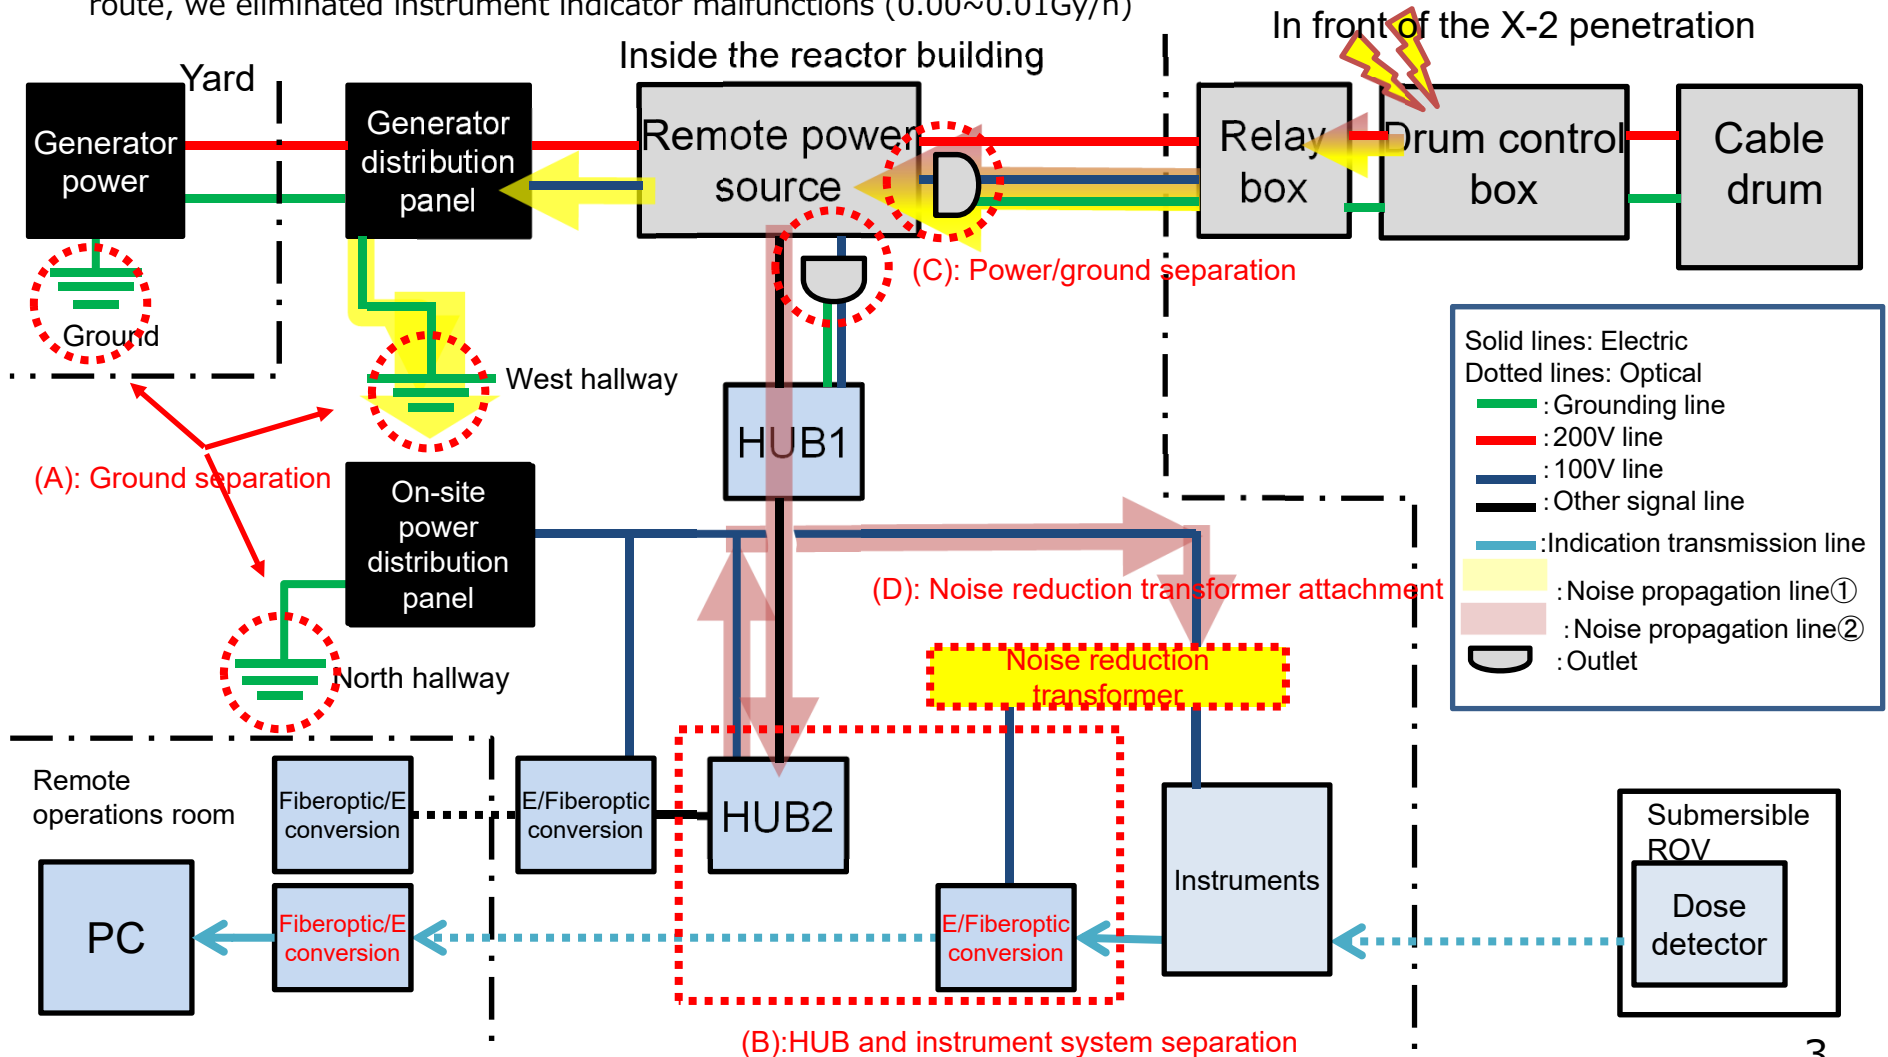
# 【Reference】 Results of countermeasures for incorrectly displayed dose data

- From the results of additional investigations we have hypothesized that noise originating from the drum control box propagated as follows and affected the instruments. (①: Noise propagating from the south grounding line, ②: Noise propagating from the HUB)
- By implementing the countermeasures (A)~(D) shown in the diagram below and cutting off each noise propagation route, we eliminated instrument indicator malfunctions (0.00~0.01Gy/h)
