Conditions at the Fukushima Daiichi Nuclear Power Station after the Earthquake of March 16 (Update)

< Reference document >
M a r c h 1 8 , 2 0 2 2
Tokyo Electric Power Company Holdings, Inc.
Fukushima Daiichi Decontamination &
Decommissioning Engineering Company

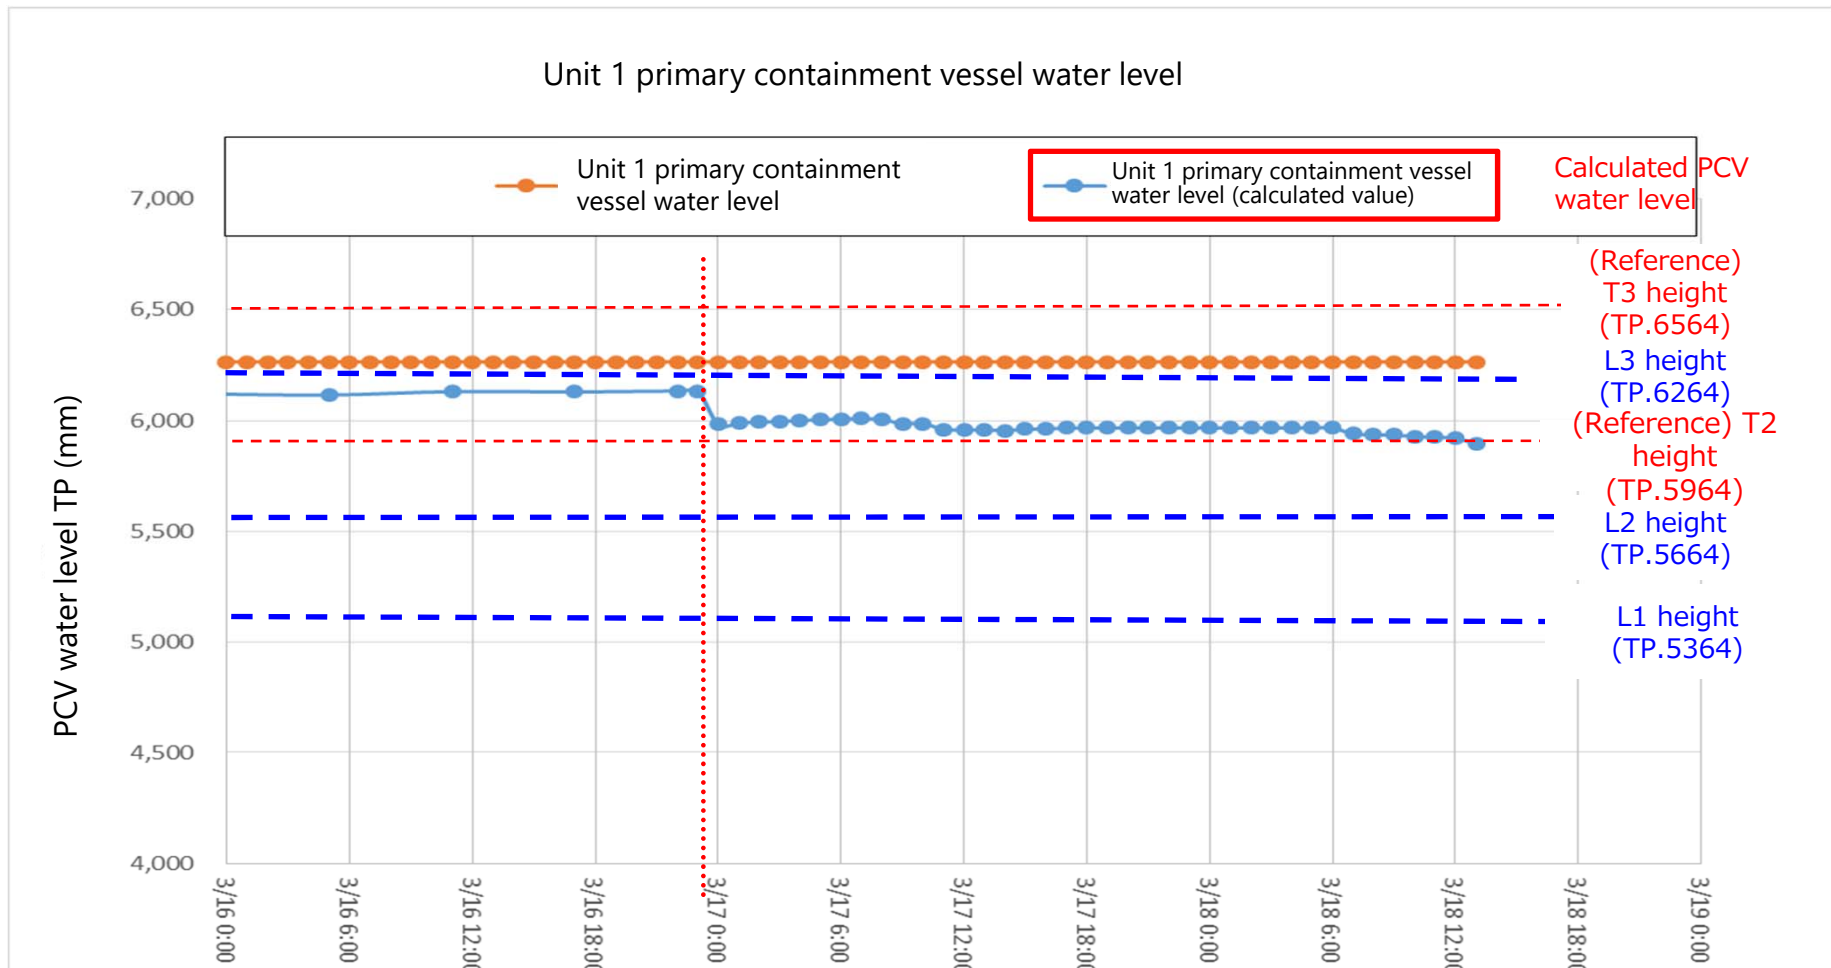
Water level inside the Unit 1 primary containment vessel

- Although the water level inside the Unit 1 primary containment vessel had temporarily decreased as follows, no significant changes have been confirmed. Fluctuations in the water level will continue to be closely observed.
- The current water level is close to the position of water gauge L3 (T.P.+6,264mm).
(Primary containment vessel bottom is T.P.+4,744mm)

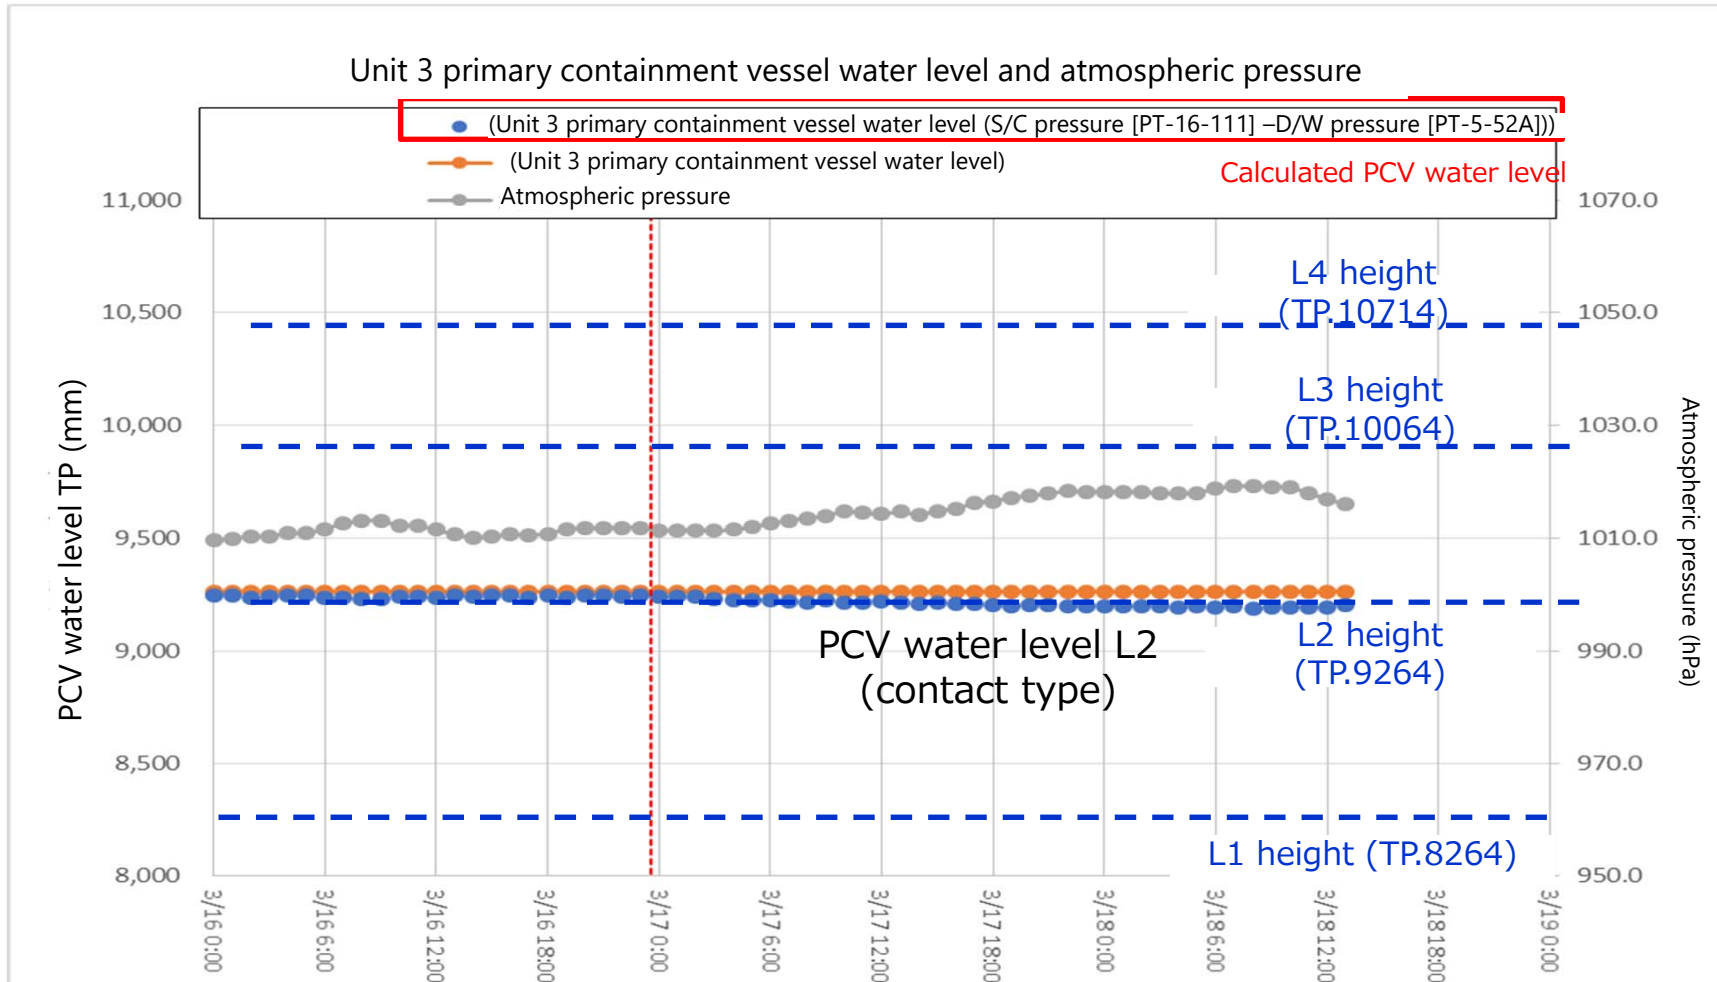
Water level inside the Unit 3 primary containment vessel

- No significant changes have been confirmed regarding the water level inside the Unit 3 primary containment vessel, as follows.
 - The current water level is close to the position of water gauge L2 (T.P.+9,264mm).
- (Primary containment vessel bottom is T.P.+4,044mm)

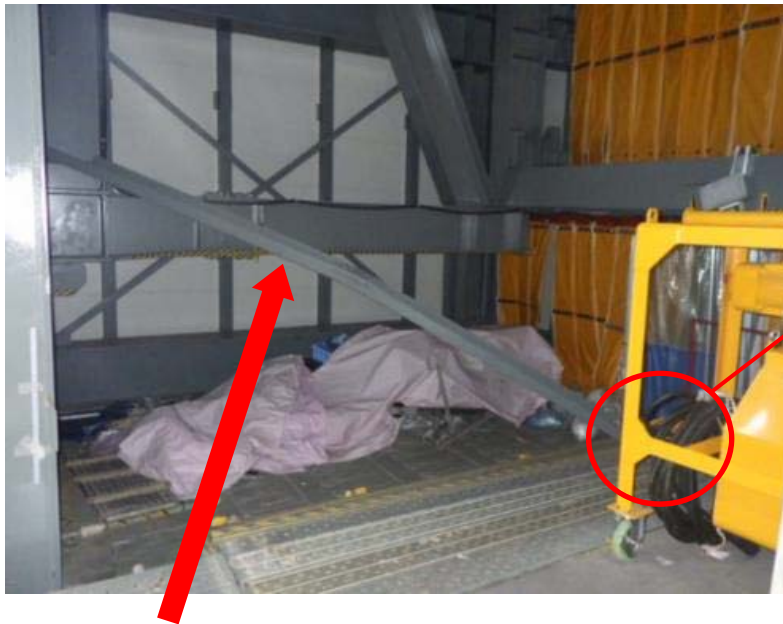
Falling of steel auxiliary member inside the Unit 4 reactor building cover building

Description: TEPCO employees found a steel auxiliary member used for exterior wall installation had fallen. It is speculated that the member had fallen due to bolts at the joint rupturing. No significant corrosion was found on the bolts.

Specifications of the beam-like steel frame
Length approx. 5.6m width approx. 25cm height approx. 10cm,
thickness approx. 10-13mm, weight approx. 200kg

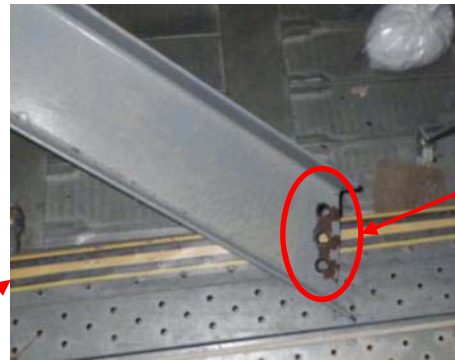
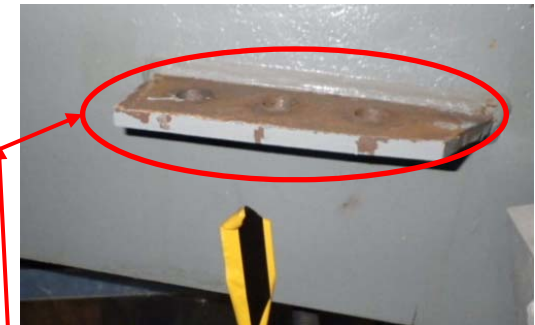
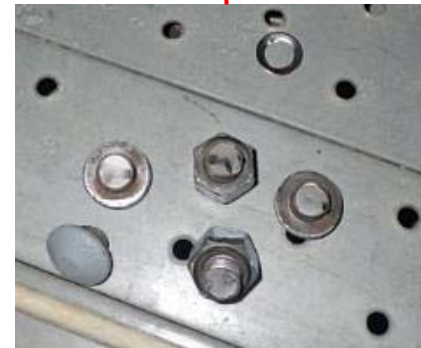
Bolts at the joint ruptured

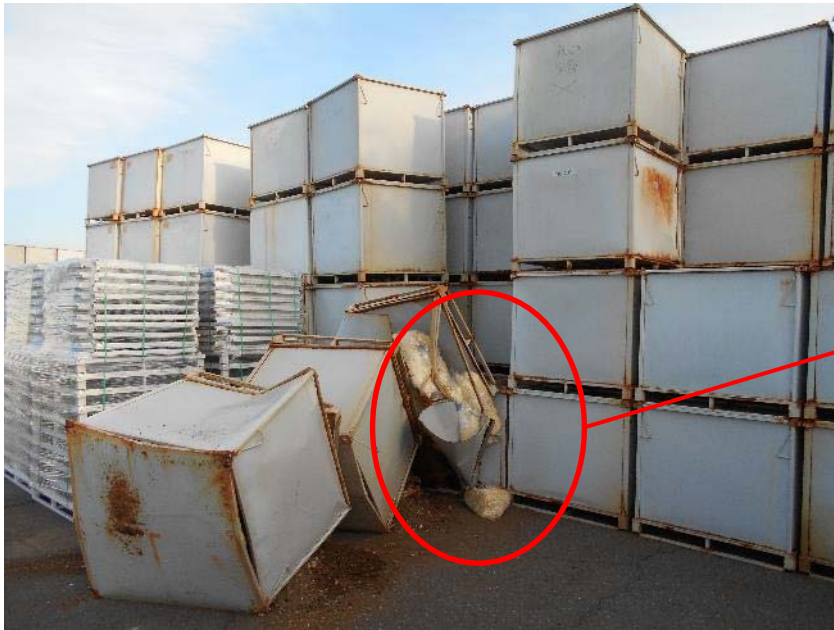
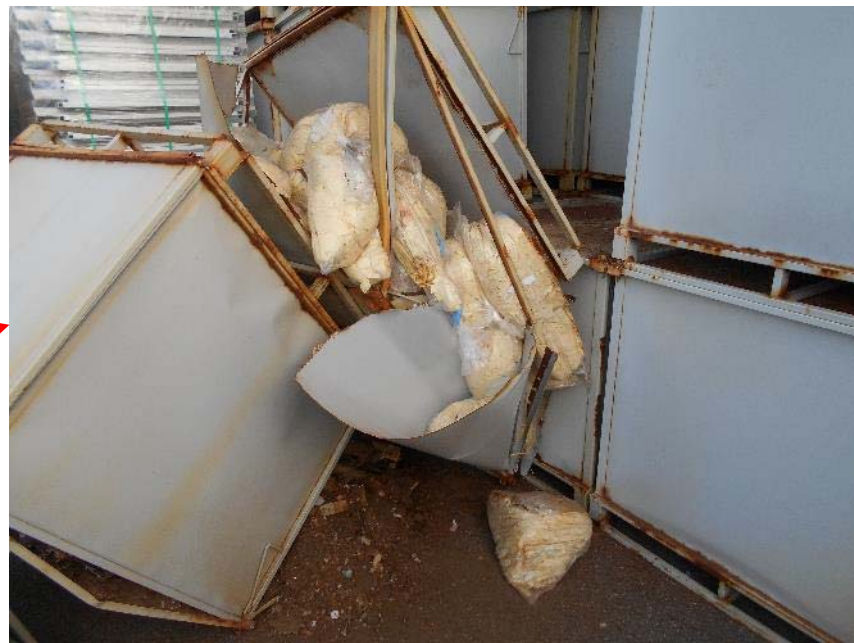
State of containers

- It was confirmed that six containers stored in temporary storage area "a" had toppled over and its contents had come out. Five of the toppled containers stored used protective clothing, and one container stored scrap iron. Dose of the contents was confirmed to be at the same level as the background.
- Cracks were found on some parts of the on-site road (asphalt). This did not obstruct passage.
- Waterproof coating was found to be peeling from the subdrain collection tank No.1. Tank functions were not affected.
- Tank water gauge indication failure was found on 38 units. 27 of the units were restored with initialization work. The remaining 11 units are planned to be restored using spare parts.
- Water puddle was found on the stair landing (between fourth floor and fifth floor) at Unit 5 reactor building. It was confirmed that water had stopped dripping.

- Abnormalities have not been found for other revetment equipment
- Regarding containers where damage was found before the earthquake in temporary storage area (f), it was found that the damage expanded due to this earthquake. The containers contain used protective clothing, and it was confirmed that the dose of the contents was at the same level as the background.
