## Presumed cause of temporary increase in Strontium 90 concentration at the outlet of ALPS (A) at Fukushima Daiichi Nuclear Power Station and its recurrence prevention measures

<Reference Material>  
October 17, 2022  
TEPCO Holdings  
Fukushima Daiichi D&D  
Engineering Company

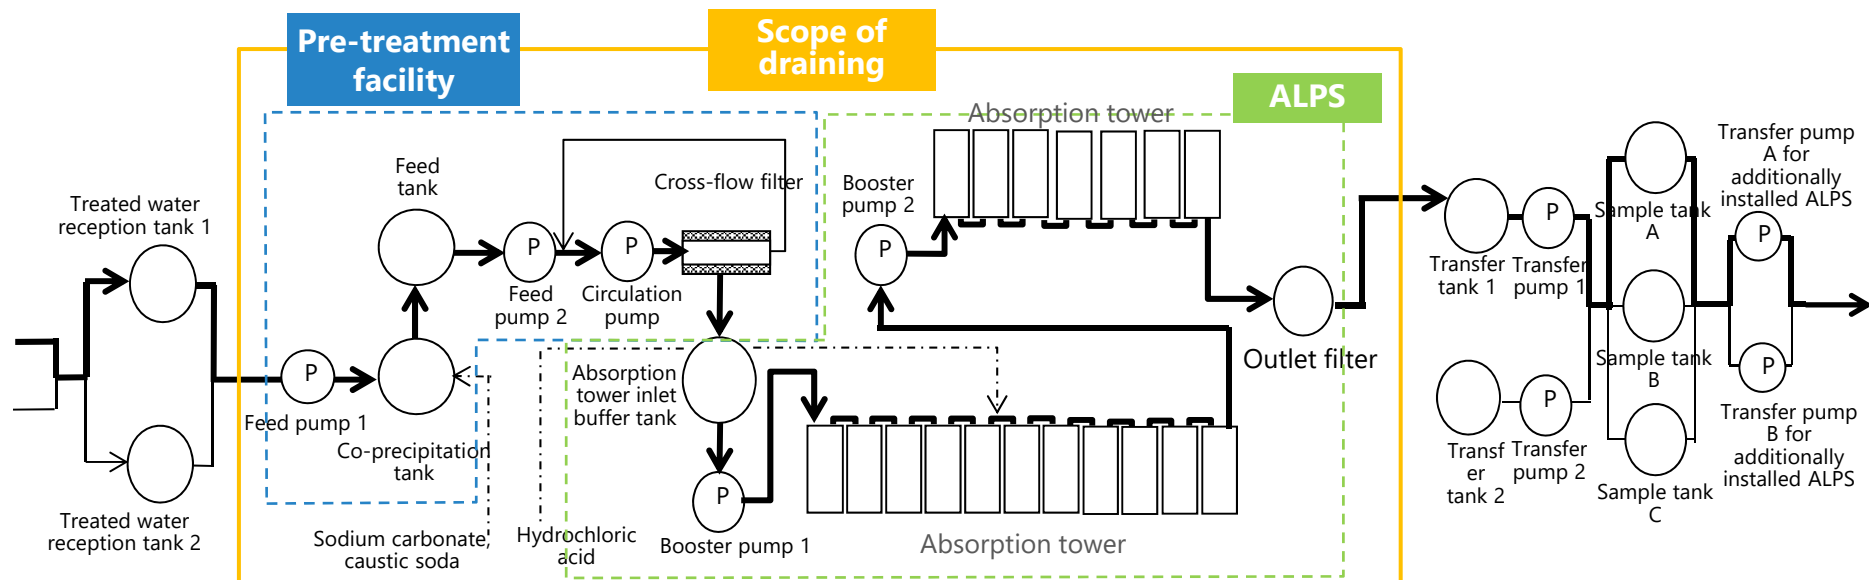
- As a result, it was confirmed that all absorption towers (total of 18 units) were subjected to draining and filling (feeding of filtered water)\* as part of initiatives for preventative maintenance starting this inspection (first time where all absorption towers were subjected to draining and filling during inspection).

- All absorption towers being subjected to filling (feeding of purified water) may have caused the pH (hydrogen ion concentration) in the absorption towers to deviate from normal values.

Figure. Scope of draining during periodic inspection of additionally installed ALPS (A)

### [Measure 1] Review the appropriate scope for water draining and filling during periodic inspection

- ✓ In the most recent periodic inspection of ALPS, all absorption towers were planned to be subjected to water draining and filling as initiatives for preventative maintenance.
- ✓ Future inspection methods shall be reviewed based on the experience gained to prevent occurring of significant changes in the pH environment within the absorption tower, such as not conducting water draining and filling for absorption towers (total of five towers) with pH set to [12] at once.
- ✓ To confirm that absorption towers with pH set to [12] are at appropriate levels when conducting water draining and filling, sampling shall be conducted at later stages of absorption towers that have been inspected to verify effectiveness of measures.

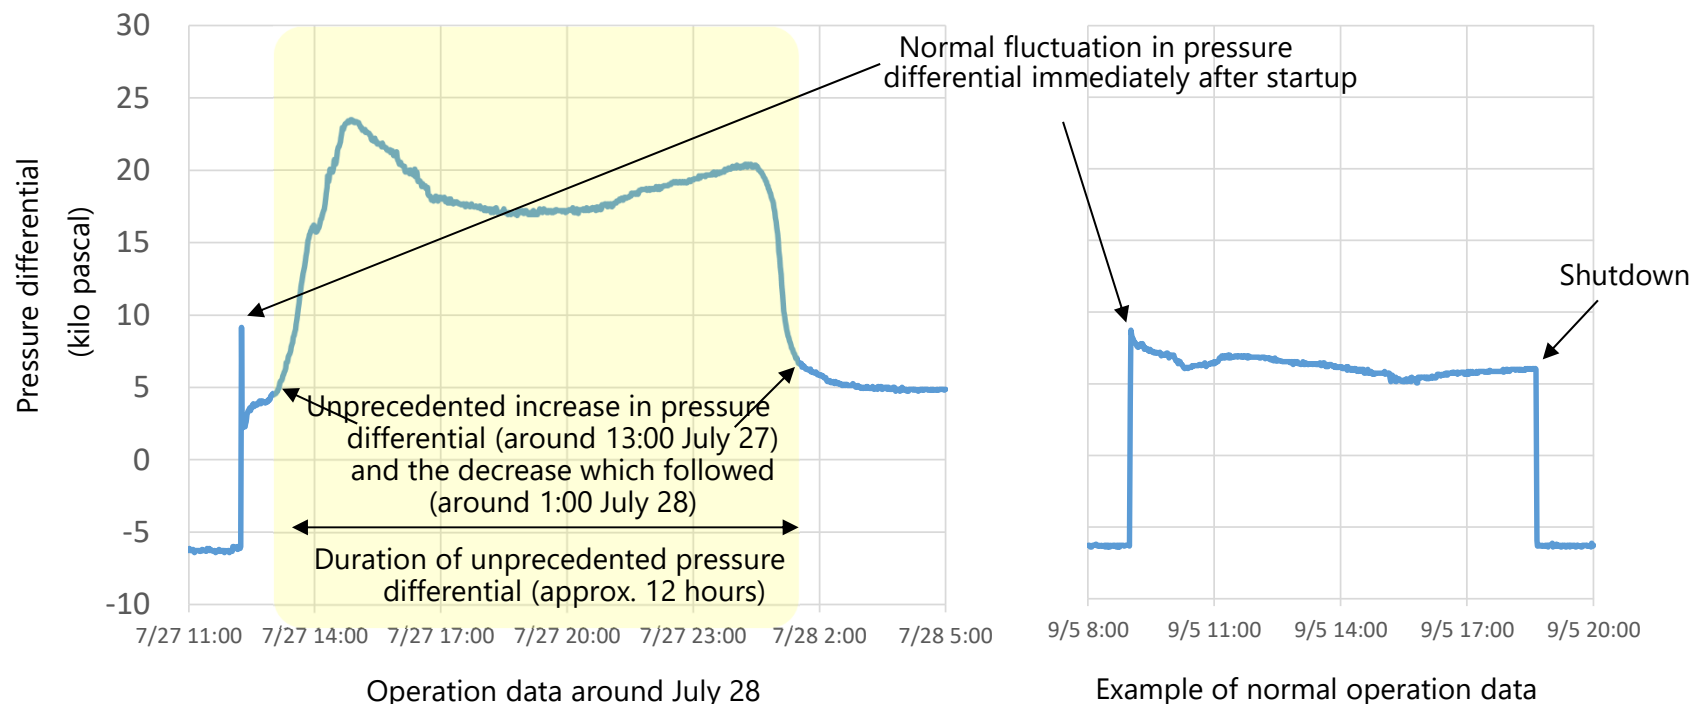
- As a result, it was confirmed that from July 27<sup>th</sup> to 28<sup>th</sup>, the pressure differential at the outlet filter (which is the difference in pressure between the filter inlet and outlet) had experienced an increase and a decrease, which was unprecedented based on past operations.

- Based on this data, it is possible that some material was temporarily clogging the outlet filter.
- A visual inspection was conducted for the outlet filter, and it was confirmed that there were no abnormalities such as physical damage, etc. Also, the operation data for additionally installed ALPS (A) was confirmed, and it was verified that there were no data that significantly deviated from normal status other than the outlet filter pressure differential.

Figure. Trend graph of pressure differential of outlet filter for the additionally installed ALPS (A)

- ✓ It is presumed that minute precipitates containing Strontium 90 flowing out of the Strontium adsorbent were captured by the outlet filter (2µm mesh) after passing through each adsorbent towers, resulting in the filter becoming clogged and increasing the pressure differential.
- ✓ Minute precipitates containing Strontium 90 captured at the outlet filter dissolved and micronized while being held for several hours in a pH [7(neutral)] environment and being subjected to the water flow of the ALPS system, and passed through the outlet filter. This caused the outlet filter pressure differential to drop and **resulted in the Strontium 90 concentration in water passing through the outlet filter to increase.**

### [Measure 2] Strengthen monitoring of outlet filter pressure differential after concluding periodic inspection and sampling of outlet water

- ✓ Consider experiences gained to strengthen monitoring of outlet filter pressure differential after concluding periodic inspection. Also, conduct sampling of outlet water after startup to confirm that water is being treated appropriately to remove radionuclides.

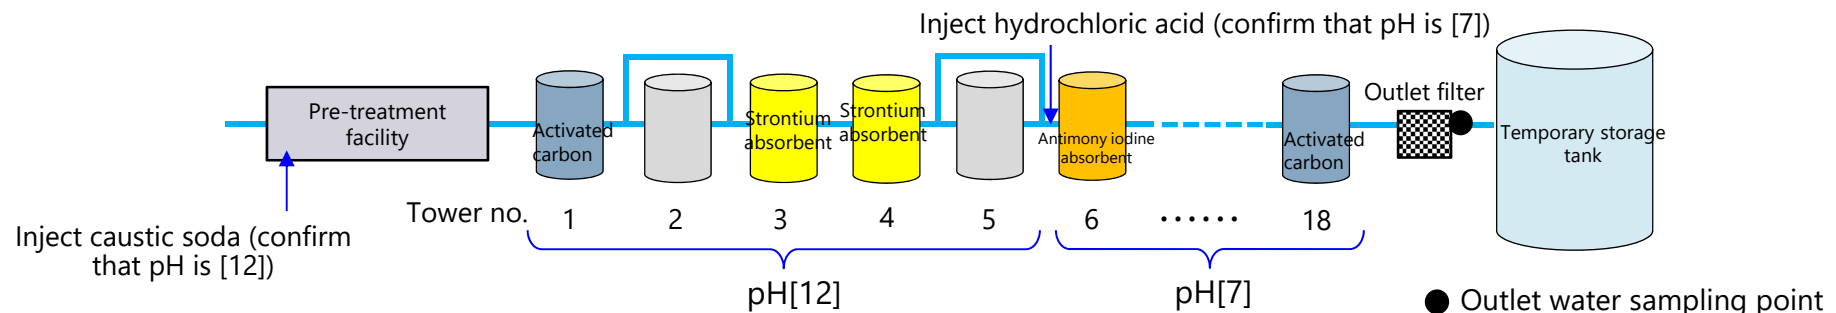
- ✓ ALPS has a set pH (hydrogen ion concentration) to ensure optimal treatment by each absorption tower. The system is designed to check pH at two points, where is within the pre-treatment facility and is between absorption towers 5 and 6. This allows the proper absorption of radioactive material in each absorption tower (Strontium adsorbent set pH to (12)) .

- ✓ On the other hand, it was presumed that the Strontium adsorbent had fluctuated slightly to the neutral side from the normal pH (12 (alkaline)) immediately after commencing operation (on July 27) due to all absorption towers being subjected to water draining and filling (feeding of filtered water) during this periodic inspection.

- ✓ The pH of the Strontium adsorbent fluctuating to the neutral side makes it easier for precipitates\* captured by the Strontium adsorbent to dissolve when compared to pH [12]. This could have caused precipitates containing Strontium 90 to micronize and separate, allowing it to continue into the absorption towers of later stages.

Figure. pH for each absorption tower in the additionally installed ALPS (A)
