Progress with the Unit 3 Reactor Building Internal Investigation

May 30, 2024

TEPCO

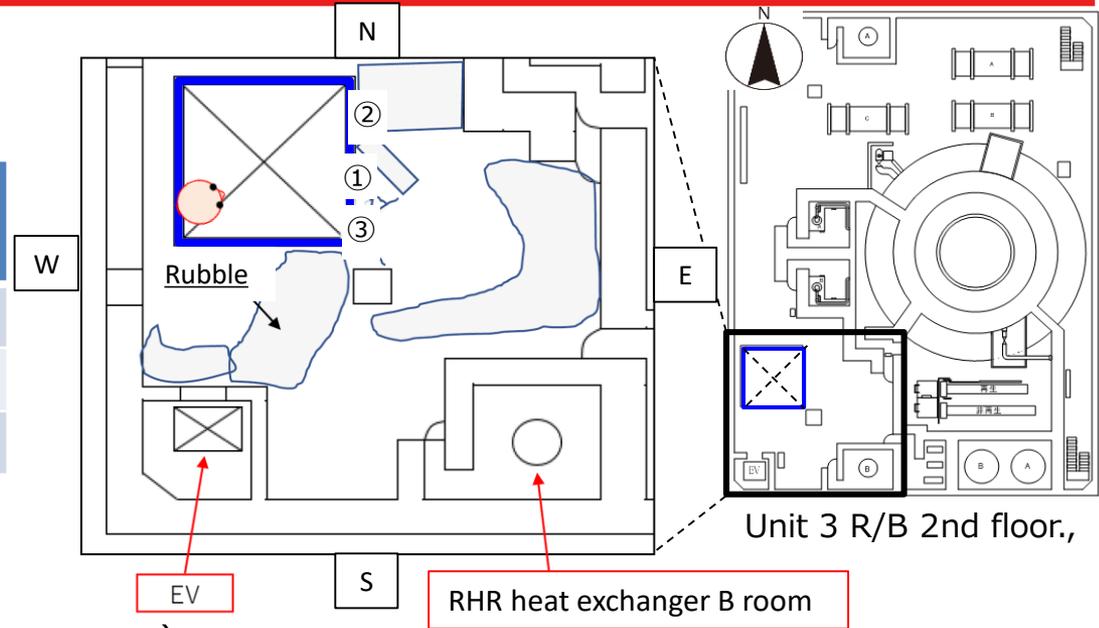
- Air dose rate inside the building
 - 2nd floor, East side
(Measurement date: May 13, 2024)

Measurement location	Height of measurement ※Based on elevation of 2nd floor (T.P.17264)	Dose rate [mSv/h]
①	Approx.850mm	4.64
②		4.75
③		4.60

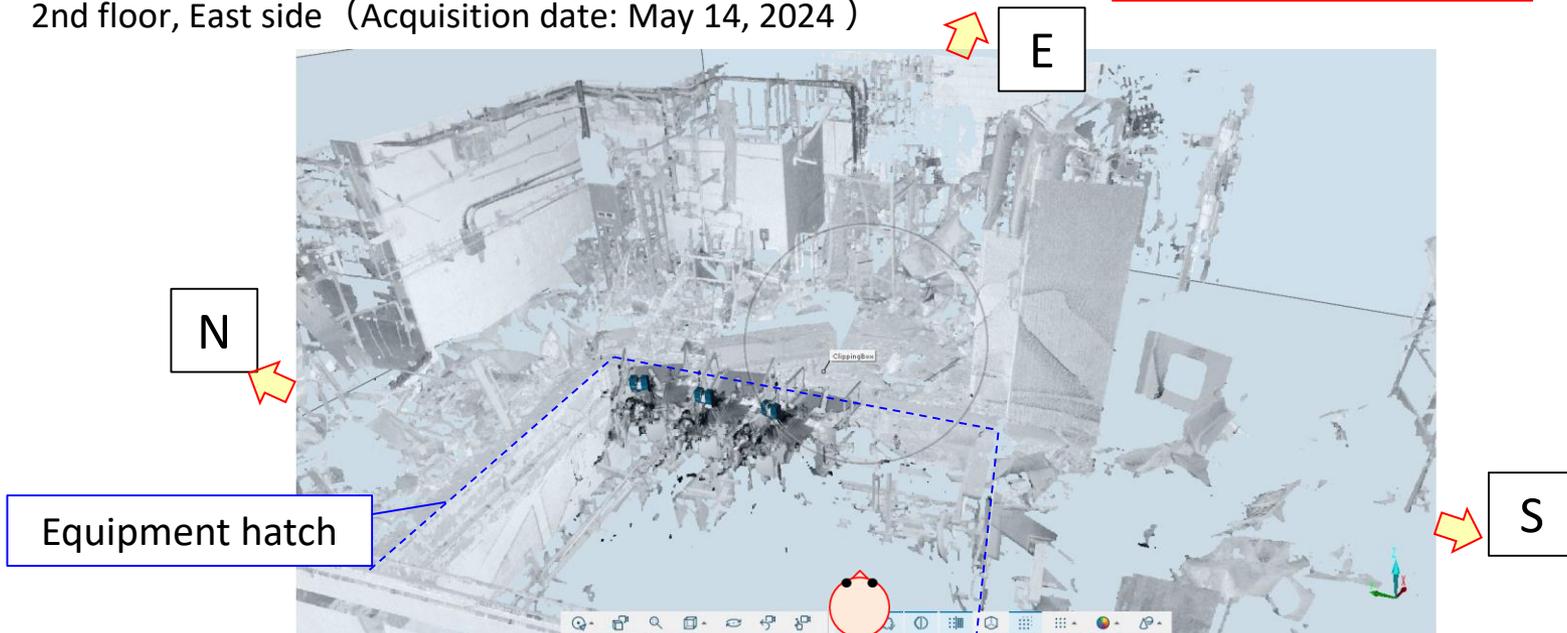
- Point cloud data
 - 2nd floor, East side (Acquisition date: May 14, 2024)

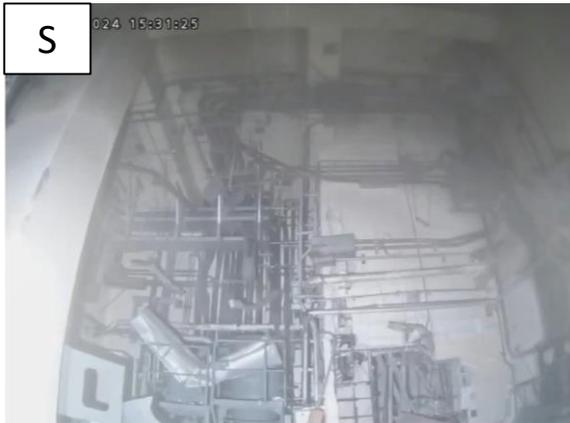
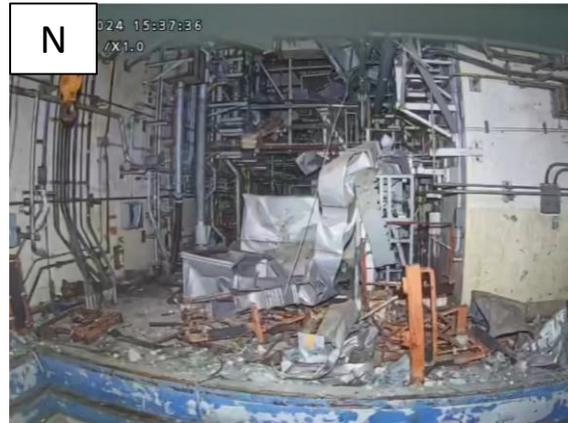
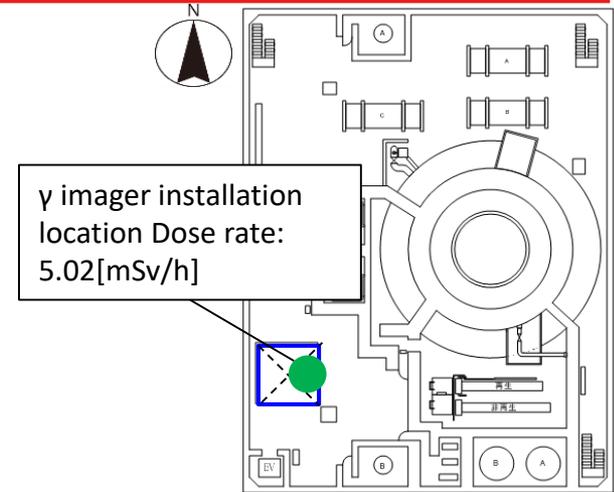
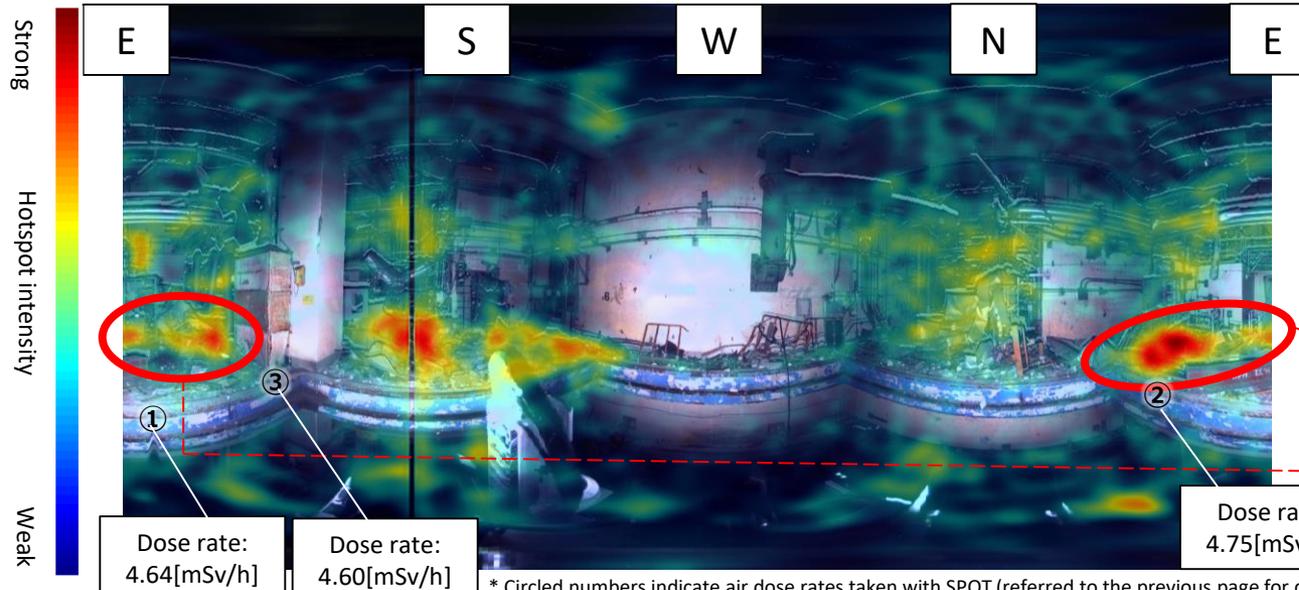
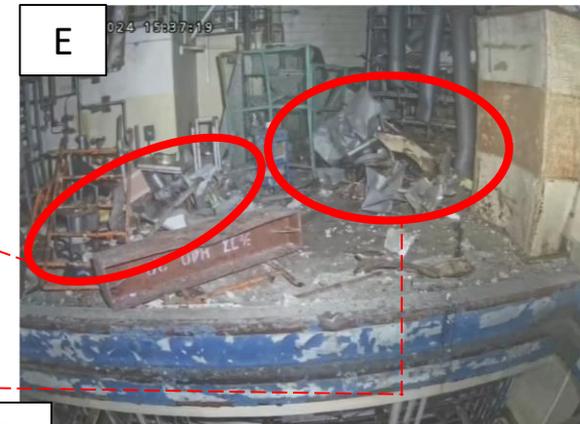
Unit 3 R/B 2nd floor,

- γ ray distribution by γ imager measurement
- On the 2nd floor, it was confirmed that the hot spot was around the rubble near the floor.

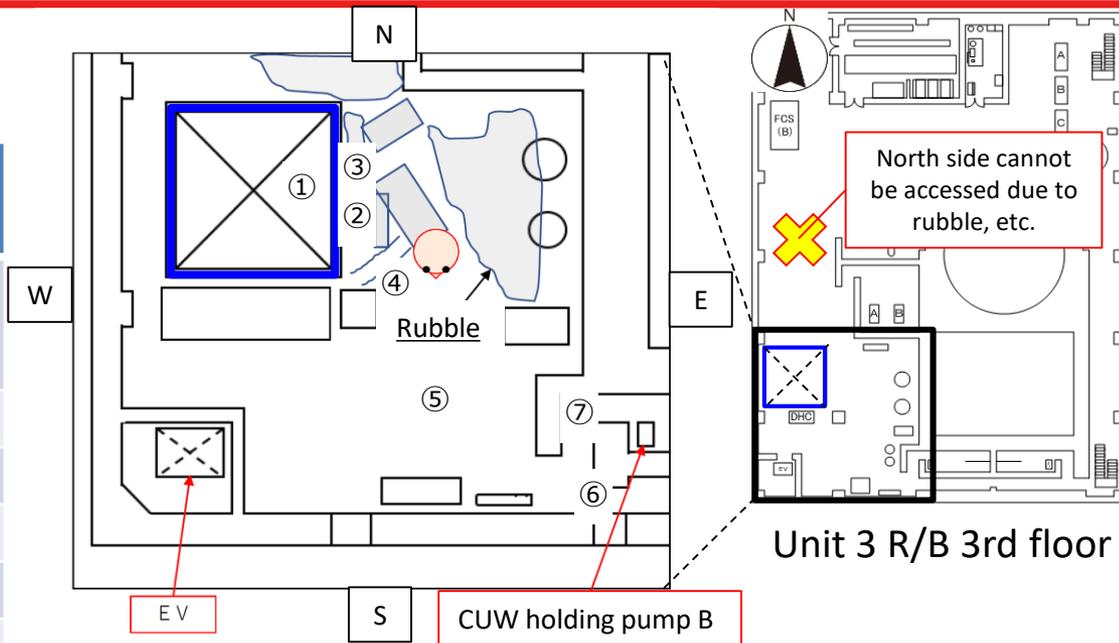
- Air dose rate inside the building
 - 3rd floor, East side
(Measurement date: May 21, 2024)

Measurement location	Height of measurement ※Based on elevation of third floor (T.P.25464)	Dose rate [mSv/h]
①	Approx.650mm ※Mounted on elevated work platform truck	8.21
②	Approx.750mm	10.2
③		10.1
④		12.7
⑤		14.4
⑥		4.75
⑦		3.27

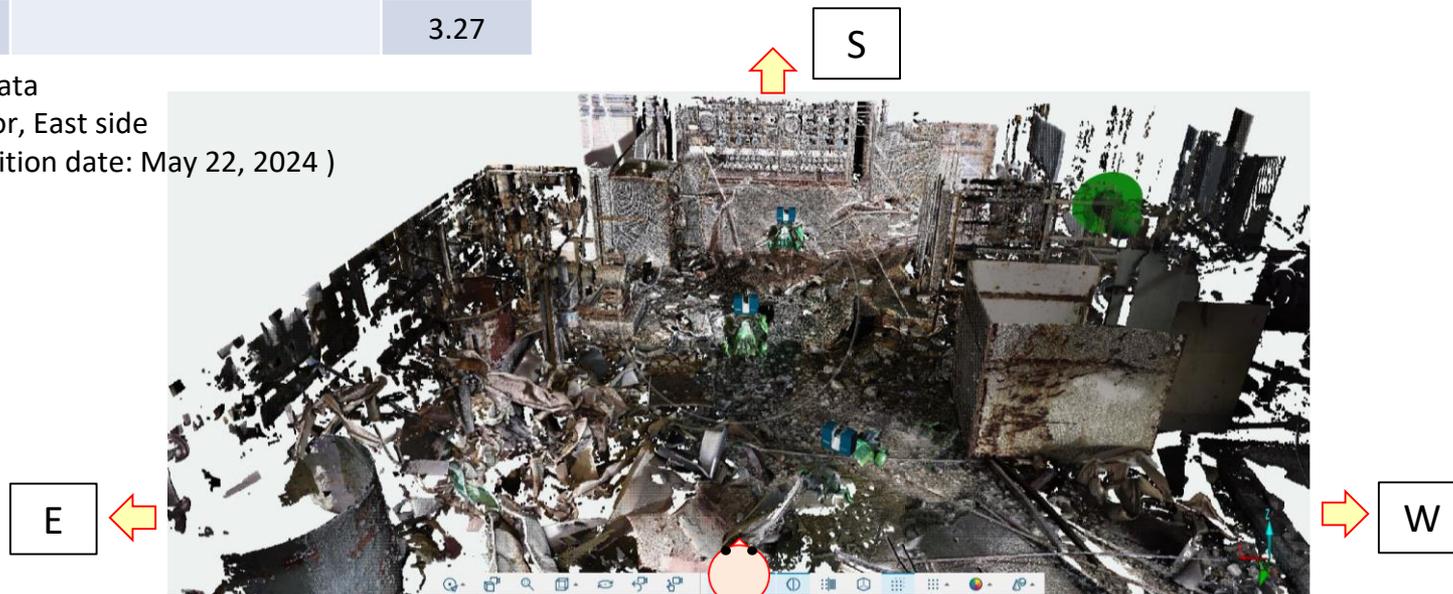
- Point data
 - 3rd floor, East side
(Acquisition date: May 22, 2024)

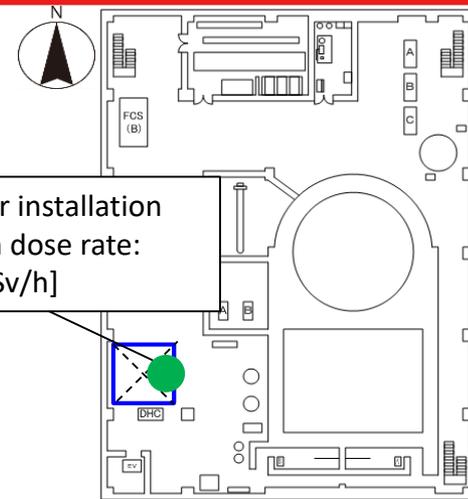
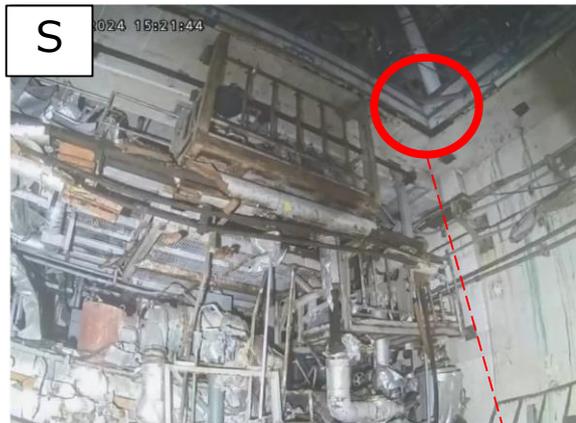
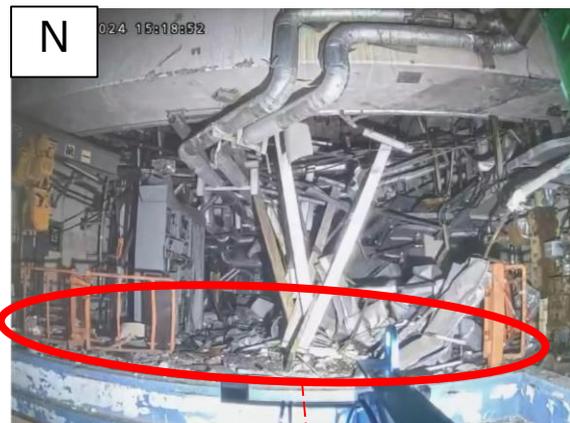
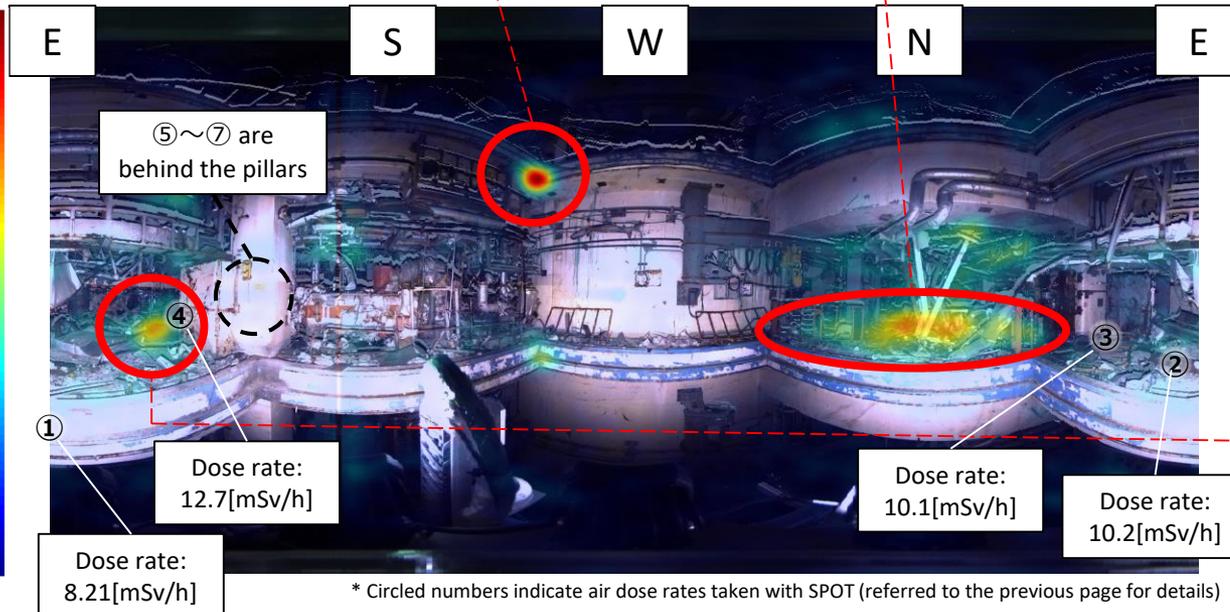
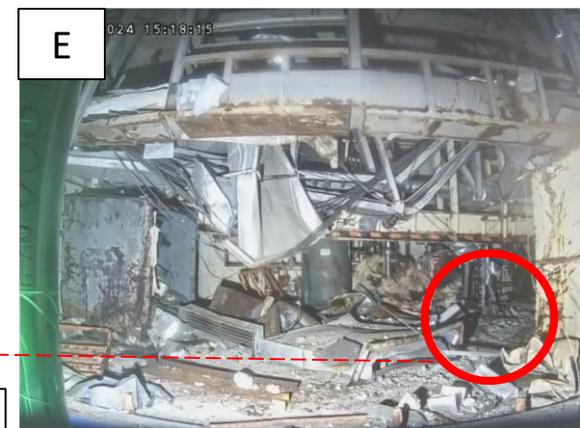
Unit 3 R/B 3rd floor

- γ ray distribution by γ imager measurement
- On the 3rd floor, it was confirmed that the hot spot was around the edge of the top of the equipment hatch and around the rubble near the floor.

γ imager installation location dose rate: 7.89[mSv/h]

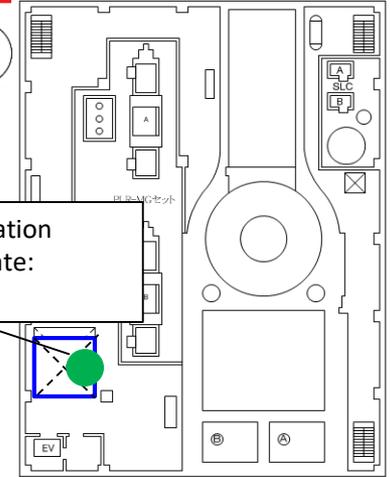
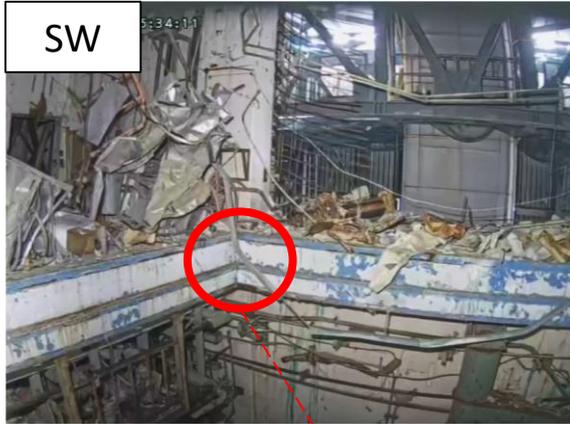
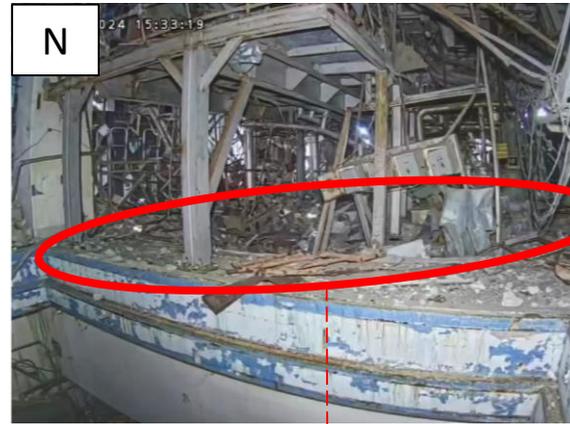
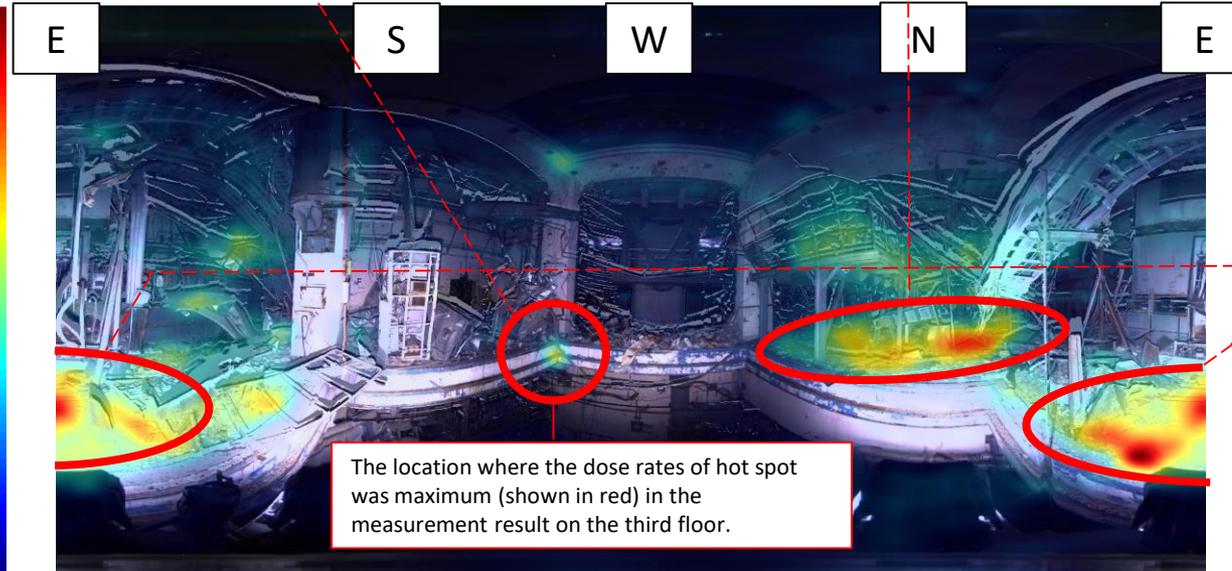
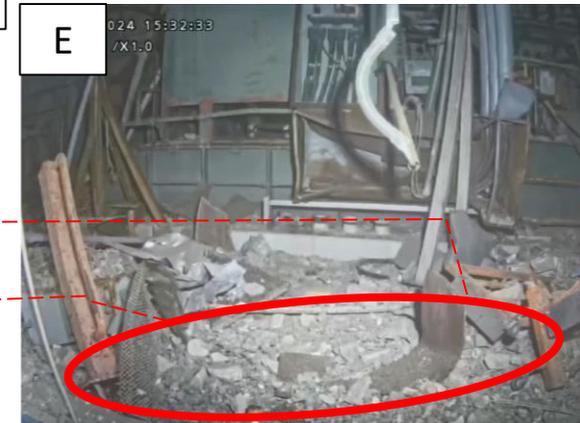
Unit 3 R/B 4th floor

- γ ray distribution by γ imager measurement
 - On the 4th floor, it was confirmed that the hot spot was around the rubble near the floor.
 - Since the intensity of the hot spot on the 3rd floor are relatively weak, it is assumed that dose rates on the 4th floor are higher.

γ imager installation location dose rate: 19.1[mSv/h]
