# Unit 3 Reactor Building Internal Investigation Results

June 27, 2024

Tokyo Electric Power Company Holdings, Inc.

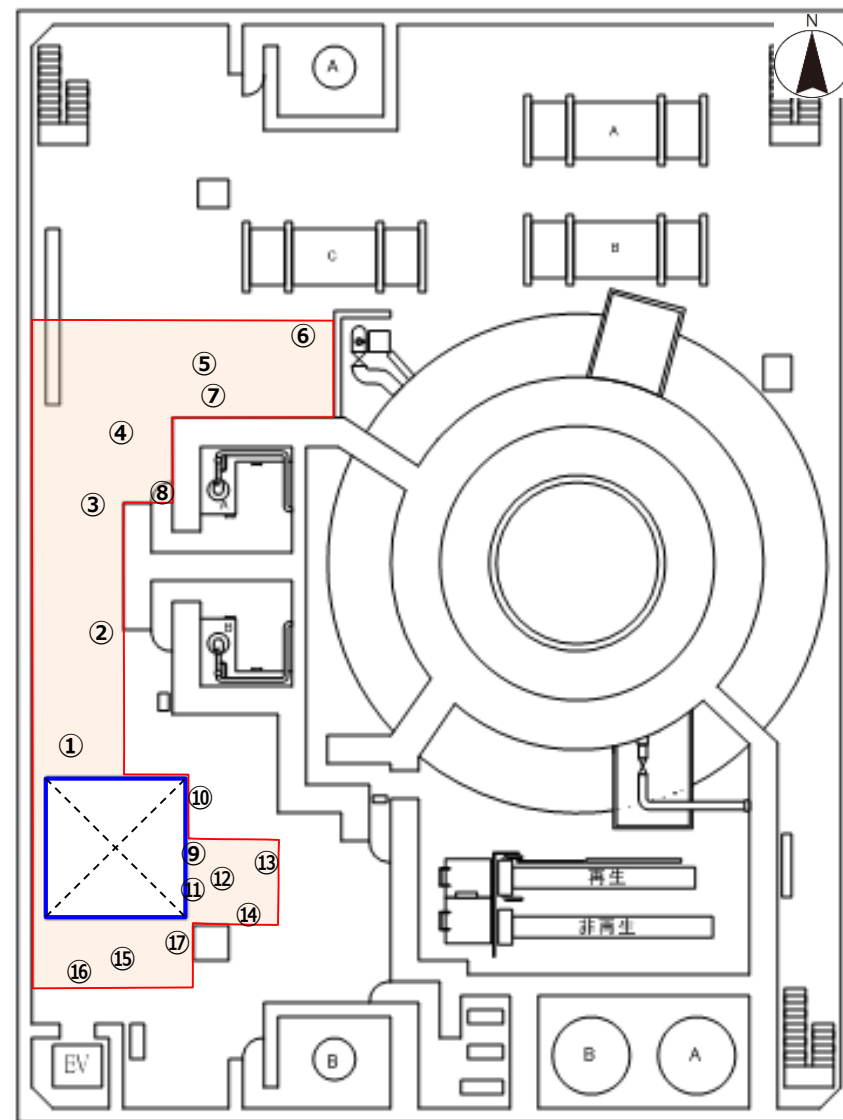
Unit 3 R/B 2nd Floor

- Air dose rate inside the building
- Dose rates on the 2nd floor were confirmed to be between approx. 3~10mSv/h

Measurement location	Height of measurement ※Based on elevation of second floor (T.P.17264)	Dose rate [mSv/h]
①	Approx. 750mm	5.39
②		5.65
③		4.67
④		8.61
⑤		7.84
⑥		8.12
⑦		10.5
⑧		3.48
⑨	Approx. 850mm	4.64
⑩		4.75
⑪		4.60
⑫	Approx. 750mm	6.31
⑬		7.34
⑭		6.24
⑮	Approx. 850mm	7.67
⑯		7.93
⑰		7.20

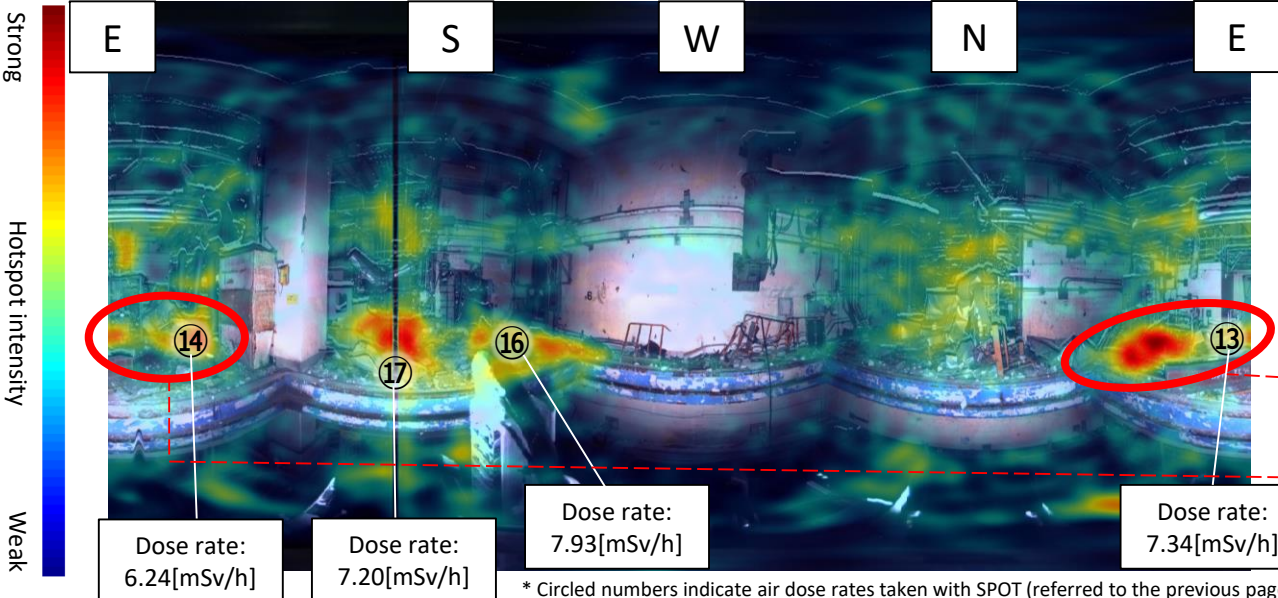
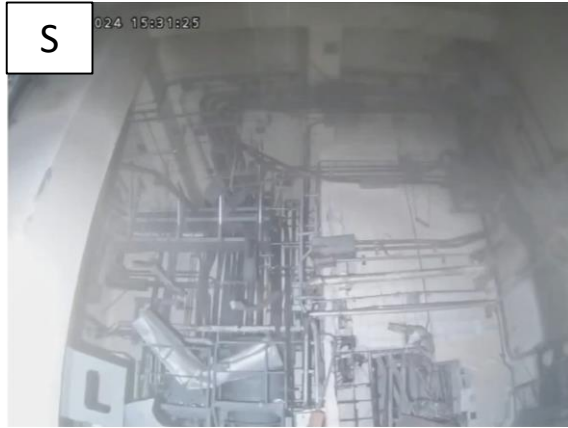
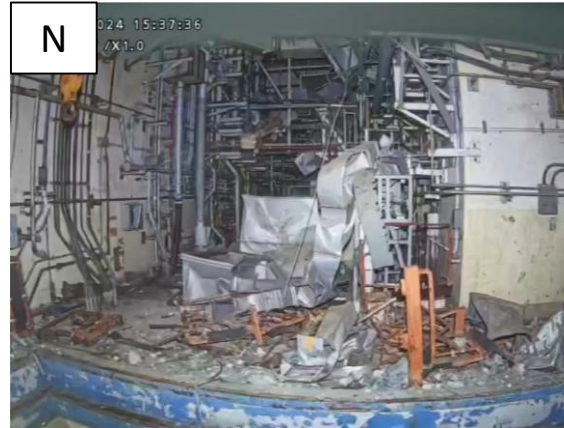
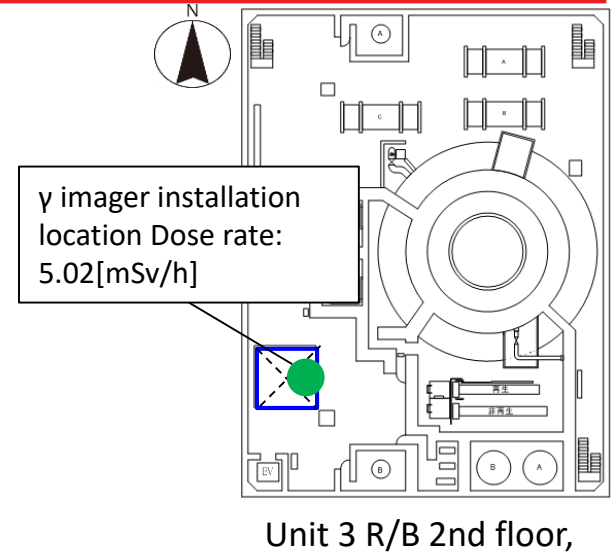
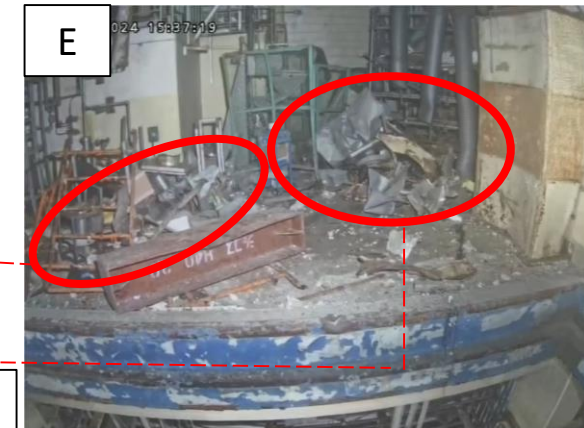
- $\gamma$  ray distribution by  $\gamma$  imager measurement
- On the 2nd floor, it was confirmed that the hot spot was around the rubble near the floor.

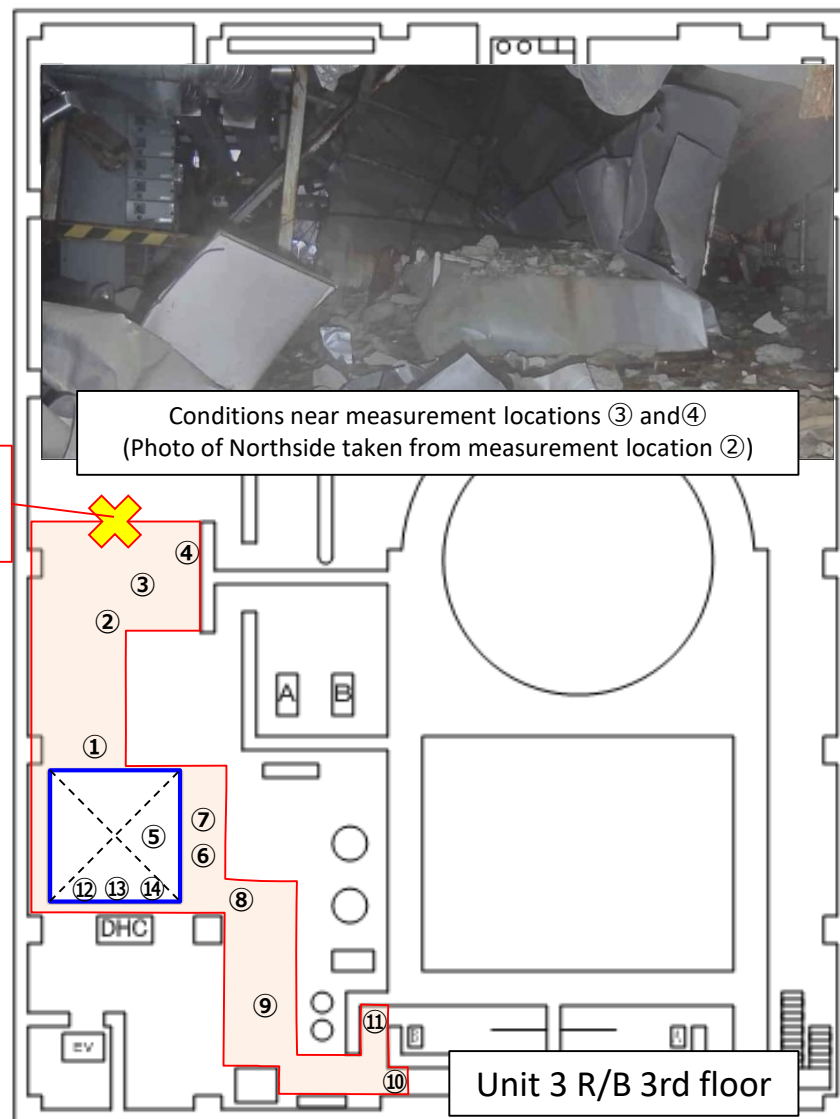
- Air dose rate inside the building
  - On the 3rd floor high-dose rates of over 20mSv/h were measured at measurement locations ②, ③, and ④

Measurement location	Height of measurement ※Based on elevation of third floor (T.P.25464)	Dose rate [mSv/h]
①	Approx. 750mm	15.6
②	Approx. 850mm	<b>21.1</b>
③		<b>28.4</b>
④		<b>28.2</b>
⑤	Approx. 650mm ※Above platform mounted to tracked bucket truck	8.21
⑥	Approx. 750mm	10.2
⑦		10.1
⑧		12.7
⑨		14.4
⑩		4.75
⑪		3.27
⑫	Approx. 1750mm ※Above platform mounted to tracked bucket truck	7.65
⑬		7.13
⑭		7.40

North side inaccessible due to rubble, etc.

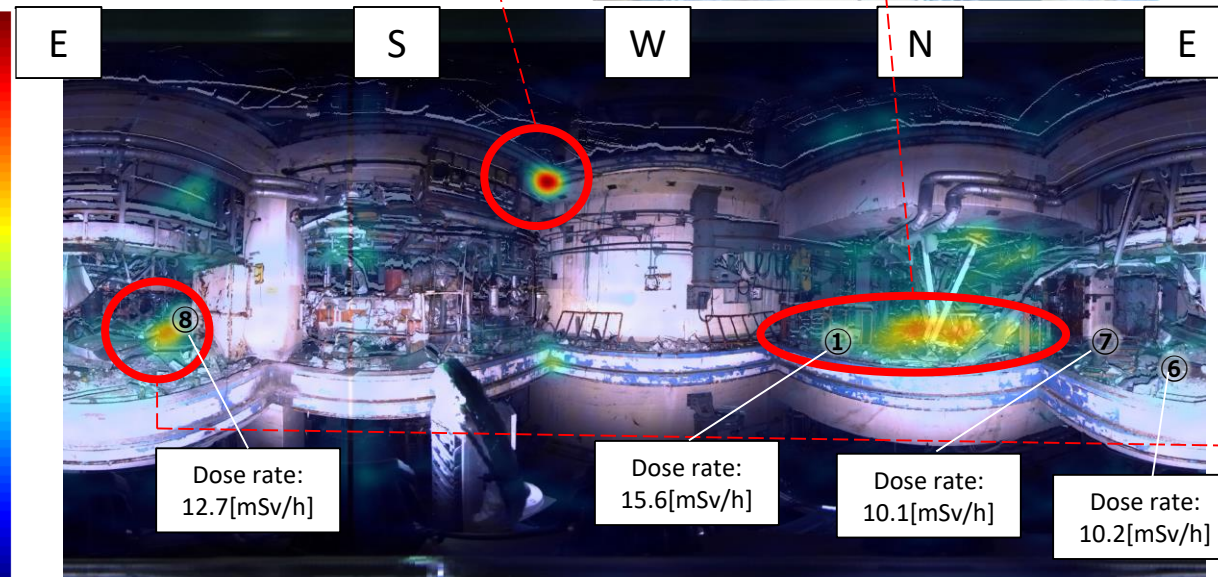
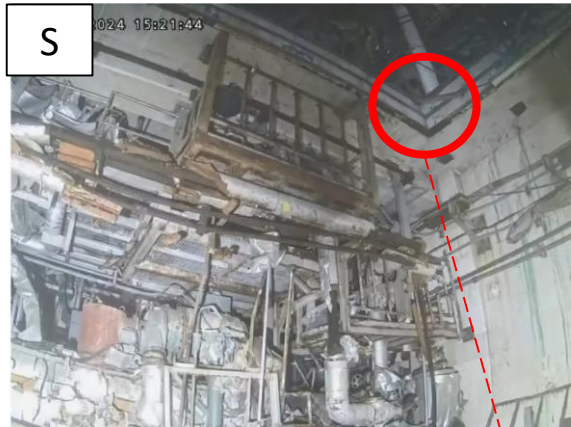
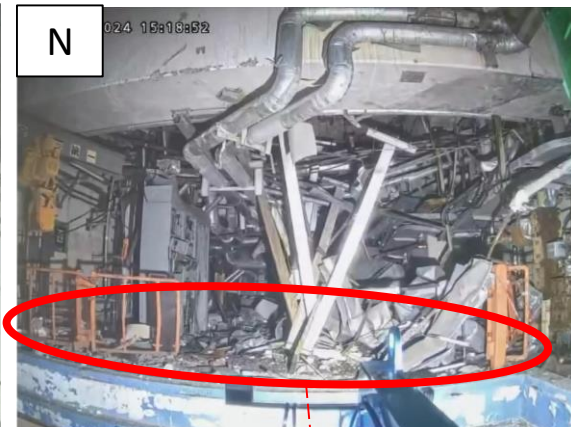
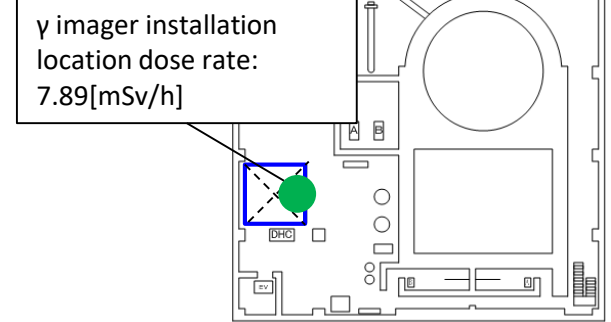
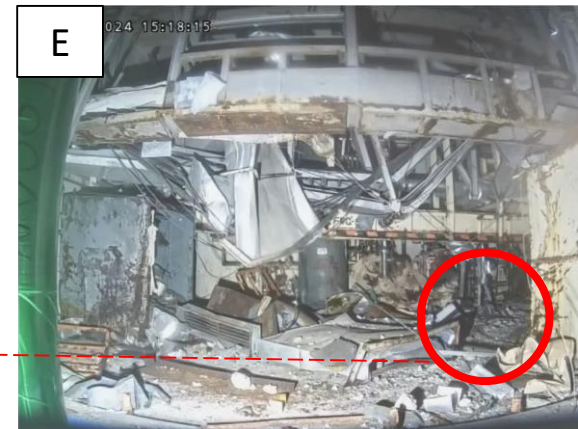
Unit 3 R/B 3rd fl.

- $\gamma$  ray distribution by  $\gamma$  imager measurement
- On the 3rd floor, it was confirmed that the hot spot was around the edge of the top of the equipment hatch and around the rubble near the floor.

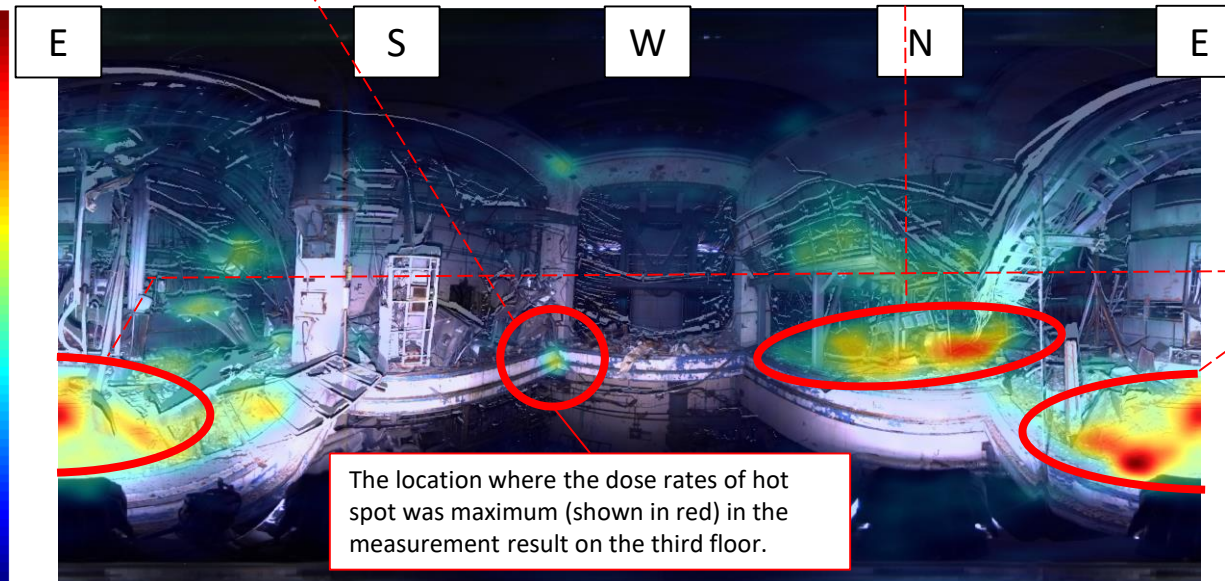
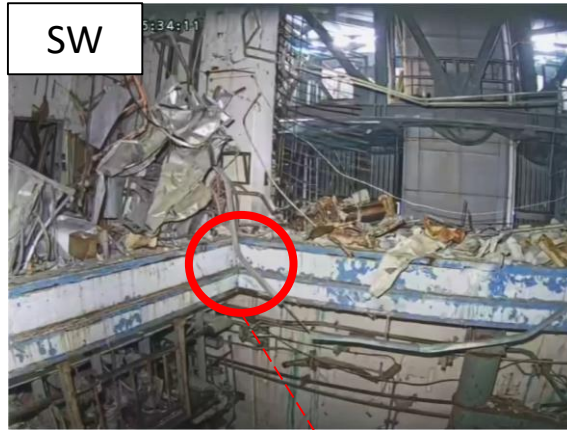
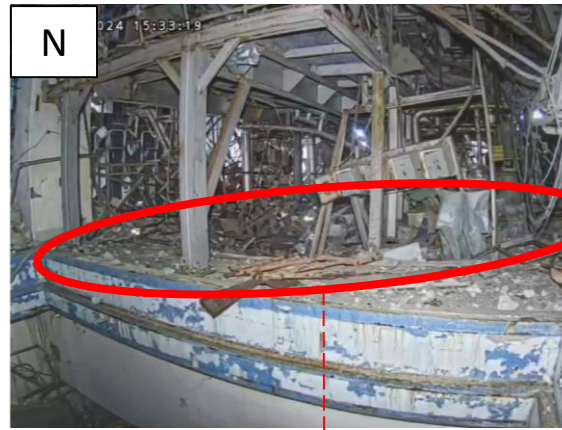
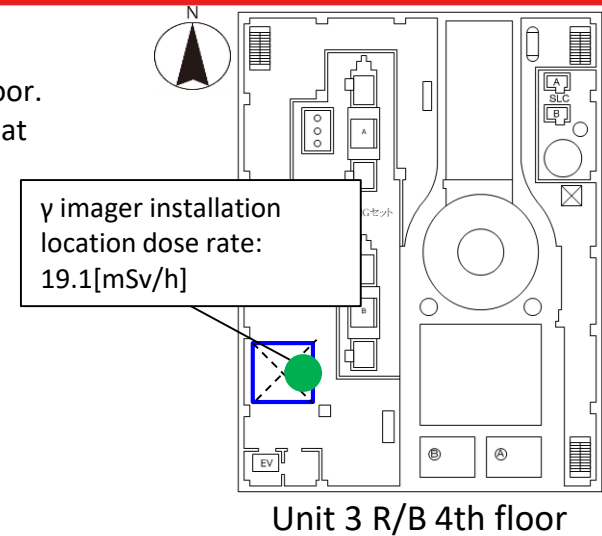
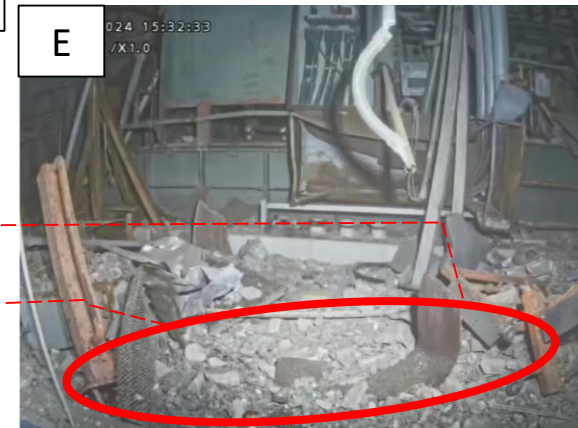
- $\gamma$  ray distribution by  $\gamma$  imager measurement
  - On the 4th floor, it was confirmed that the hot spot was around the rubble near the floor.
  - Since the intensity of the hot spot on the 3rd floor are relatively weak, it is assumed that dose rates on the 4th floor are higher

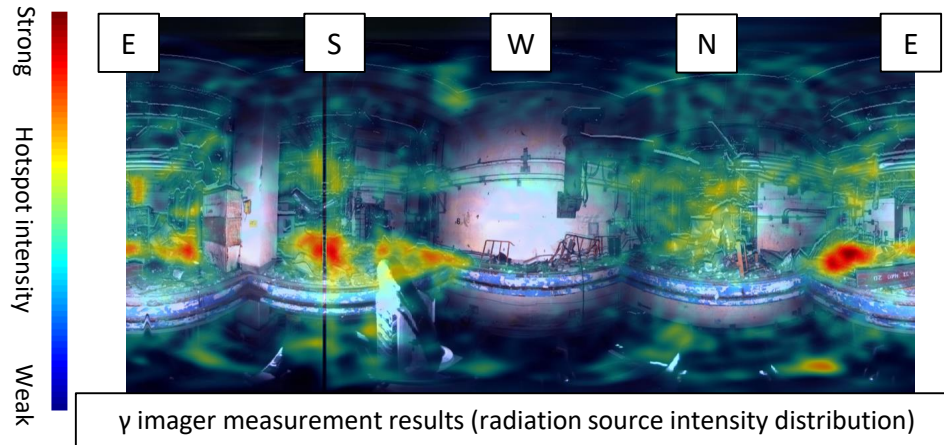
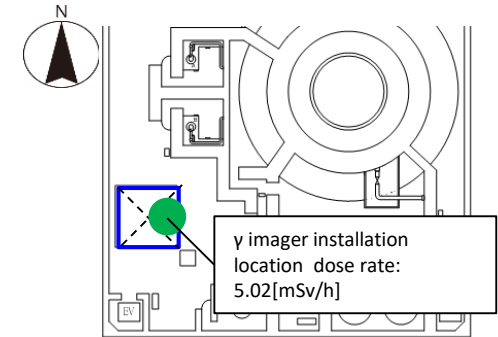
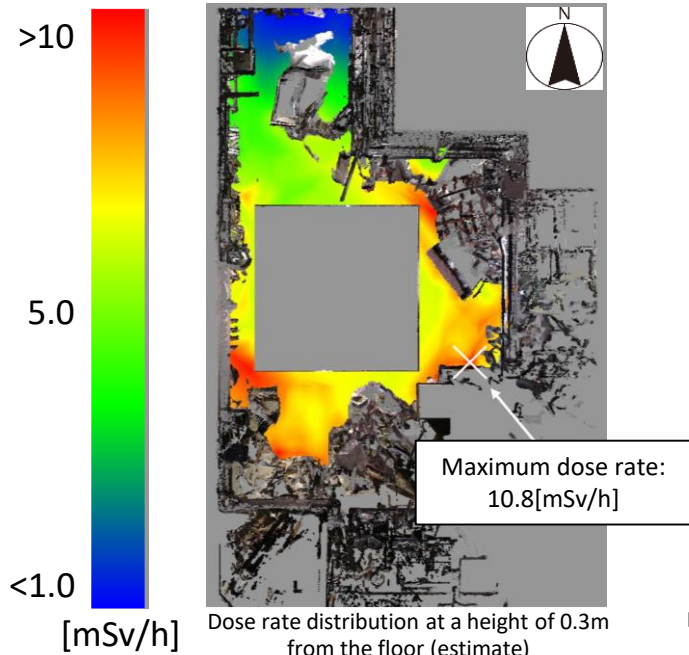
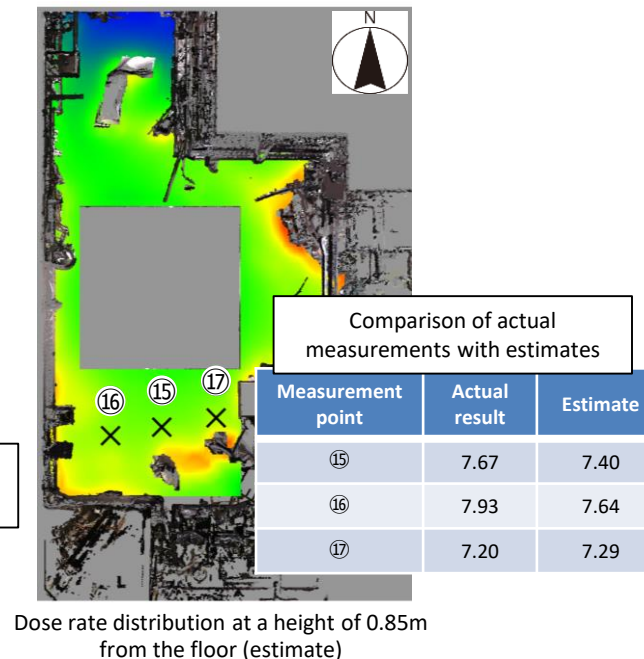
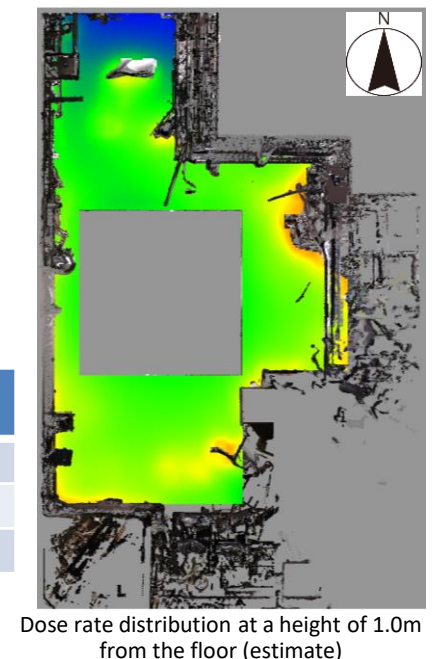
Unit 3 R/B 2nd floor

- Dose rate distribution estimate for the 2nd floor of the Unit 3 R/B (provisional result)
- On the 2nd floor, dose rates were high around rubble on the east and south sides, and maximum dose rate at a height of 0.3m from the floor was estimated to be 10.8mSv/h

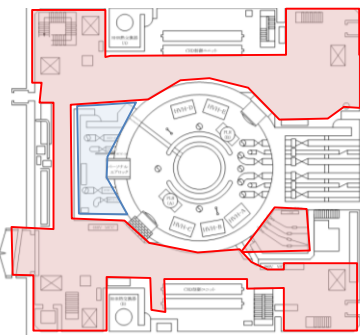
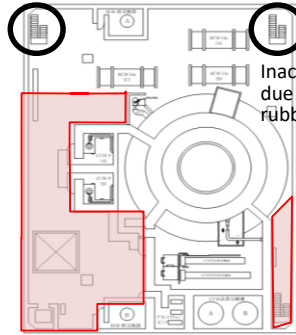
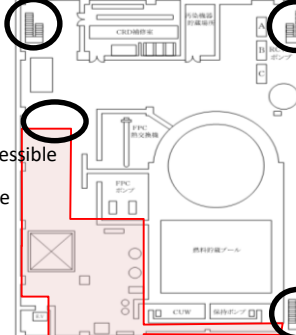
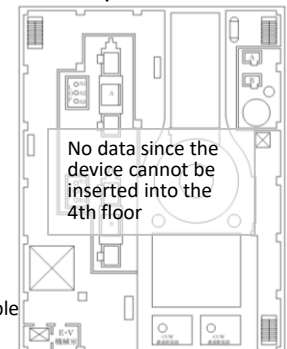
Inaccessible due to stair damage
