- On February 3, 2025, a contractor worker discovered a fire breaking out in the dust collection equipment in the periodic inspection equipment storage warehouse B (site of horizontal tank dismantling), and the fire breaking was declared a “fire” by the Futaba Fire Department. (*Since the horizontal tank being dismantled was unused so there is no contamination, there are no injuries.)

Incident overview I

[Reference] Assumed mechanism of duct scorching (primary incident) **TEPCO**

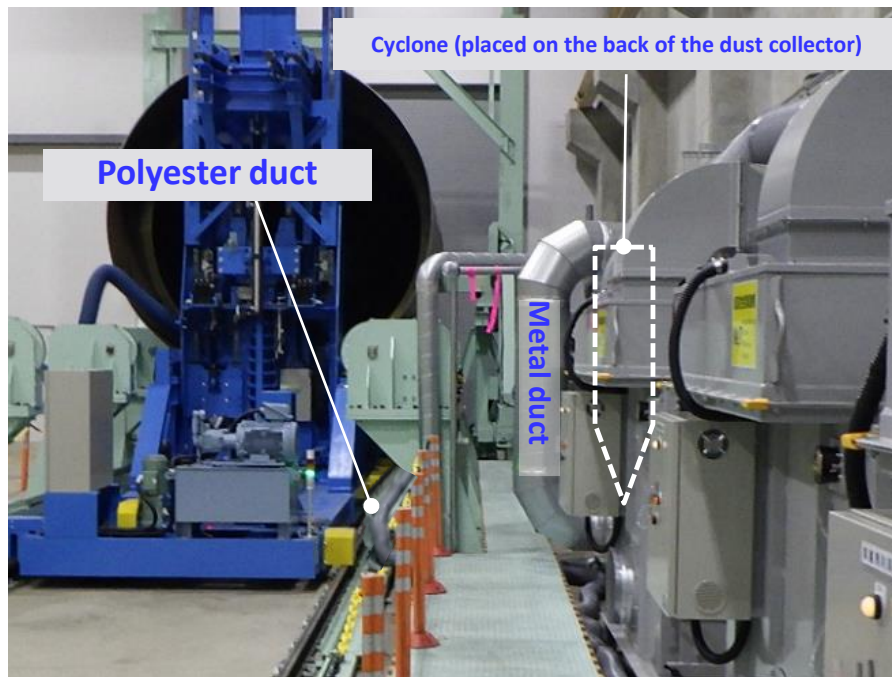
【Before incident】

- Hot cutting scraps are generated when the cutter is used to cut the horizontal tank, so a cyclone trap the large particles and the filter inside the dust collector trap the fine particles, while also cooling by the intake air of the dust collector, etc.
- Around 2:00 PM on February 3, 2025, a fire broke out during cutting of the horizontal tank (unused) and the polyester duct connected to the dust collection pocket and cyclone was fire damage.
- The cover of dust collector deformed and the cyclone toppled. The metal duct also became disconnected.

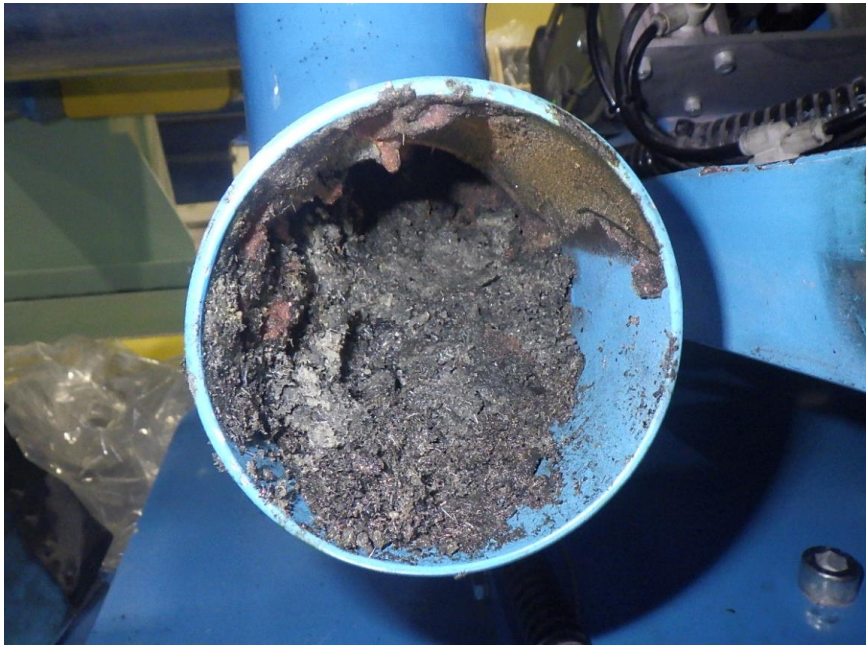
- When checking the adjustment dial for the cutting oil sprayed onto the cutter during cutting, it was found that the dial was pointed at 5.0mL/minute, which is more than normal (2.5mL/minute).
- Accumulated clumps of scraps of metal from the horizontal tank restricted airflow inside the duct.
- The top and bottom of the dust collector were deformed outward.

Duct with accumulated cutting scraps

Basic approach①—Preventing airflow inside of the dust collection pocket and duct from being restricted

- Consider to measure preventing the generation of cutting scraps and the accumulation of cutting scraps to accumulate inside the dust collection pocket and duct.

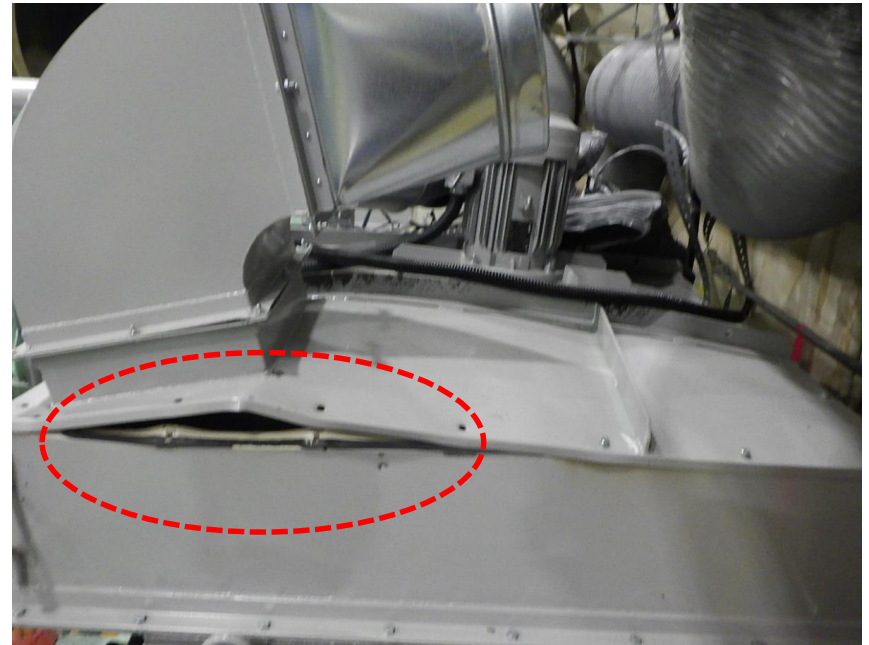
Top of dust collector deformed outward

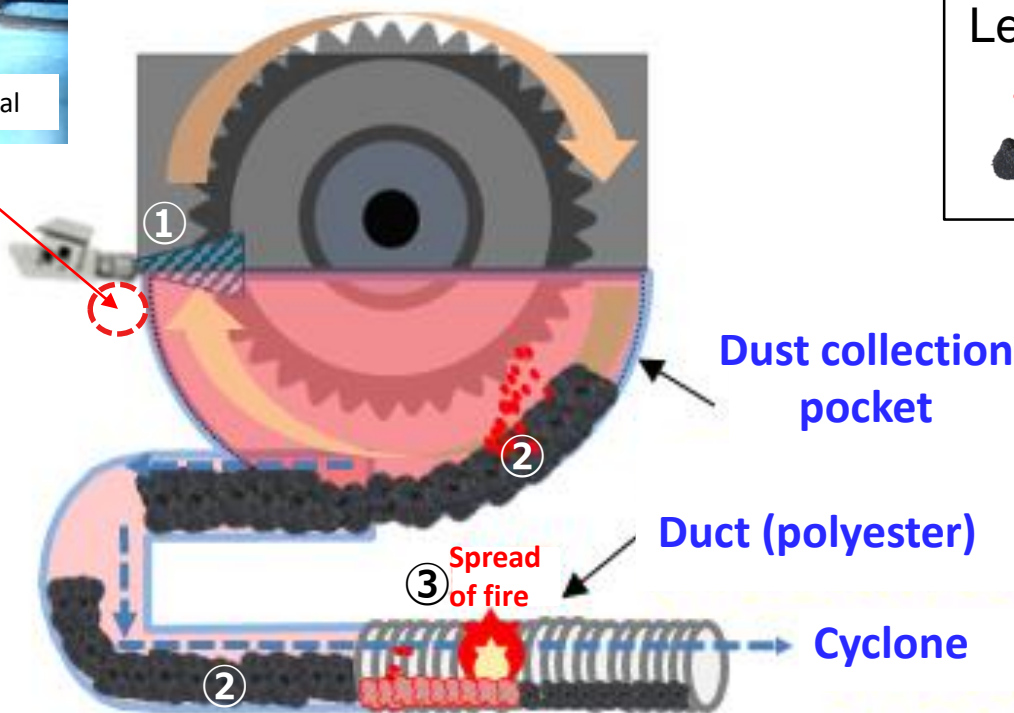
【Around the area of the tank being cut】

The cutting oil adjustment dial was unintentionally changed dulling preparation work on the day (①) causing many clumps of scraps of metals were generated and accumulated inside the dust collection pocket and duct (②). Decreased the airflow and cooling function of the duct and dust collection pockets caused high temperature scraps of metals to not cool sufficiently leading to become a fire source and burning out of the duct (③).

Basic approach②—Cooling cutting scraps

- Consider to adopt a different cooling method in addition cooling by the intake air of the dust collector.

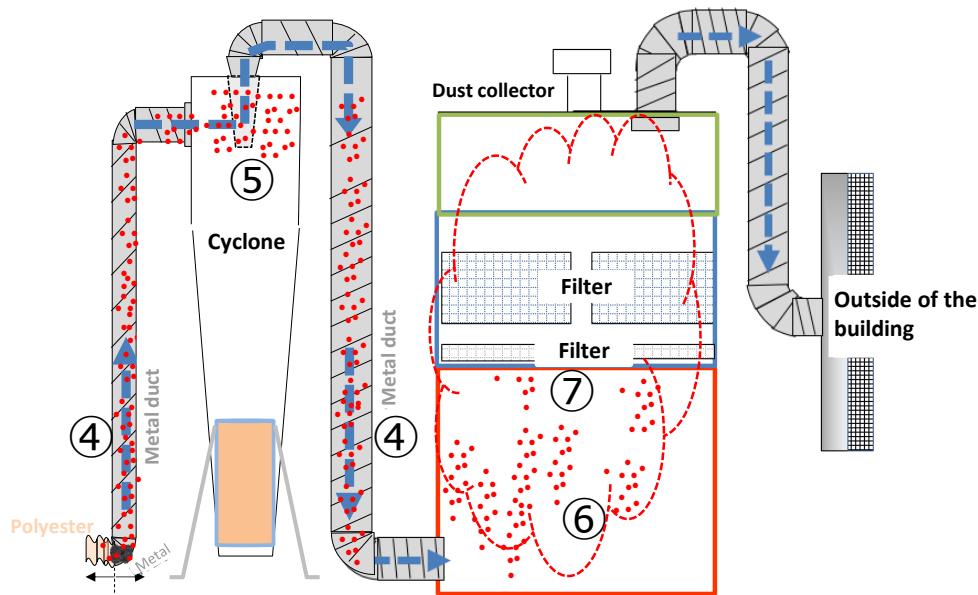
【Area around the cyclone/dust collector】

Duct burning out caused high temperature gas and dust particles to be generated (④). Because of airflow inside the duct was restricted and the capacity of the cyclone to collect dust particles was decreased (⑤), high temperature gas and dust particles accumulated inside the dust collector and ignited (⑥). The resulting shock caused deformation of the dust collector cover and etc. (⑦).

Deformation of the dust collector cover was a secondary incident caused by the duct burning out, so it is important to prevent the duct burning out.

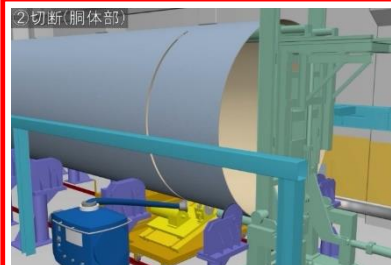
Cutting **The incident was occurred at this step**

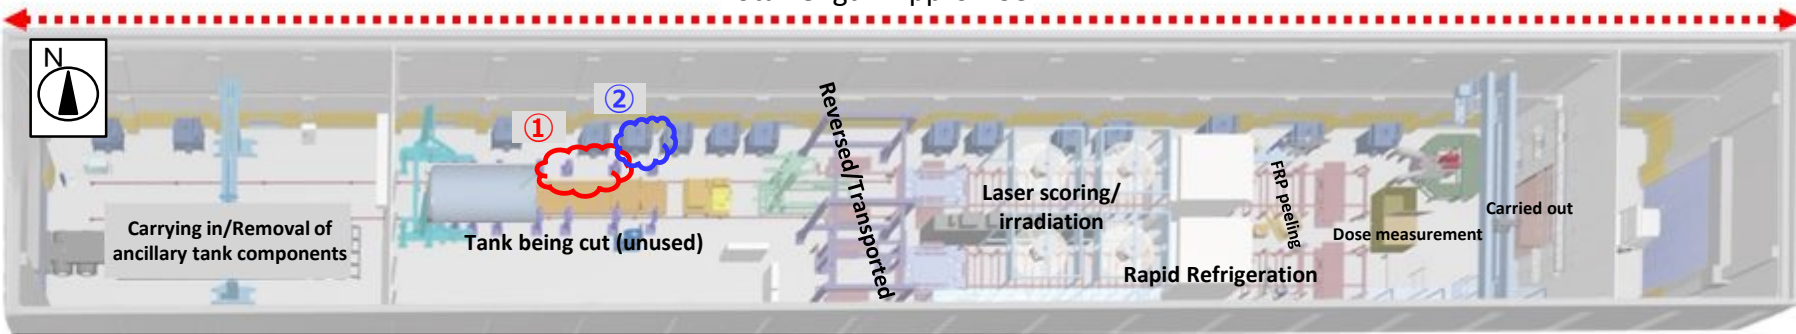
① : Duct burning out ② : Dust collector deformation, etc.
