Fukushima Daiichi Nuclear Power Station Measurement/confirmation tank Group B inspection results (corrosion on the manhole)

< Reference document >
J u n e 1 2 , 2 0 2 5
Tokyo Electric Power Company Holdings, Inc.
Fukushima Daiichi Decontamination &
Decommissioning Engineering Company

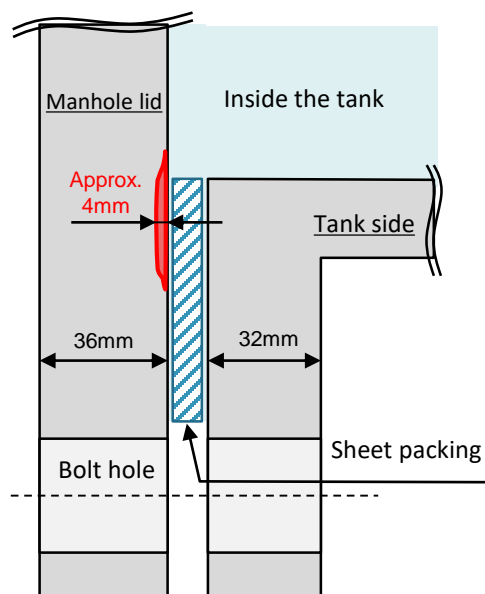
- K4-B4: approximately minimum 32mm on the lid side (approximately maximum corrosion thickness: 4mm)
 - K4-B6: approximately minimum 32mm on the lid side (approximately maximum corrosion thickness: 4mm),
approximately minimum 26mm on the tank side (approximately maximum corrosion thickness: 6mm)

K4-B4 tank corrosion condition

- In addition, after repairing the area of corrosion on the manhole with metal putty, a Liquid gasket was applied to improve sealing performance.

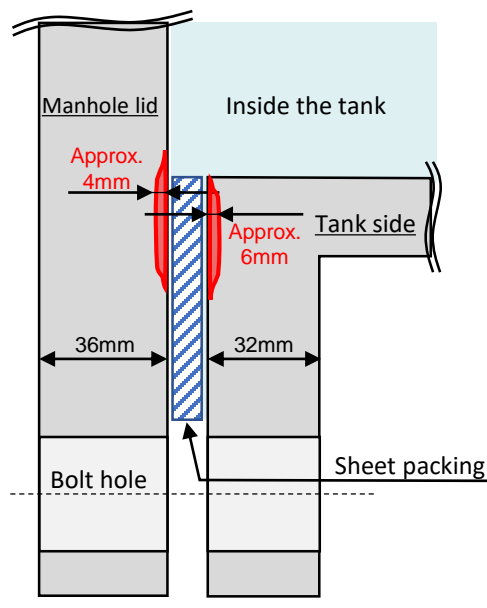
K4-B6 tank corrosion condition

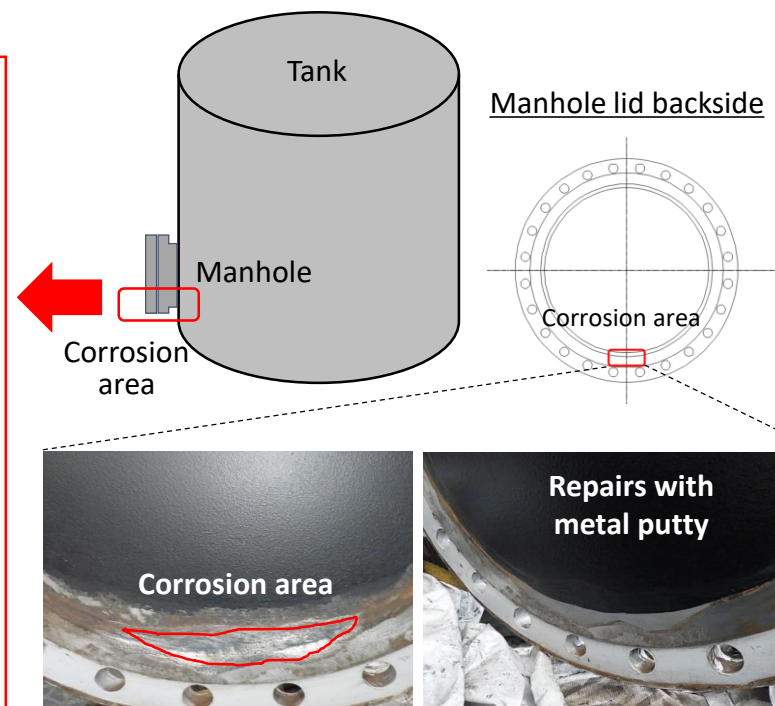
【Prior to repairs】

【After repairs】

Photographed the manhole lid backside (K4-B6 tank)
