Fukushima Daiichi Nuclear Power Station  
Investigation Results for the inside of the Unit 3 Personal Access Lock  
and Past Investigation Results for each penetration

November 30, 2025

Tokyo Electric Power Company Holdings, Inc.

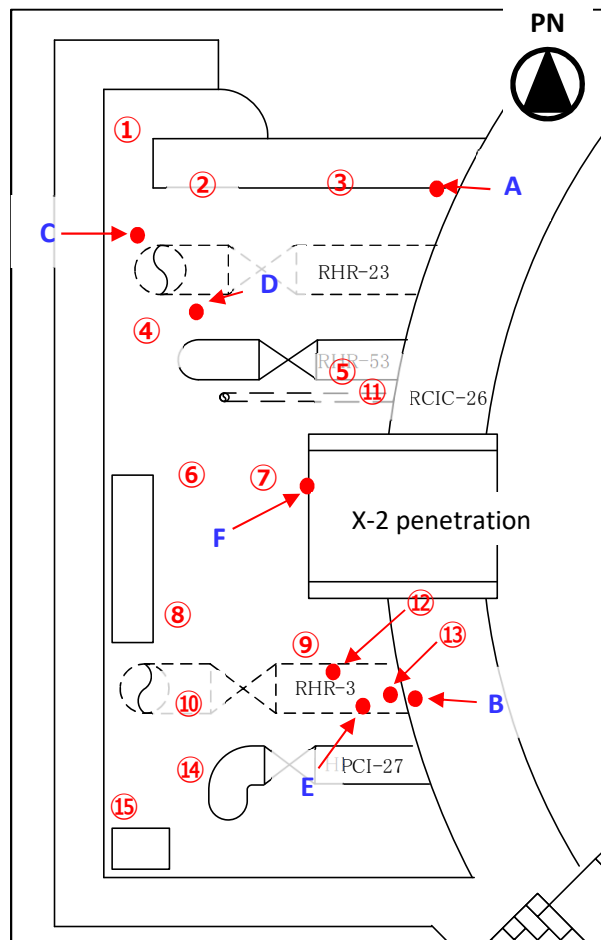
P/A room Dose measurement locations

- The maximum dose rate measured inside the P/A room was 1,120mSv/h (floor surface dose).

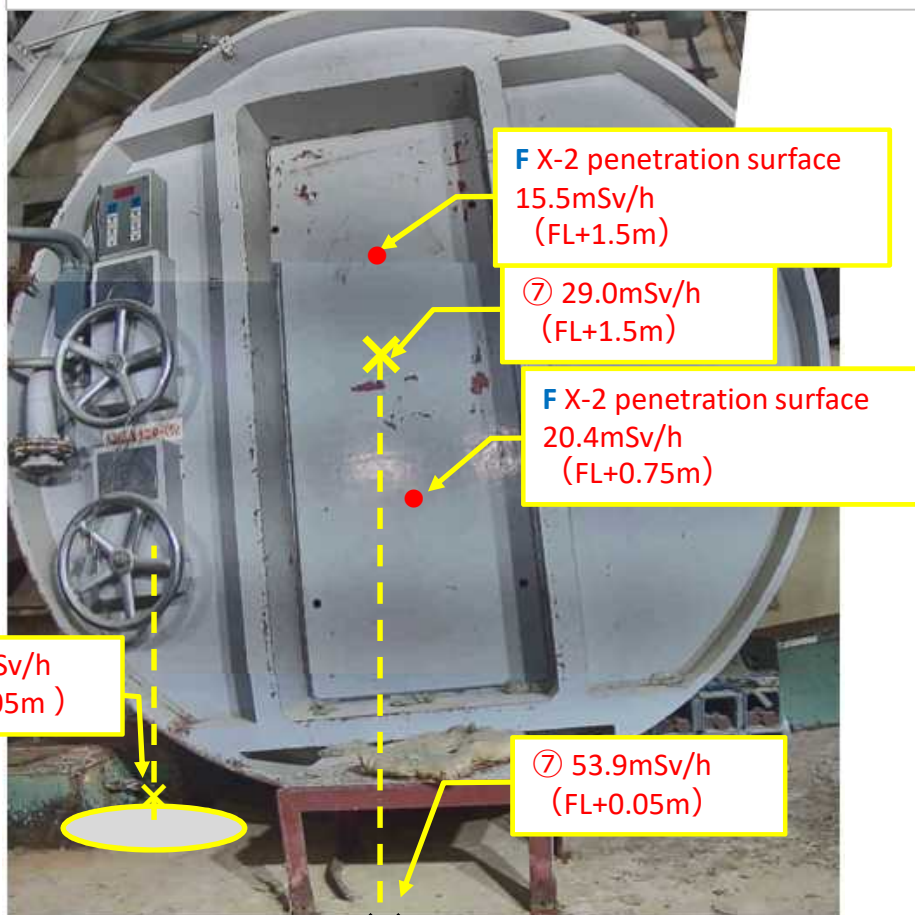
**Arrow I** (Front of X-2 penetration (Near No.⑦) )

- No adhesion of molten material was found on the surface of the X-2 penetration flange like that found in the front chamber of the Unit 2 X-6 penetration, and no signs of leakage or deformations were confirmed.

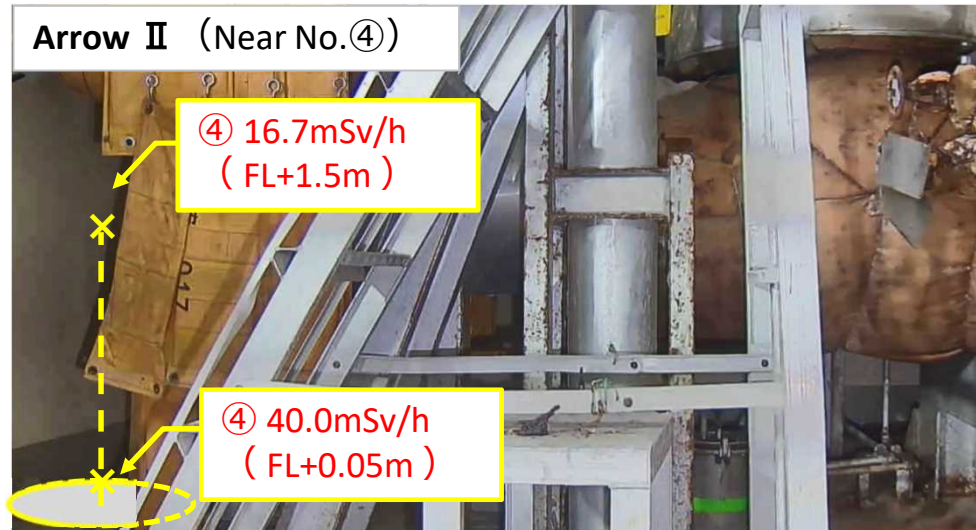
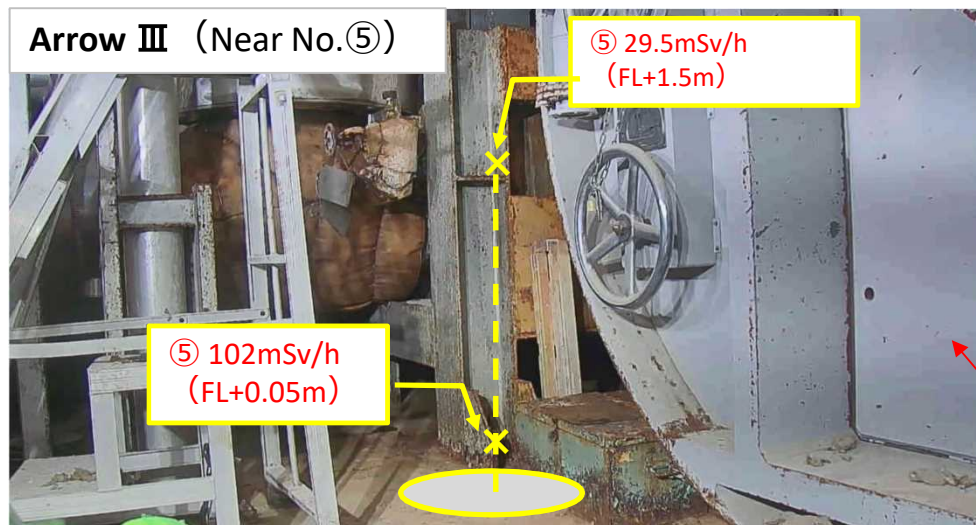
- Some corrosion was found inside the P/A room, but no deformities were confirmed.

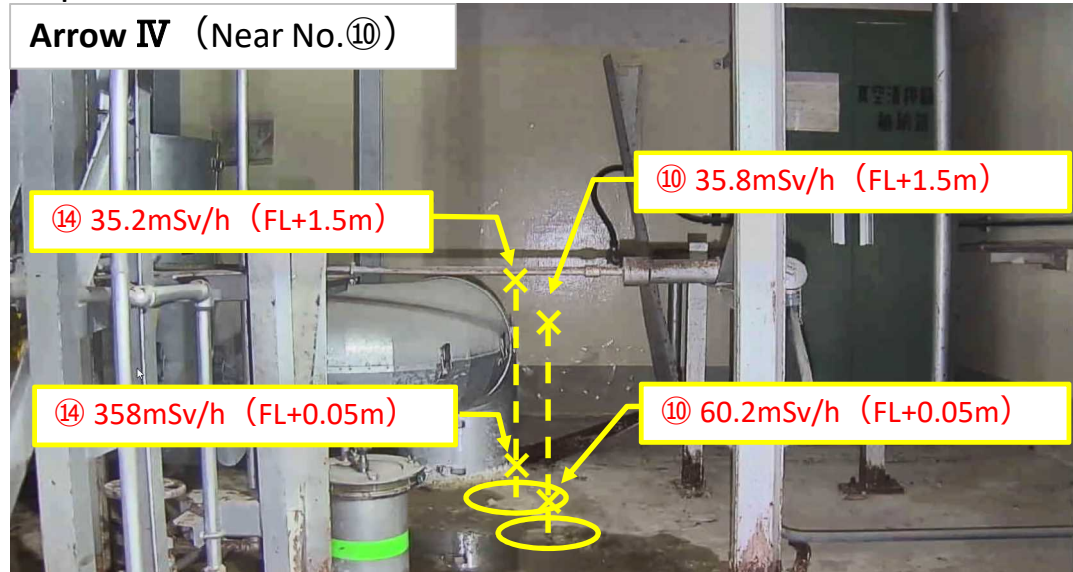
**Arrow IV** (Near No.⑩)

- A strong hotspot of max 1,120mSv/h was confirmed near the floor on the south side of the X-2 penetration.

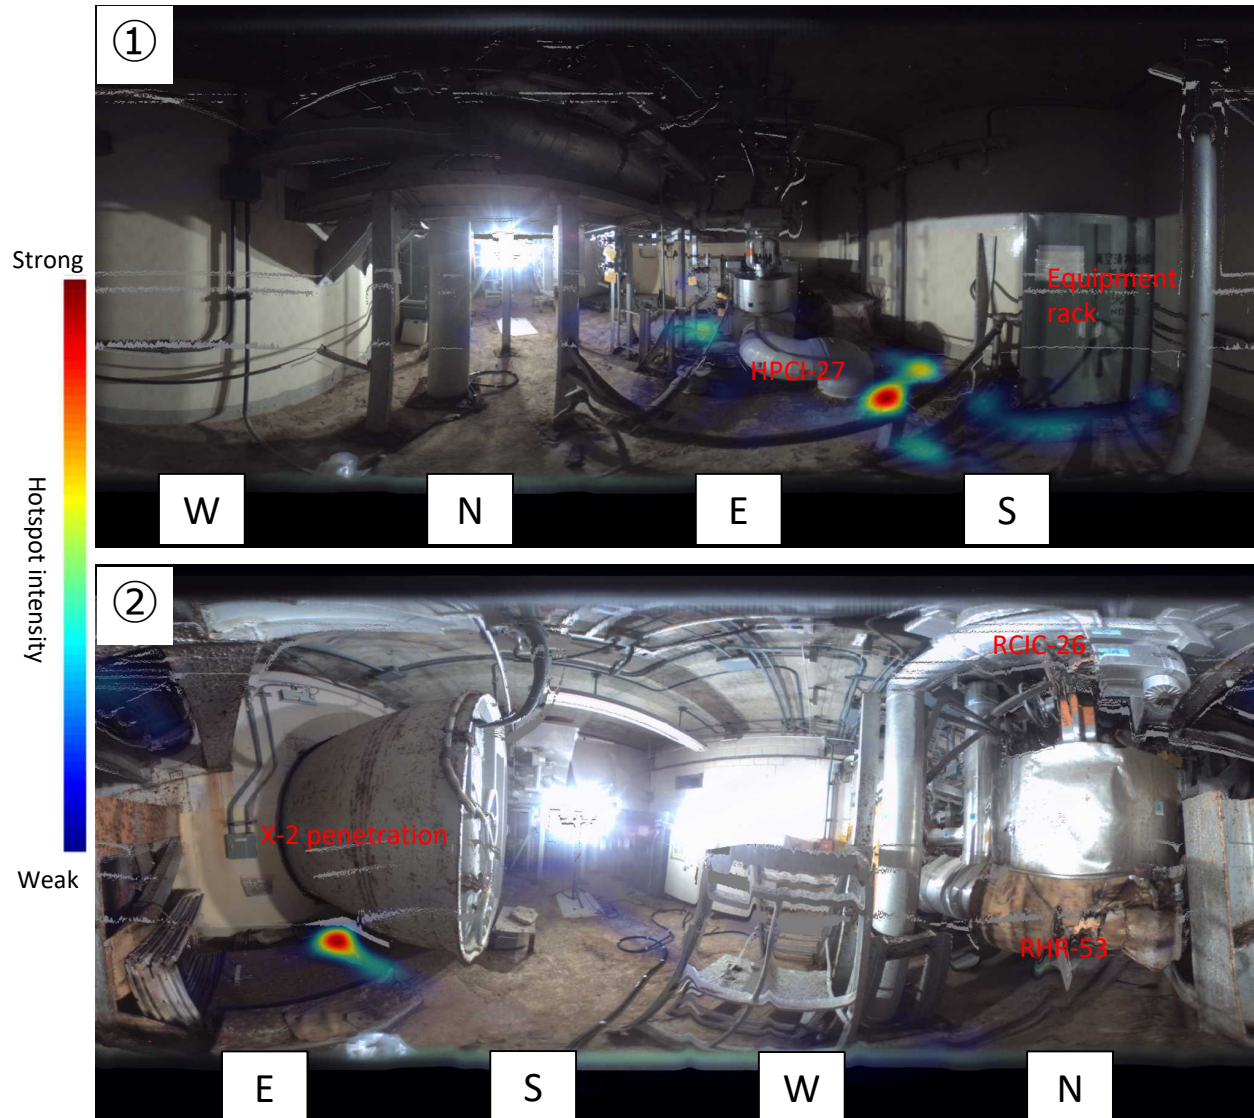
- Dose measurement results show hot spots to exist in the same locations where high doses were measured.
- Hotspots were mainly found on the floor.

➡ In addition to the hotspots identified during this investigation it is possible that there is contamination in other places as well, so G/I measurement results will be analyzed to create a more detailed radiation source distribution.

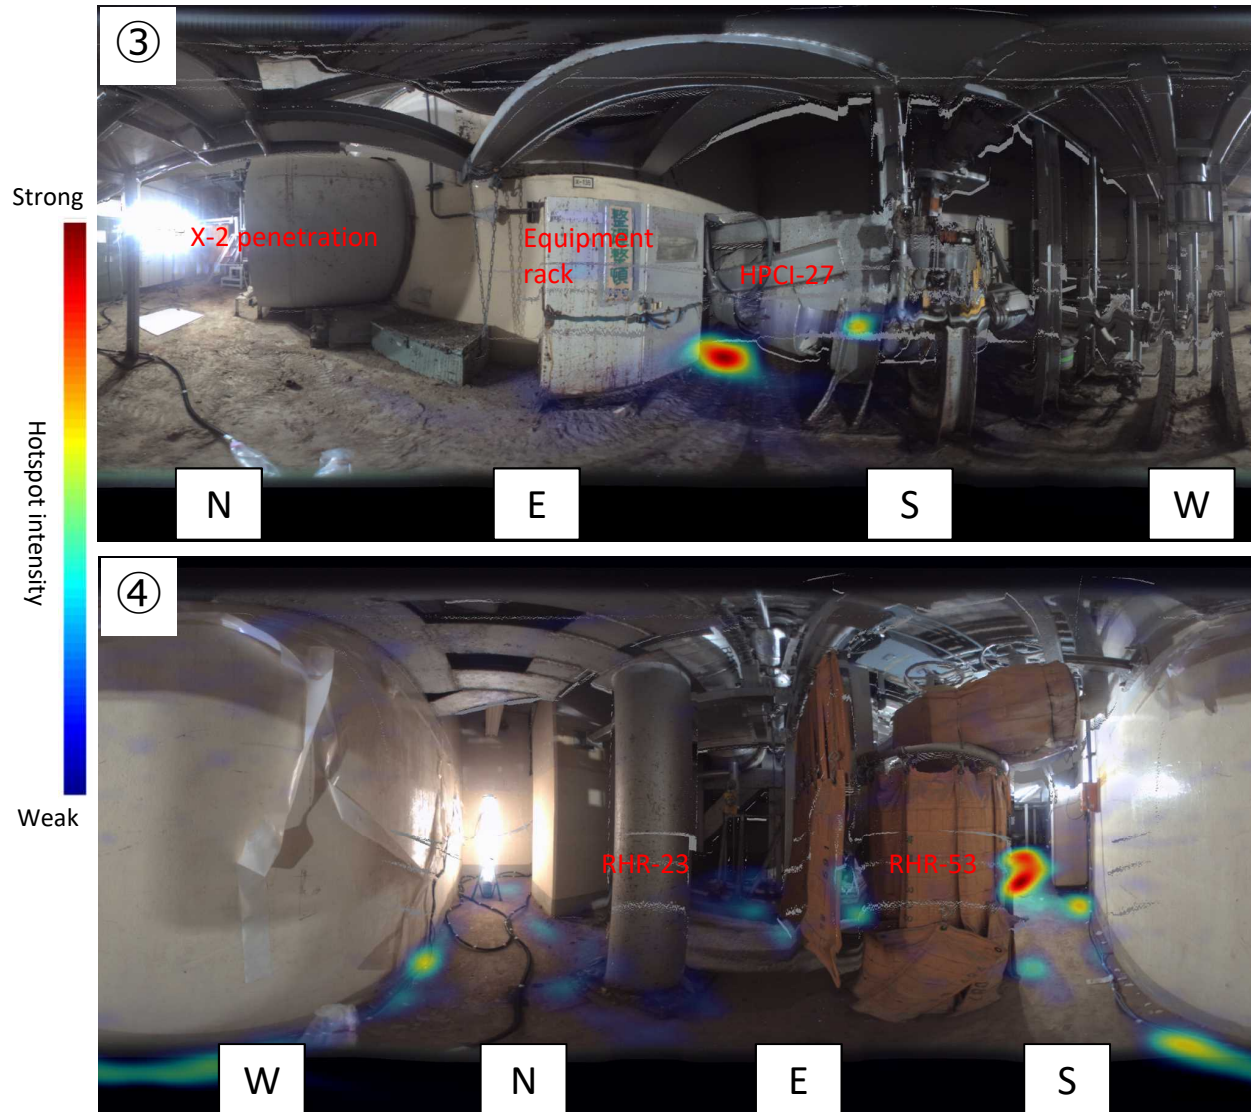
- Dose measurement results show hotspots to exist in the same locations where high doses were measured.
- G/I measurement ④ hotspot is assumed to contribute greatly to the doses from the back of the P/A room.

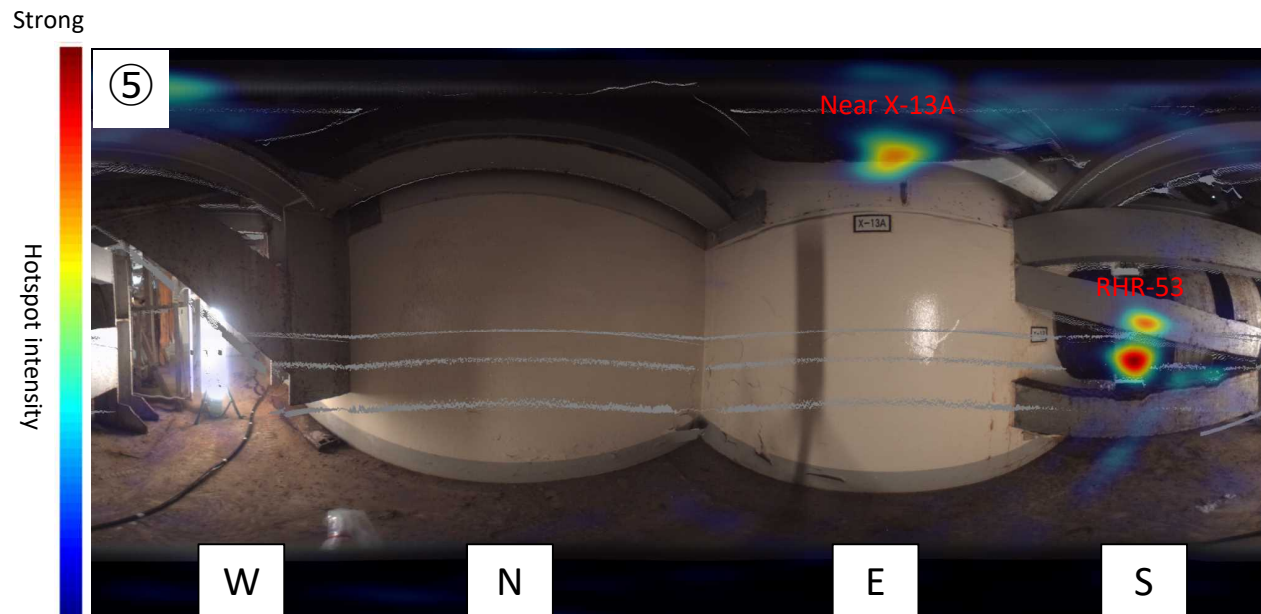
- G/I measurement ⑤ hotspot was found in the direction of the upper penetration (X-13A) and the RHR-53 piping.
- The hotspot in the direction of the RHR-53 piping is assumed to be a contribution from the hotspot found on the north side of the X-2 penetration behind the piping.

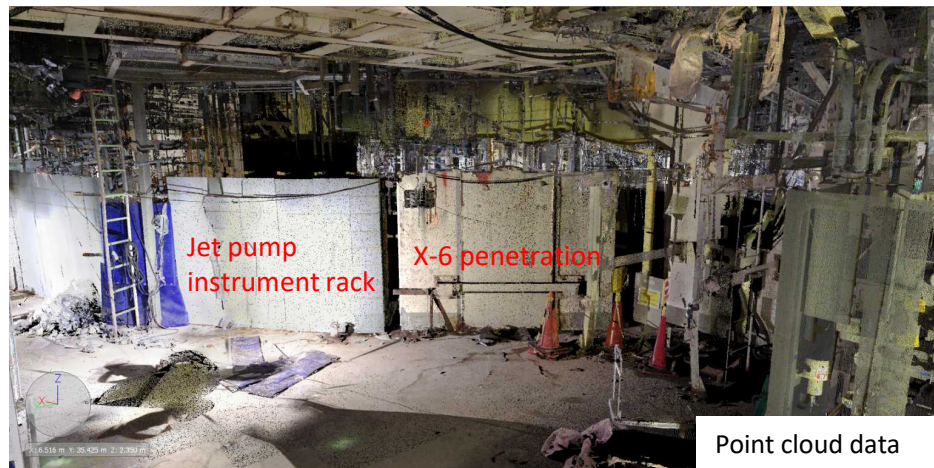
- 124mSv/h was measured near the surface of the Unit 3 X-6 penetration flange, but surface dose is low compared to the investigation results from the Unit 2 X-6 penetration flange surface taken in 2015. Furthermore, molten deposits found on the floor of Unit 2 were not found in Unit 3.
- Steel (concrete block filled) shielding walls have been installed around the X-6 penetration front chamber. Dose investigations and dose reduction measures inside the penetration will be deliberated after removing the shield walls.

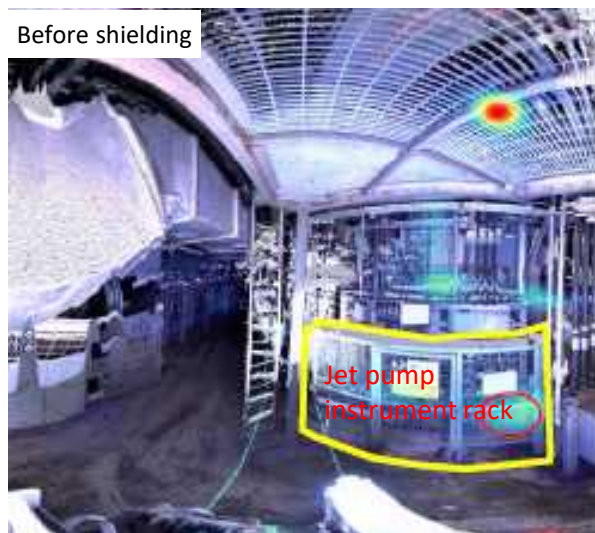
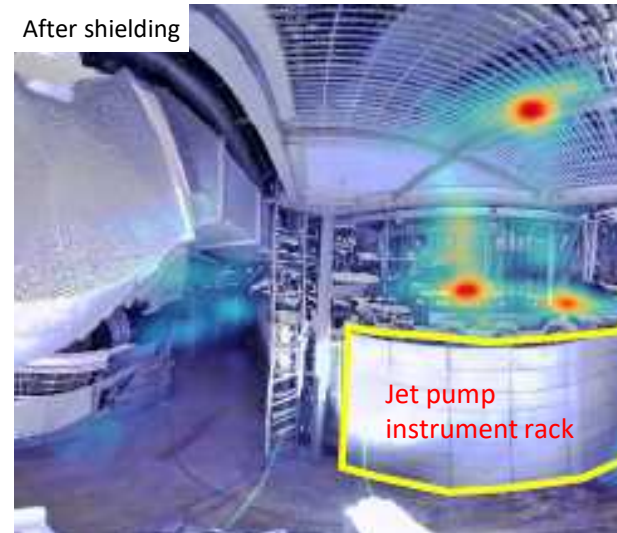
<G/I measurement >  
measurements taken  
between 2019-2020

- The HCU (north side) is greatly affected by doses from the jet pump instrument rack, and it is not clear whether there are any other radiation sources.
- The HCU and jet pump instrument rack, which are the main radiation sources, have been shielded, and the air dose rate around the X-6 penetration is between 3~5mSv/h, thereby prohibiting workers from remaining in the area for a long period of time.

- Dose reduction measures for the jet pump instrument rack closest to the X-6 penetration are being deliberated.
- Due to the difficulty of work implementation, it is expected that much time will be needed to reduce doses in the HCU.

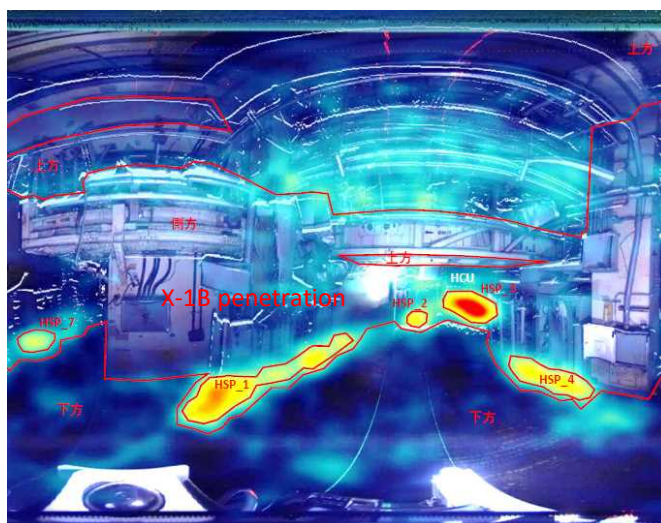
### <G/I Measurement >

- The dose contributions from the HCU (south side) and parts of the floor are substantial, and it is not clear whether there are any other radiation sources.
- The HCU, which is the main radiation sources, has been shielded, and the air dose rate around the X-1B penetration is between 5~8mSv/h, thereby prohibiting workers from remaining in the area for a long period of time.

- Since floor surface contamination is concentrated around the places where existing panels are installed and the edges of the walls, we are deliberating the removal of the existing panels.
- Due to the difficulty of work implementation, it is expected that much time will be needed to reduce doses in the HCU.

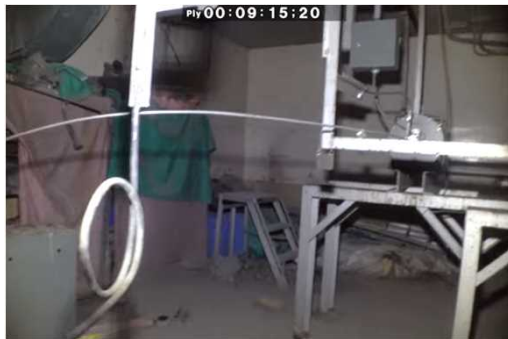
Prior to dose reductions in the TIP room

■ Dose reduction measures were implemented in the Unit 3 R/B 1<sup>st</sup> floor TIP room to reduce exposure for upcoming tasks.

- ① Equipment and sludge removal
- ② Wall decontamination through water spraying
- ③ Pressure wash stripping decontamination of floor surfaces
- ④ Decontamination through mechanical stripping (floor surfaces)
- ⑤ Shield installation

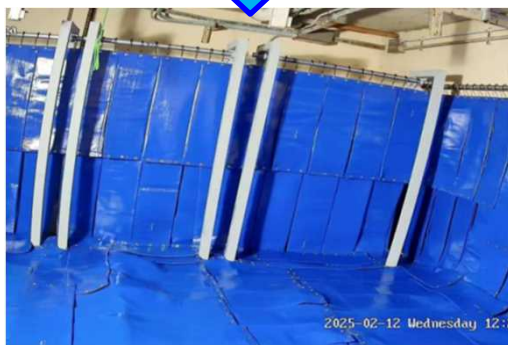
After dose reductions in the TIP room

⇒ Average dose of 1.2mSv/h has been achieved

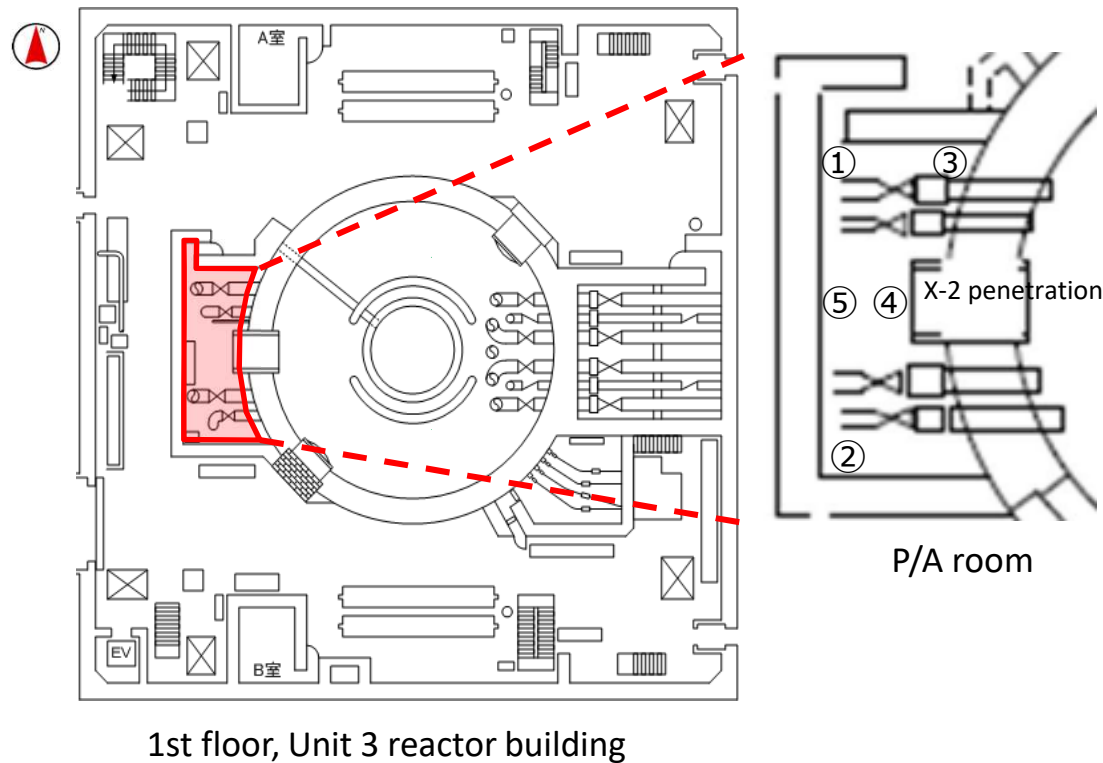
- The investigation in 2016 of the inside the P/A room confirmed high doses.

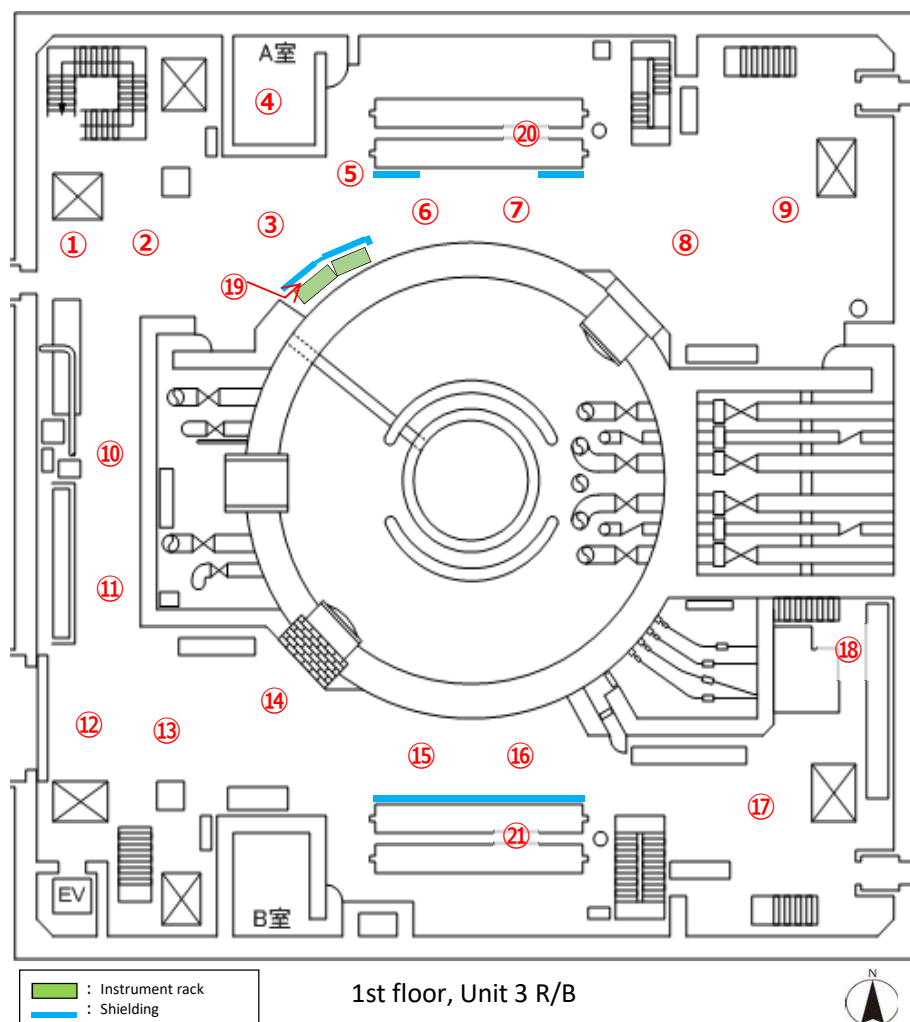
- Air dose rates inside the building
  - Dose rates of greater than 10mSv/h measured in the vicinity of the north/south HCU. Air dose rates in all other areas were between 1~8mSv/h.

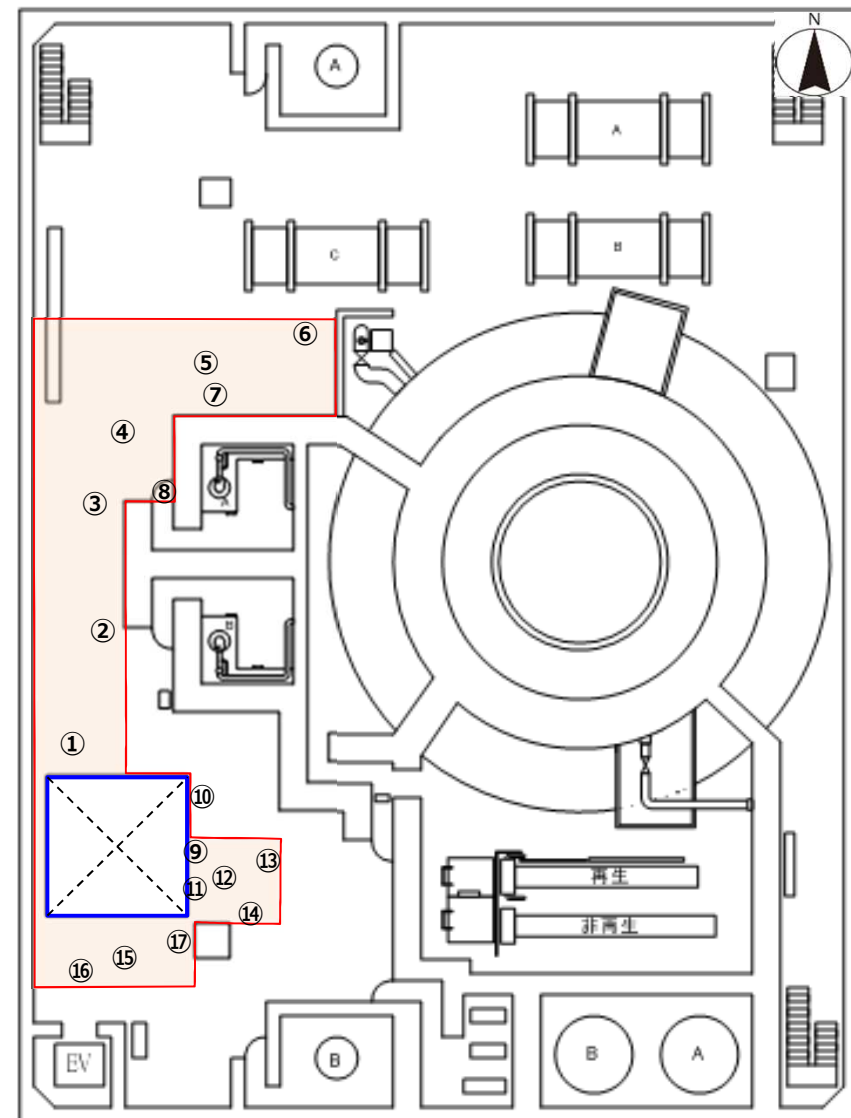
Unit 3 R/B 2nd Floor

- Air dose rate inside the building
  - Dose rates on the 2nd floor were confirmed to be between approx. 3~10mSv/h

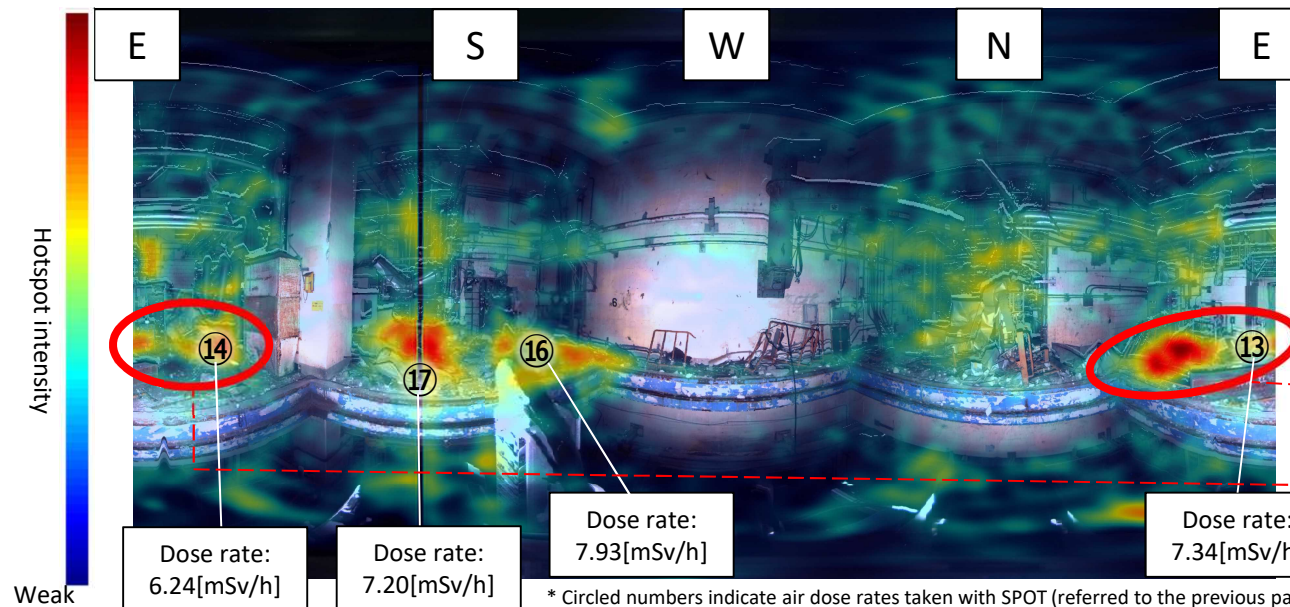
- $\gamma$  ray distribution by  $\gamma$  imager measurement.
- On the 2nd floor, it was confirmed that the hot spot was around the rubble near the floor.

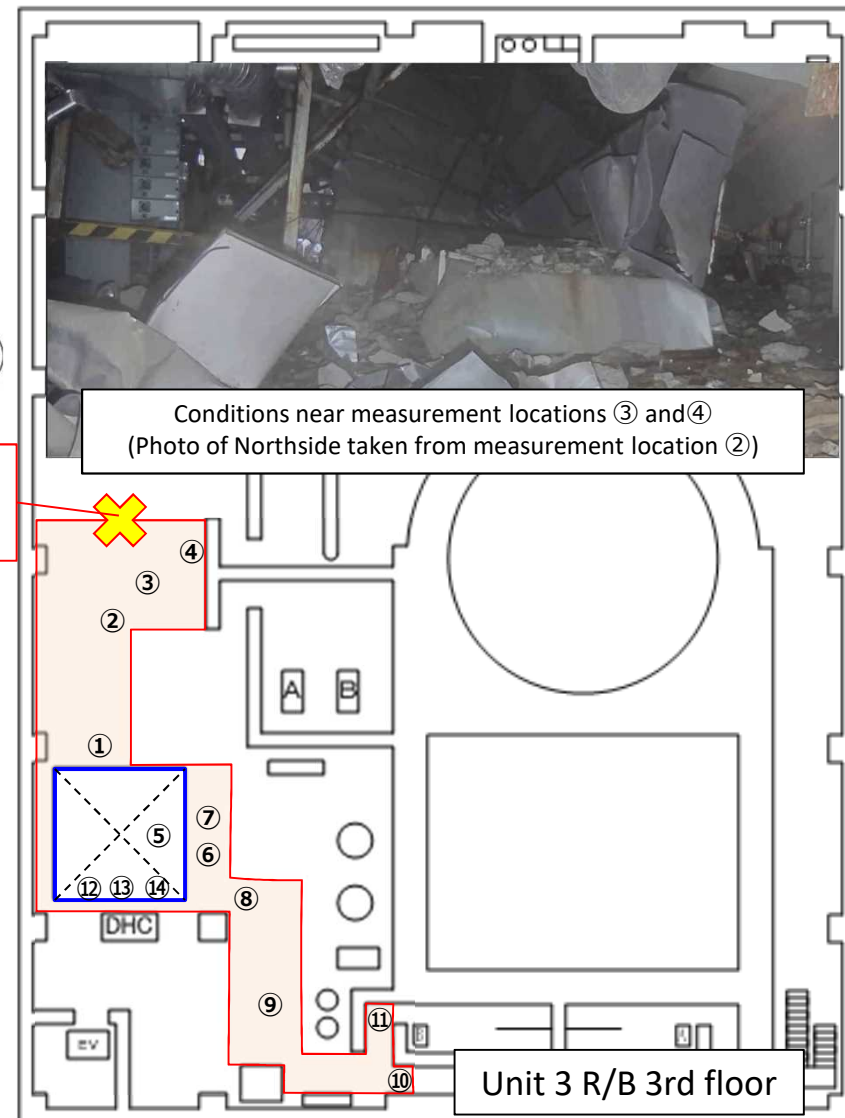
- Air dose rate inside the building
  - On the 3rd floor high-dose rates of over 20mSv/h were measured at measurement locations ②, ③, and ④

North side inaccessible due to rubble, etc.

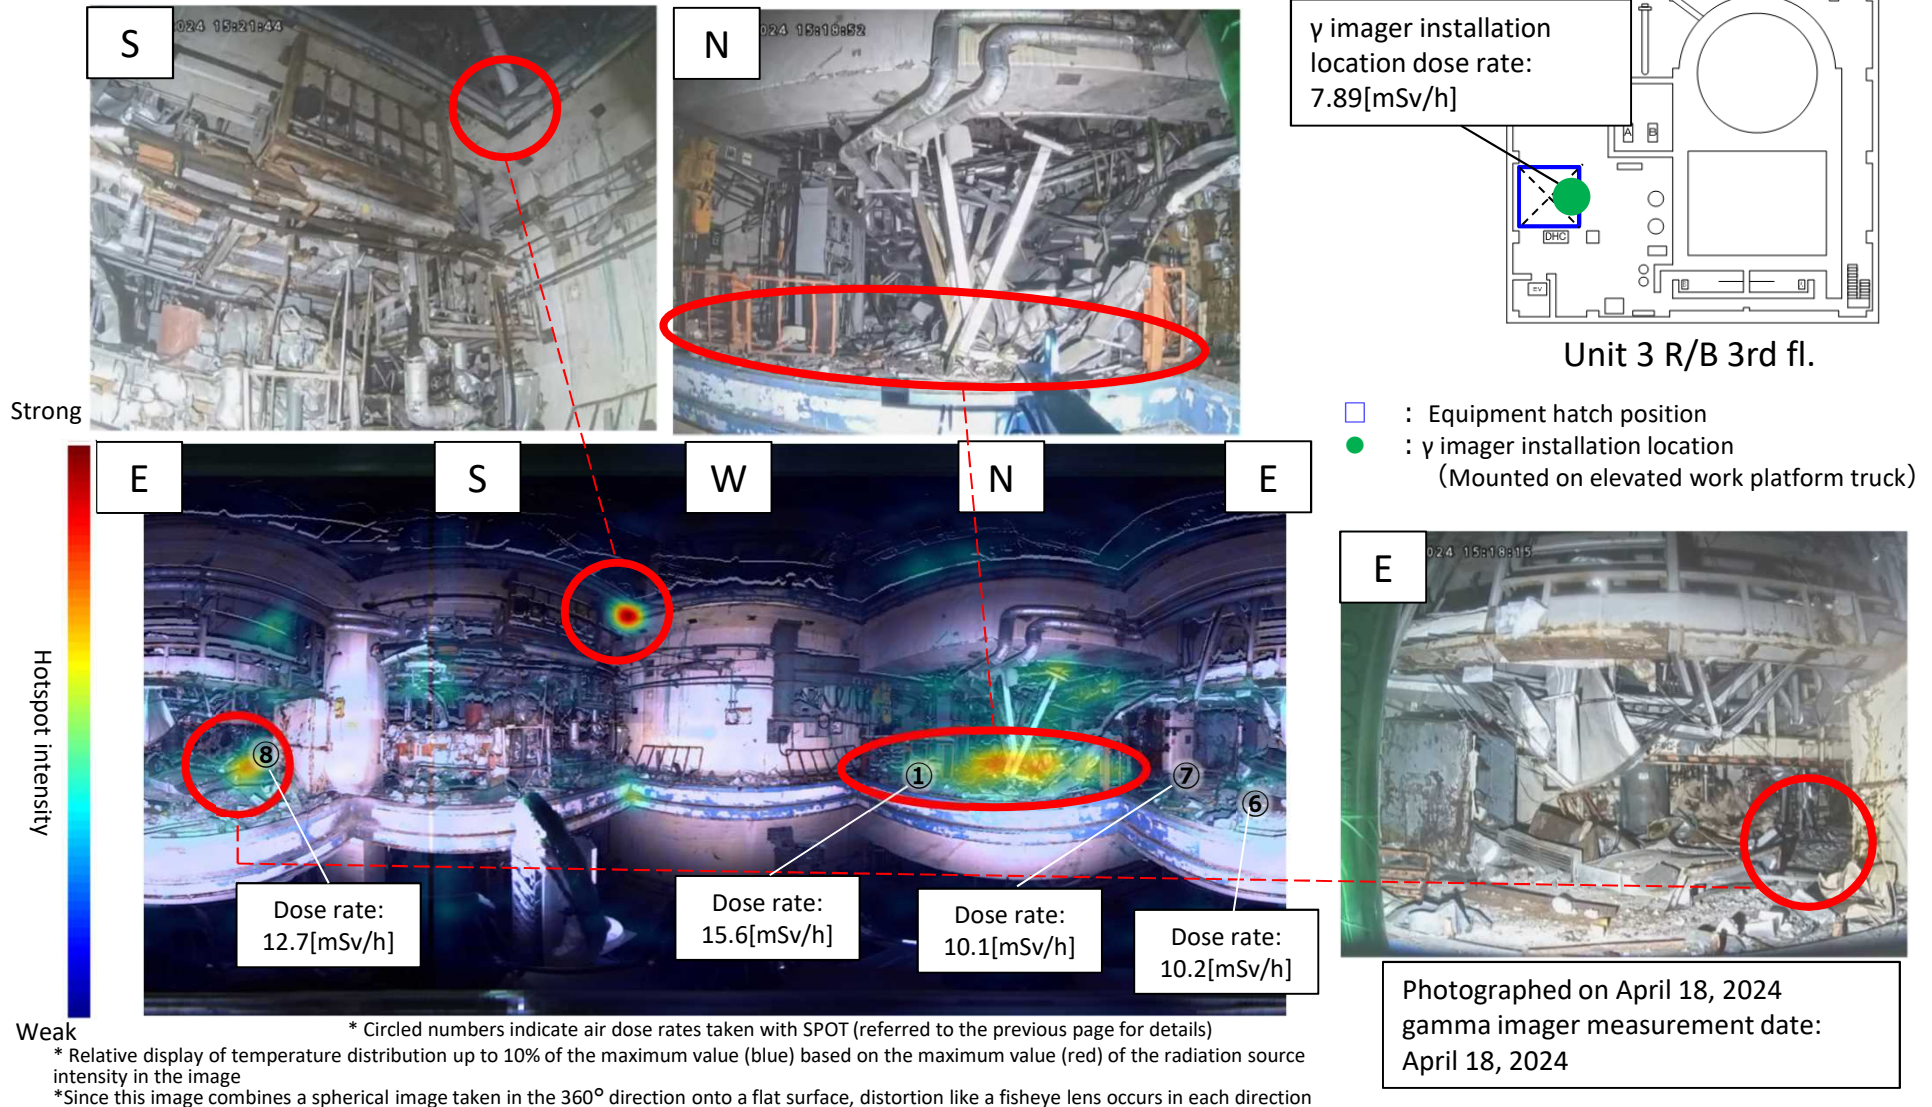
- $\gamma$  ray distribution by  $\gamma$  imager measurement
- On the 3rd floor, it was confirmed that the hot spot was around the edge of the top of the equipment hatch and around the rubble near the floor.

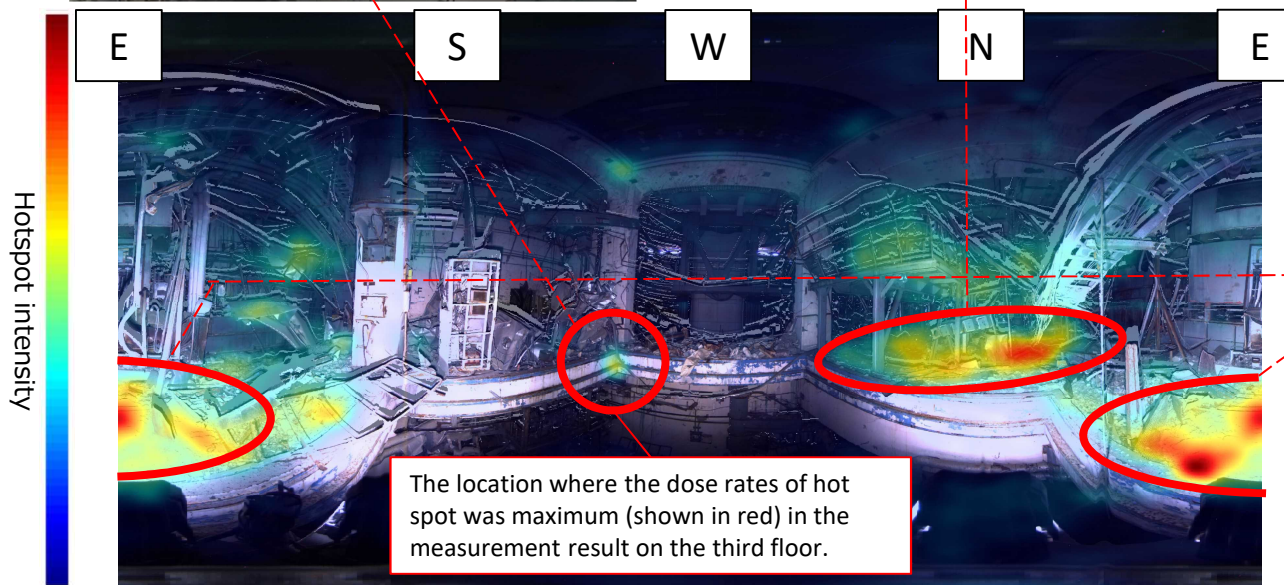
- Gamma ray distribution by gamma imager measurement
- On the 4th floor, it was confirmed that the hot spot was around the rubble near the floor.
- Since the intensity of the hot spot on the 3rd floor are relatively weak, it is assumed that dose rates on the 4th floor are higher
