Restart of Hot Test for Multi-nuclide Removal Equipment System A

<Reference> October 28, 2013 Tokyo Electric Power Company

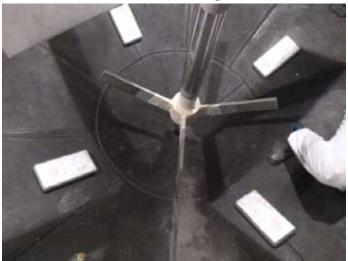
Batch treatment tank 1C (after rubber lining was provided)

After the damaged parts were repaired, **rubber lining (chloroprene rubber) was provided** on the internal surfaces of the tanks.

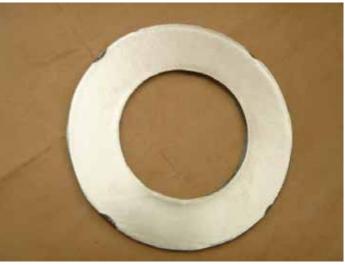
Gasket-type sacrificial positive electrode

Gasket-type sacrificial positive electrodes were provided to flanges that have the risk of suffering crevice corrosion (only Zn putty was provided to some of large-diameter flanges). Additionally, for higher reliability, we are considering future **replacement with lining pipes**.
