Progress of Landside Impermeable Wall freezing: Phase 2 of the first stage

December 22, 2016

Tokyo Electric Power Company Holdings, Inc.

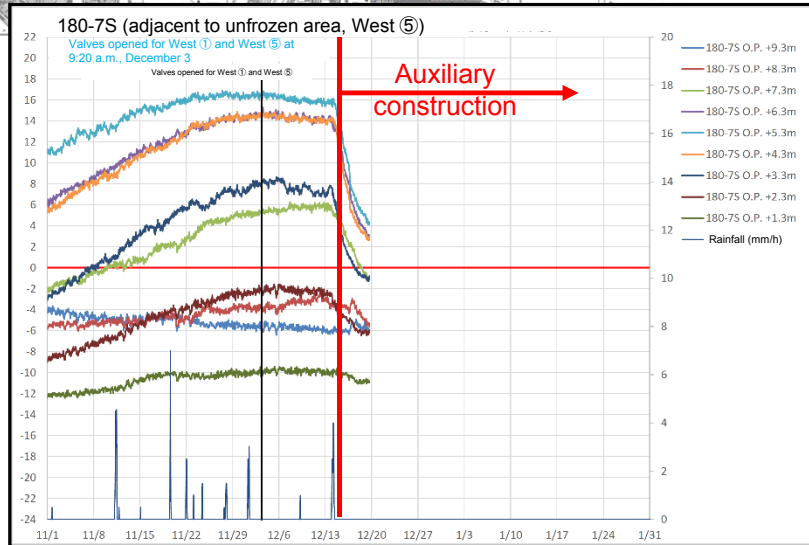
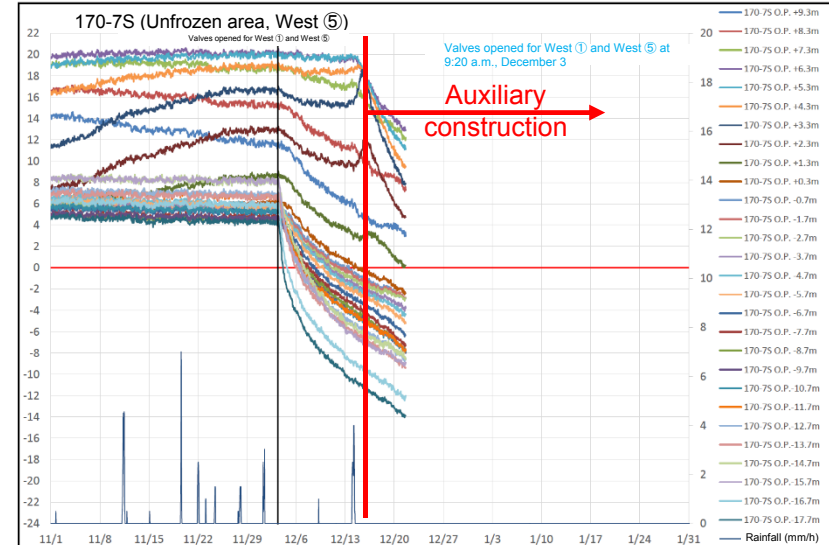
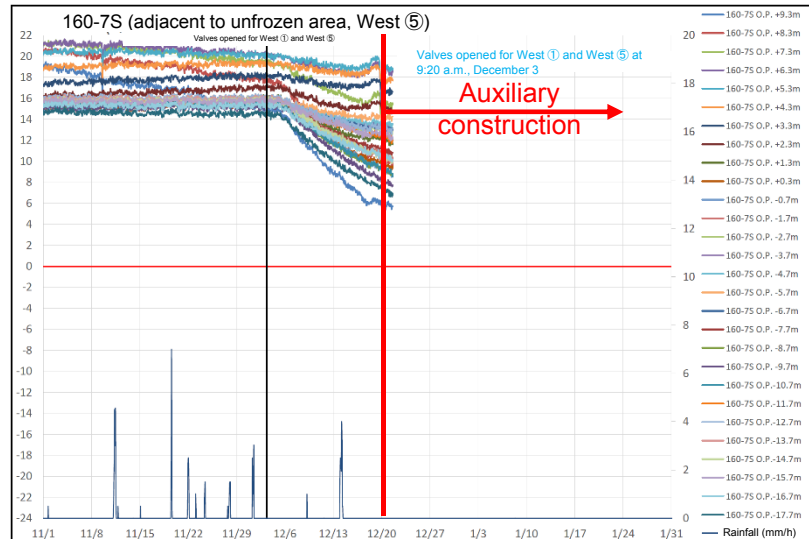
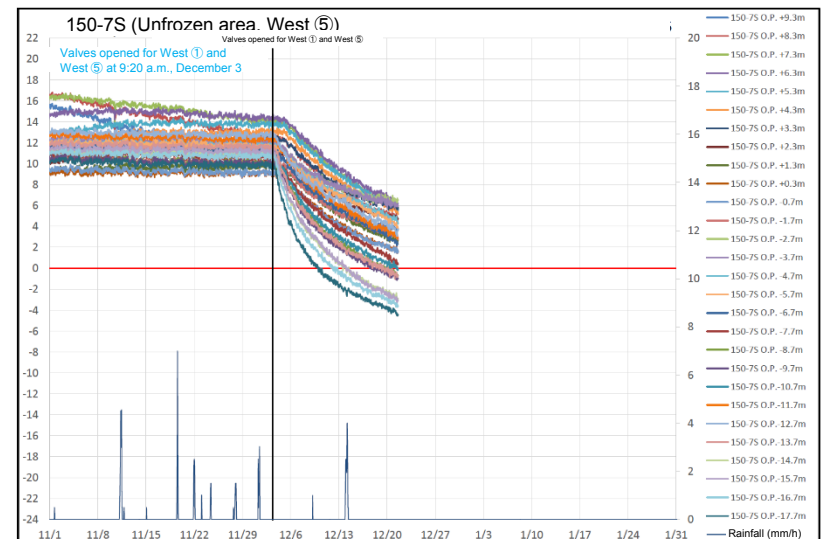
- 【180-7S】: Auxiliary construction is under way. Soil temperatures are decreasing relatively steadily.
- 【170-7S】: Auxiliary construction is under way. Soil temperatures are decreasing relatively steadily.
- 【160-7S】: Auxiliary construction is under way. Soil temperature decrease is being monitored.
- 【150-7S】: Auxiliary construction is yet to be applied. Soil temperatures are decreasing relatively steadily.

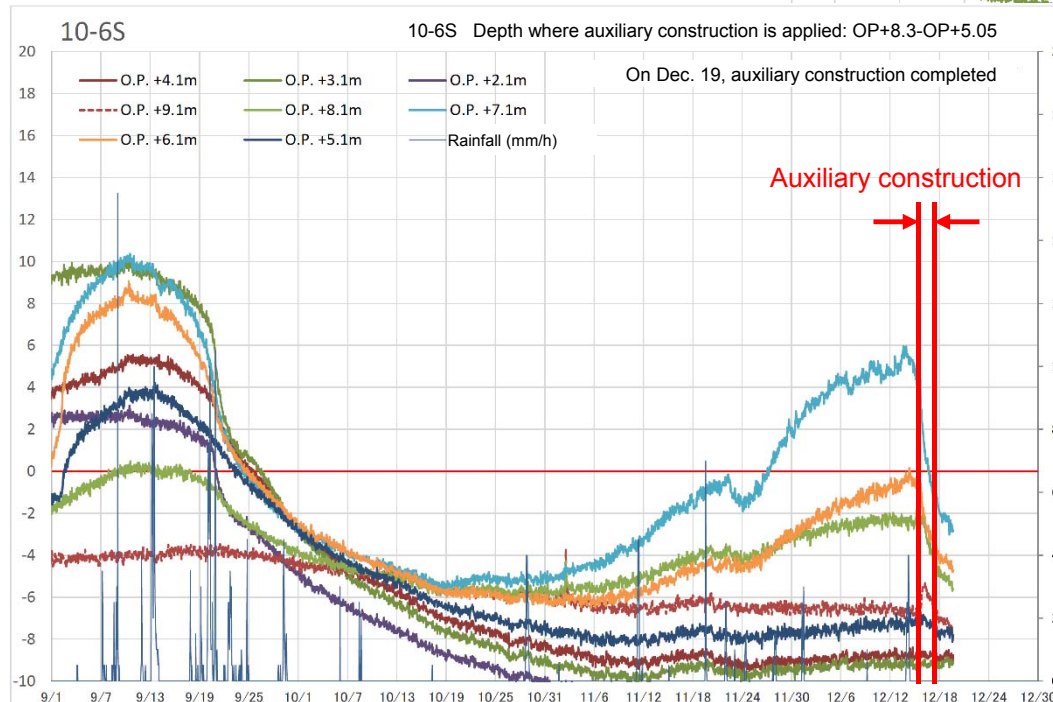
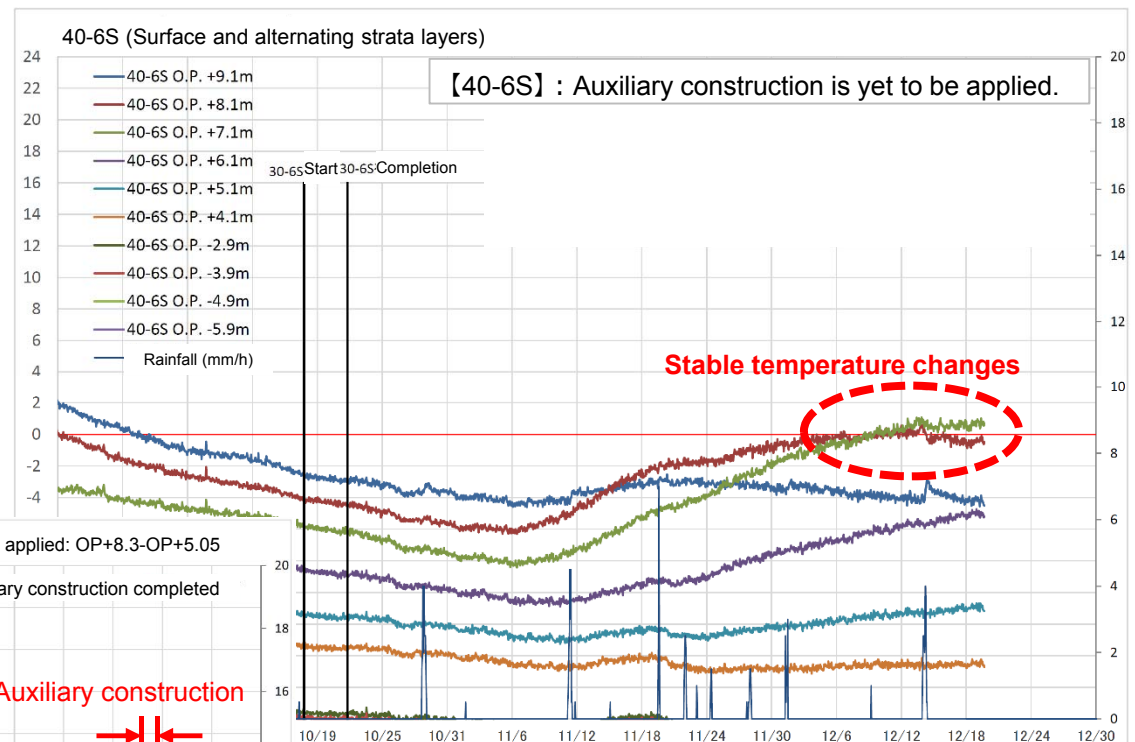
【10-6S】: Soil temperatures went below 0 °C.

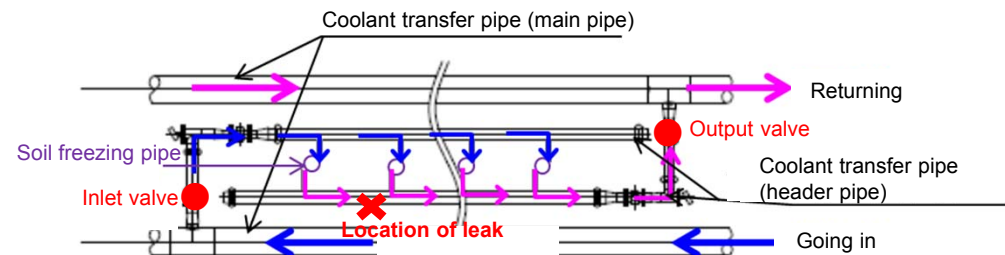
Piping structure around the location of the leakage (image)

(Current situation)
Coolant supply has been suspended for 28 soil freezing pipes
connected to the header pipe.
(The supply continues for the other soil freezing pipes.)

On December 19, 2016, a coolant leak was found around 1BLK-H1, one of the coolant header return pipes for the landside impermeable wall.

- Source of the leakage will be identified by removing insulators surrounding the pipe.
⇒ On Tuesday, December 20, source of the leakage was found at one of the header pipe joints.
- Repair will be carried out after removing coolant from the header pipe, dismantling the joint, and identifying the cause of the leak.

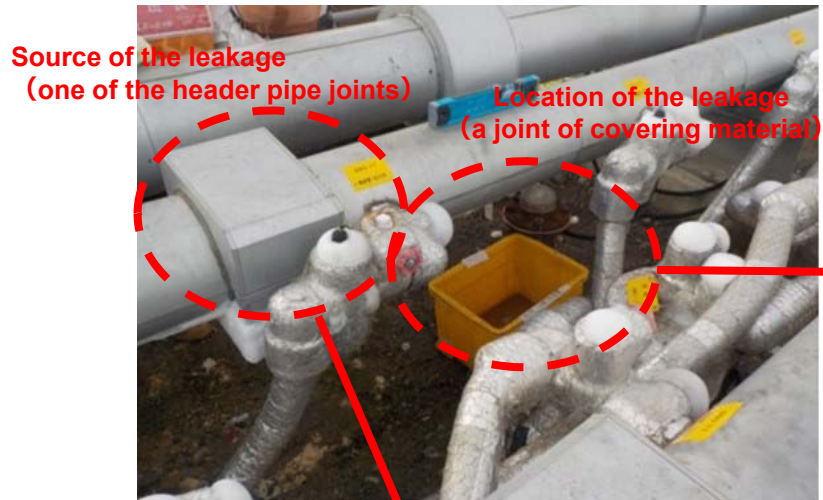
Location of the leakage on December 19
(around Soil Freezing Pipe 670-1T)

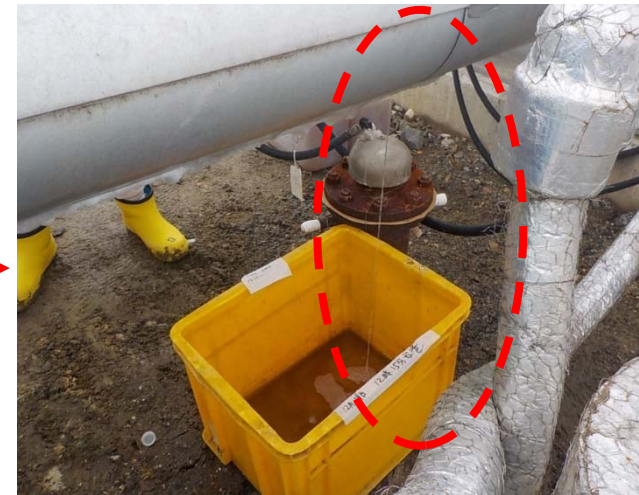
Coolant leakage on December 19
(a joint of covering material near the source of the leakage)

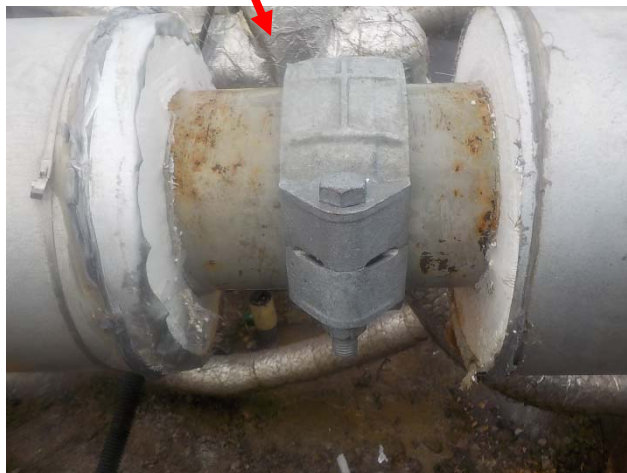
Source of the leakage identified on December 20
(one of the header pipe joints)

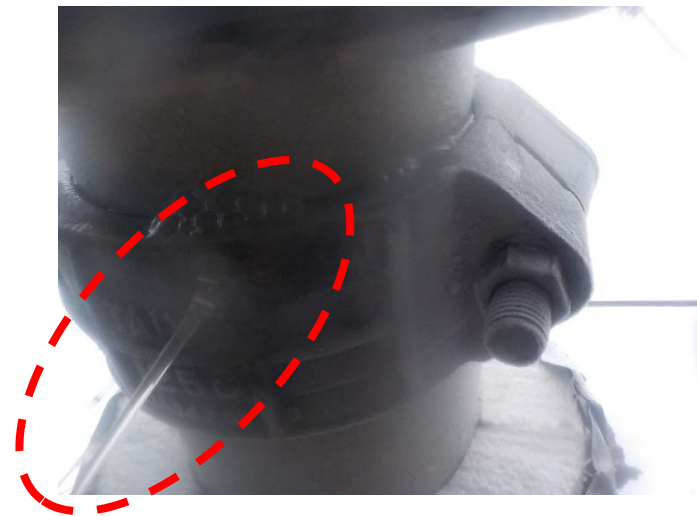
Leakage confirmed by adding pressure on December 20
