Investigation Results on the Causes of the Fire on Station Service Transformer 3B of Unit No.3 at Kashiwazaki Kariwa Nuclear Power Station (Summary)

August 23, 2007

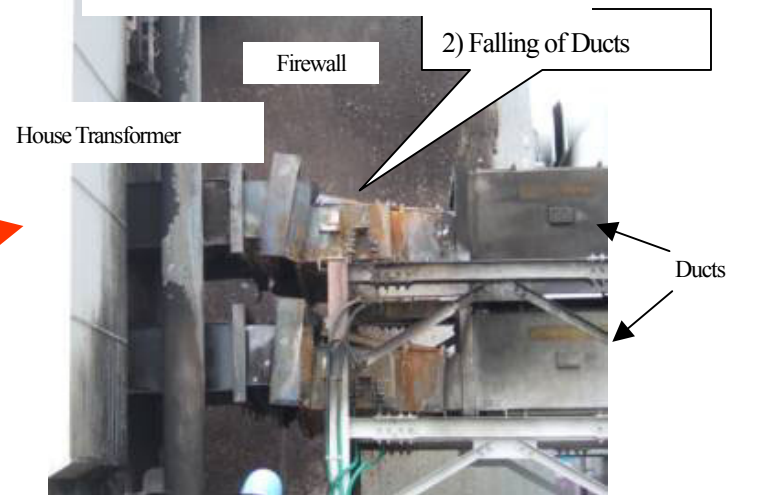
Secondary Connecting Bus of the House Transformer

1) Subsidence of Duct Foundation

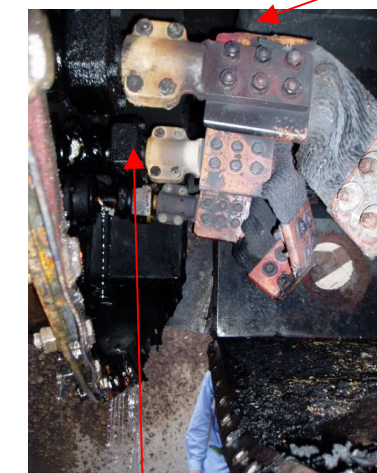
Inside of the Duct

Connecting Terminal

Bushing Part
