Visual inspection of the inside of Unit 2 PCV (Completed on May 29)

Visual inspection of the inside of Unit 2 PCV was completed on May 29, 2012.

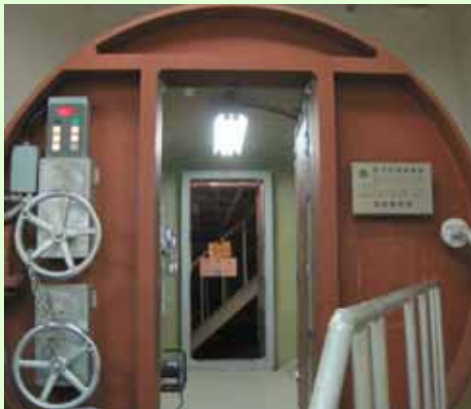
1. PCV entrance (Airlock for workers)
(Photo taken on May 10, 2012)

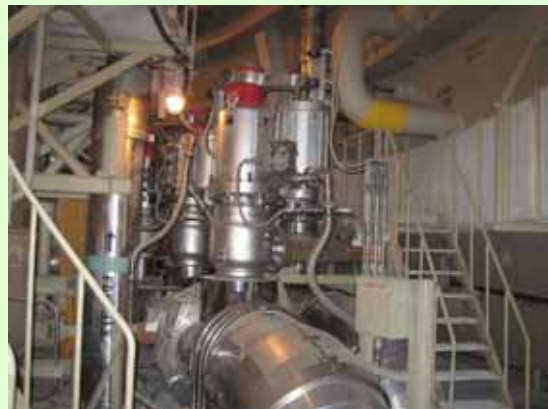
2. Inside PCV (Main steam isolation valve)
(Photo taken on April 17, 2012)

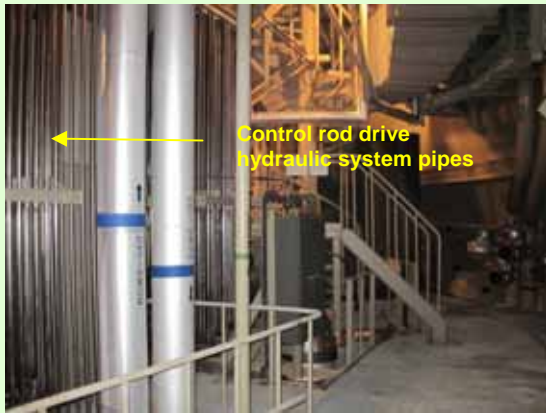
3. Inside of PCV: Near the control rod drive hydraulic system pipes
(Photo taken on April 11, 2012)

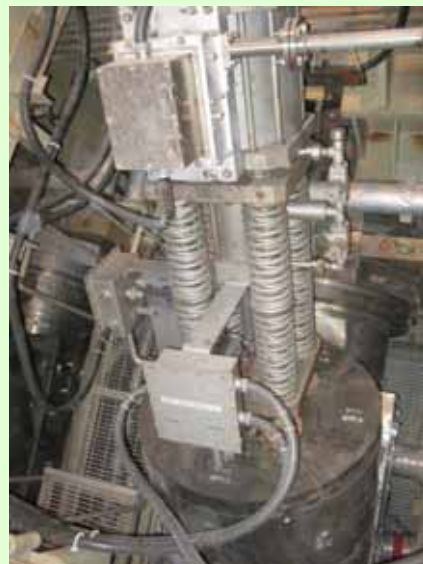
6. Main steam isolation valve
(Photo taken on April 11, 2012)

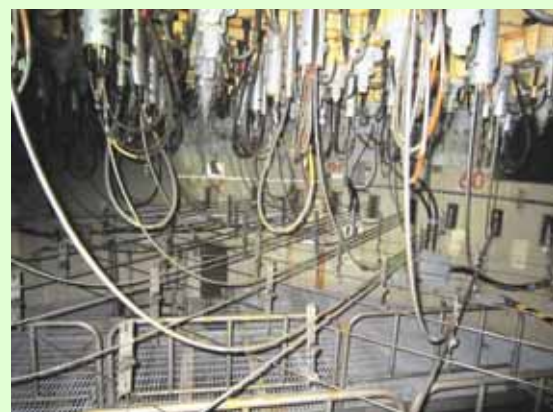
8. Pedestal (Base structure of RPV)
(Photo taken on May 10, 2012)

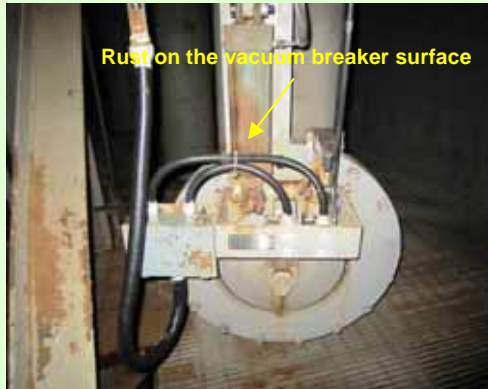
Due to the temporary temperature/humidity increase after the plant shutdown, minor issues were found such as the paint inside PCV partially coming off and rust on the surface of some equipments. However, these do not have impact on the cold shutdown function.

9. Rust on the vacuum breaker surface (Photo taken on April 17, 2012)

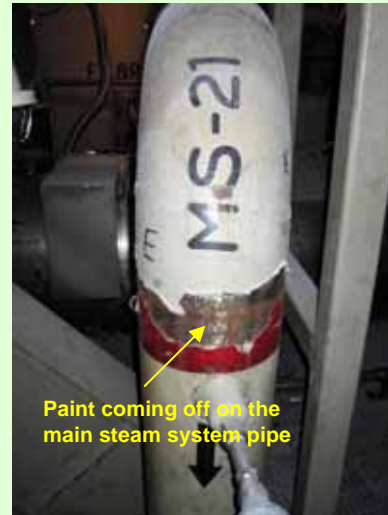
10. Paint coming off on the main steam system pipe (Photo taken on March 13, 2012)

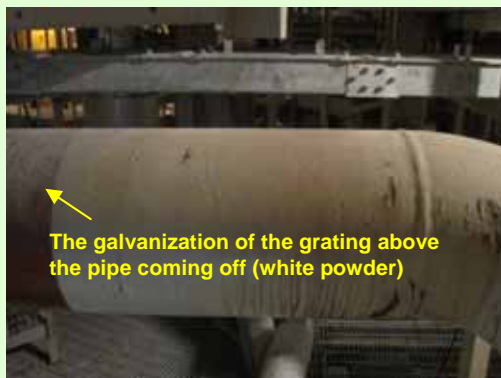
11. Galvanization of the grating coming off (white powder) (Photo taken on April 17, 2012)

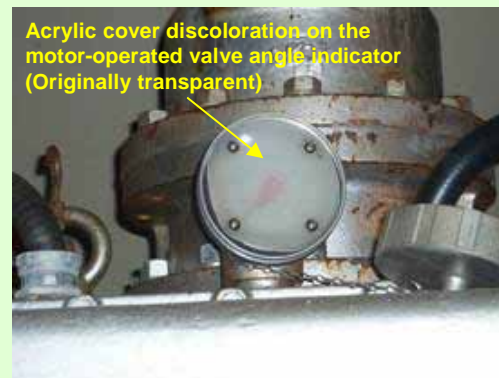
12. Acrylic cover discoloration on the motor-operated valve angle indicator (Photo taken on March 13, 2012)
