Impacts of the earthquake on Unit-1

1. Overview of the incident and subjects for examination

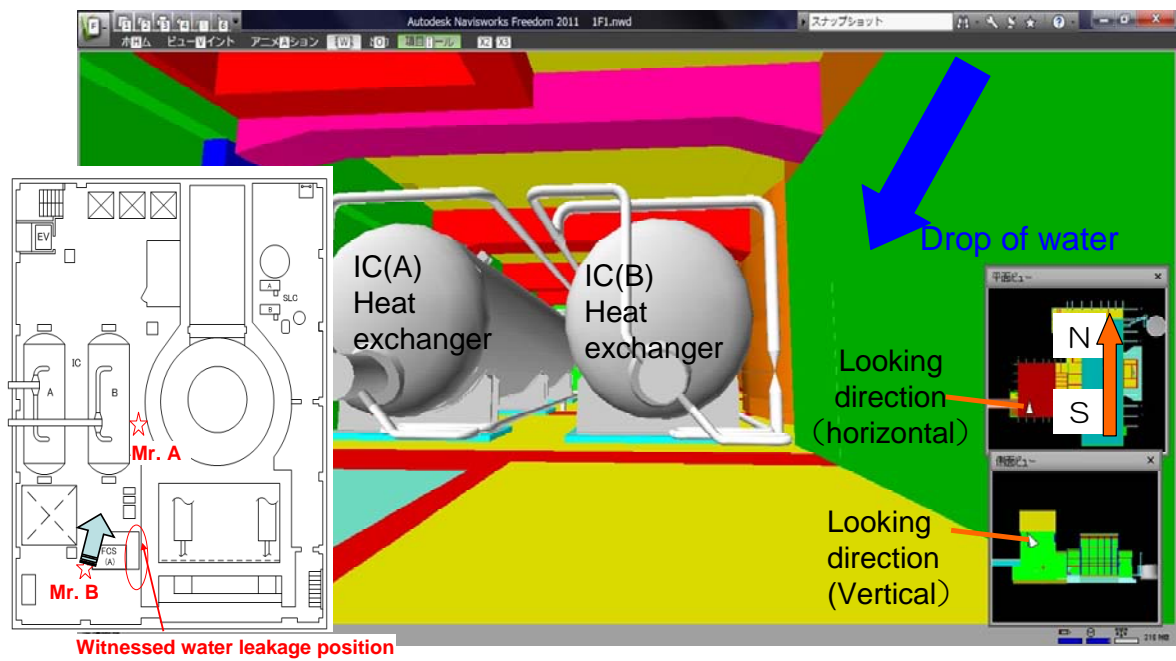
Figure 1 Situation of Person B at the time

The actual positional relations on the site can be estimated as illustrated in Figures 1 to 3 from the statements of Person B, who confirmed water leaking from the nearest position, and Person A, who confirmed water leaking in the direction of Person B. As can be seen in Figure 1, Person B stood immediately next to the hatch of the opening of the carrying-in entrance, was able to see the IC in front of him, and confirmed water leaking from the upper right. Person A, on the other hand, as can be seen in Figure 2, was hiding between the IC and containment vessel, from where he confirmed water leaking from his upper left in the direction toward Person B. Statements of these two people concerning the leak position (arrows) illustrated in Figures 1 and 2 are consistent. Therefore, it seems certain that the water was leaking from an elevated position of the east wall, as shown in Figure 3. According to a document ^{*1)} of the Nuclear Regulatory Authority (NRA) of Japan, Person A stood between the IC (A) tank and IC (B) tank. In whichever position he was confirming the water leakage at the time, there is no difference in the direction of the water leakage.

As clearly understood, the water leakage was confirmed not from the IC itself but from some other direction. It is difficult to assume the water leaked was the steam, which flowed into the IC, or the condensate for return.

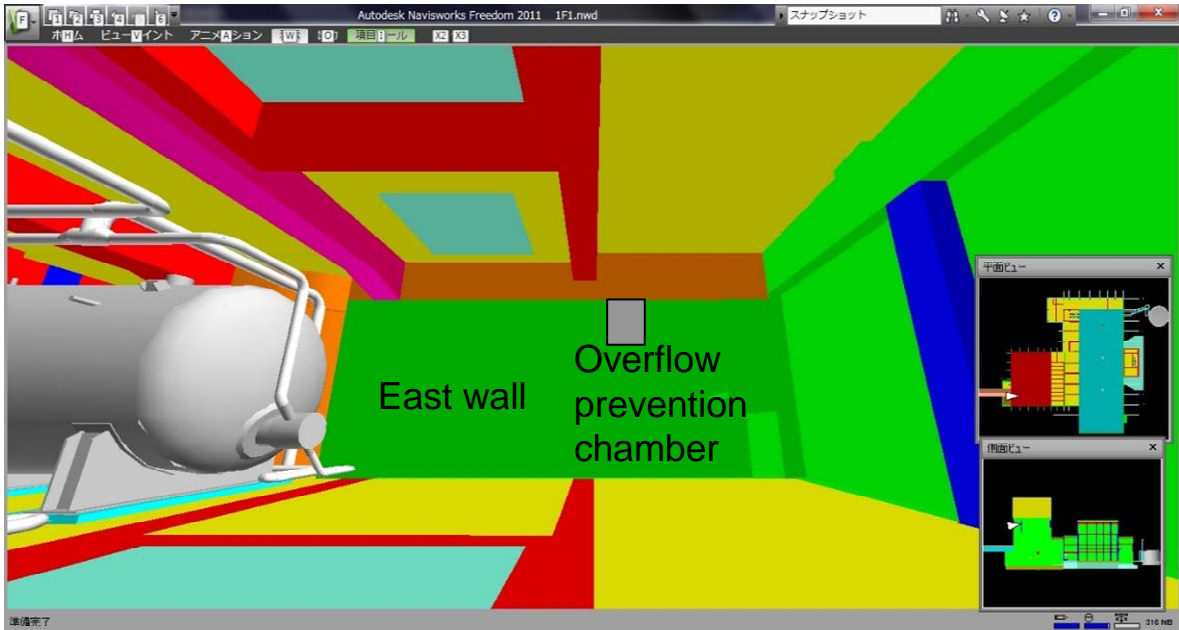
Figure 3 Position of water leak

The first subject is the water leakage in the IC room on the 4th floor of the Unit-1 reactor building. According to the Diet Investigation Commission report, it was near the hatch of the opening of the large object carrying-in entrance in the southwest area on the 4th floor of Unit-1 reactor building where the water leakage had been confirmed and the water had been leaking from an elevated position on the east wall (the spent fuel storage pool was on the other side of this wall).

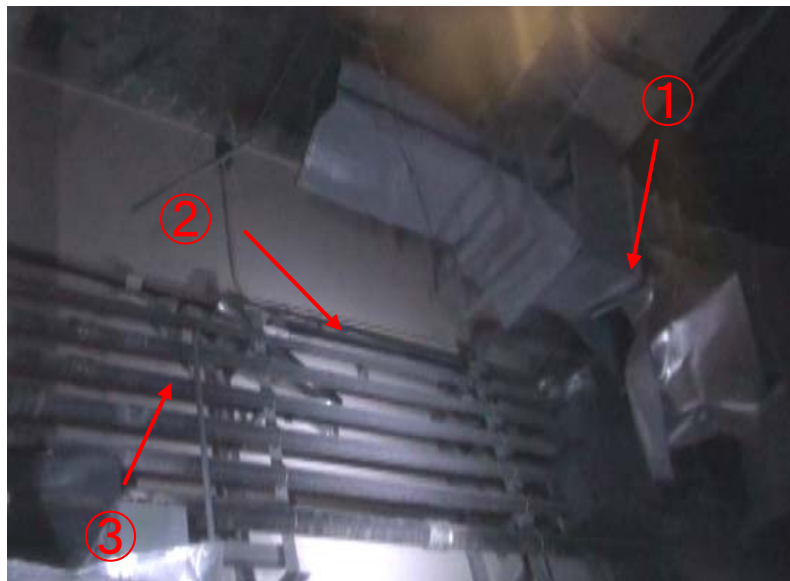
Figure 4 Pipes on the east wall

On the east wall, from where water was leaking, there were pipes and ducts, as shown in Figure 4. Among them, those pipes which could have contained water or steam were the overflow prevention chamber (①) and the IC steam venting line (②). Other multiple pipes (③) are for electric cables and contain no fluid in them.

The overflow prevention chamber was connected to a duct which took in air from the surface of the spent fuel pool and discharged it to the outside. In the case that water of the spent fuel pool flowed into the duct, this overflow prevention chamber was installed to receive the water first and then drain it via a drain line. But at the time of an earlier earthquake, an incident had been experienced in which water of the spent fuel pool flowed into a duct due to sloshing, the water was too much to be drained by the drain line, part of that water flowed further into another duct downstream, and leaked outside the radiation control area. Based on this lesson, modification work had been done to isolate the overflow prevention chamber and the duct downstream by a diaphragm.

The IC steam venting line had a role to prevent water hammers in the IC steam line. To this end, steam was constantly circulated during normal plant operations in order to warm the steam line. Once the IC started up, this venting line was isolated by a valve and no more steam was circulated. Although it is not known whether the IC was operating when the water leaked, because it is not known when the water leakage was observed, but at any rate the leakage from this path does not last long, i.e., a LOCA scenario does not exist on this path.

The fluid of the IC steam venting line was steam, and no liquid water leaked but high temperature steam of high pressure would have blown out even if a pipe break occurred. The statements are quite different from this situation. The on-site investigation conducted in later days found no pipe damage on this line, either. The overflow prevention chamber was completely destroyed so had not kept its original shape, perhaps due to the hydrogen explosion. However, from the following reasons, the water confirmed leaking on the 4th floor could be assumed to have come to the overflow prevention chamber from the spent fuel storage pool and leaked out for some reason.

- Water overflowed by sloshing from the spent fuel storage pool has been confirmed on the 5th floor.
- The spent fuel storage pool water could have flowed into the duct through its opening when the water reached that elevation by sloshing.
- The background reason for installing an overflow prevention chamber was to receive water, which could not be drained sufficiently via the drain line if a large amount of water had flowed into the duct.

It can be concluded, therefore, that the possibility of a LOCA having caused the water leakage in the reactor building, which the Diet Investigation Commission pointed out in its report based on the workers' statements, actually has no connection with a LOCA.

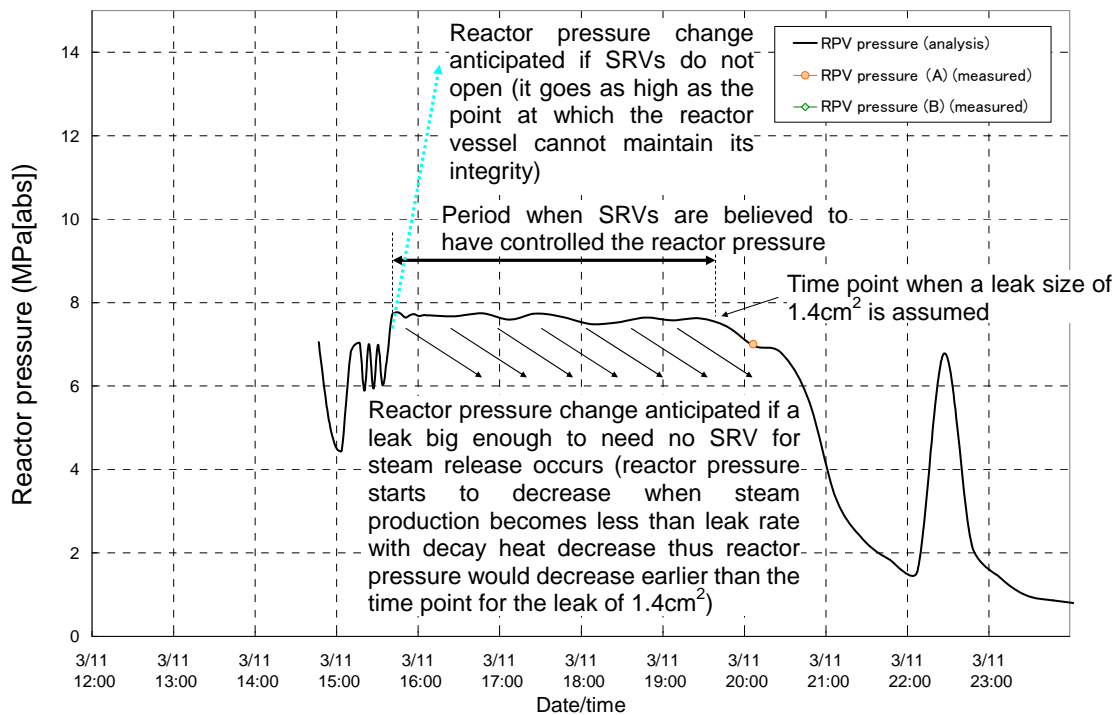
Figure 5 Reactor pressure change of Unit-1

The reactor pressure can be considered to have been continuously increasing even after arrival of the tsunami, if the plant behavior measured and the MAAP (Modular Accident Analysis Program) results were taken into account, and it could have reached far above 12MPa as of 17:00 on March 11th regardless of leaks, as can be seen in Figure 5. If so, the reactor vessel could have ruptured. But in reality no such symptoms have been noticed. In other words, the two incidents, i.e., a leak from a pipe break less than 0.3cm² which JNES assumed cannot be negated, and the SRV did not work, cannot happen simultaneously from physical viewpoints.

Based on the considerations above, a new scenario was assumed, which could meet the condition of no SRV working. The new scenario assumed that the leak size had enlarged after it became impossible to measure the plant parameters in the wake of the tsunami. In this case, the leak size had to have enlarged to a size big enough to release steam by about 16:00 on March 11th, when the reactor pressure was to approach the SRV working pressures. The steam production rate decreases monotonously in accordance with the decrease of decay heat. Therefore, once the leak size is enlarged enough to stop the pressure increase, steam discharge becomes more dominant than steam production. As a consequence, the reactor pressure starts to decrease as shown in Figure 5.

In TEPCO's MAAP results (made available on March 12th, 2012), a leak hole of 1.4cm² was assumed to have been generated at about 18:50 on March 11th. This size of leak turned out not to be big enough to release sufficient steam even with the amount of steam produced at about 18:50 on March 11th. Only by combining intermittent SRV working, could the reactor maintain a stable pressure at about 7.5MPa. This means that, as long as the MAAP results are considered, the leak size could not be less than 1.4cm² even at about 17:00 on March 11th, and the scenario cannot be concluded valid without a fairly larger leak size.

In the MAAP results, the reactor pressure started to decrease at about 19:40 on March 11th, by a leak 1.4cm² in size, and MAPP reproduced the pressure of 6.9MPa at 20:07 on March 11th. So, if the pressure decrease started much earlier and the leak size was much bigger, the pressure at 20:07 on March 11th could not be 6.9MPa, but it must have been much lower. In other words, the pressure decrease after about 19:40 on March 11th must have been faster than the MAAP results. This is inconsistent with the measured values of reactor pressure.

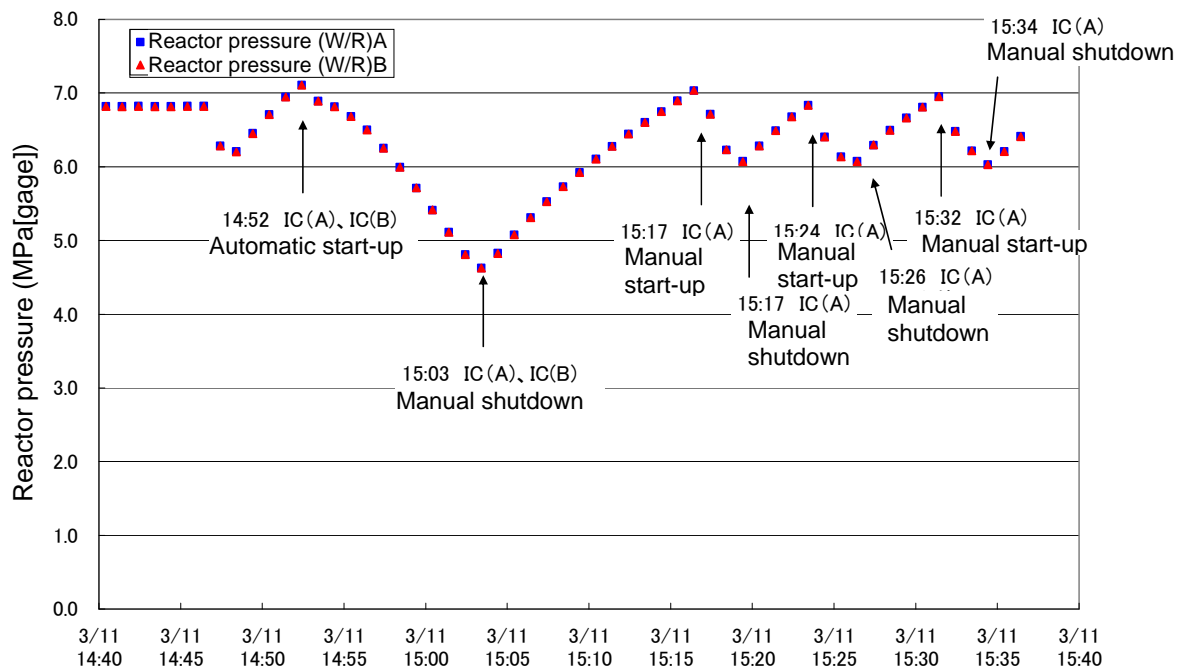
Figure 6 Reactor pressure change prior to tsunami arrival, and operators' IC maneuvering actions.

Figure 6 presents the reactor pressure changes and the IC maneuvering actions by the operators. At 14:47 on March 11th, the earthquake occurred and Unit-1 was scrammed by the “large seismic acceleration” signal. The reactor pressure decreased a little at the time of the scram, but started to increase thereafter due to steam production by decay heat. IC (A) and IC (B) were automatically started up at 14:52 when the reactor pressure reached the preset level for automatic IC start-up. It should be noted that the preset pressure for automatic IC start-up was lower than the SRV working pressures and therefore SRVs did not work when the ICs were started up.

After IC (A) and IC (B) started up, the reactor pressure started to decrease by their cooling effects and pressure was cut to 5MPa in about 10 minutes. This means that the coolant temperature in the reactor dropped about 20 deg C in about 10 minutes, because the

saturation temperature of reactor coolant is about 285 deg C in normal operations with about 7MPa, while about 265 deg C when the pressure drops to about 5MPa. This temperature change rate exceeded the upper limit of the rate allowed for normal cooling at reactor shutdown, which is 55 deg C per one hour. For negating the possibility of a leak causing at the rapid pressure decrease, and for reducing the cooling speed (temperature decrease rate) and controlling the reactor pressure, the operators manually shut down IC (A) and IC (B).

The pressure started to increase again and reached about 7MPa. Thereafter, three times the operators repeated manual start-up and manual shutdown. In all actions, the pressure increase and decrease were under the operators' control.

From the above deliberations, it is considered that the operators thought of the possibility of a LOCA at the beginning but negated it based on the plant behavior upon IC start-up and shutdown. It is not extraordinary for the operators of Unit-1 to be concerned about leaks from the reactor pressure change because they are trained, by operation simulators, etc. to always take operating actions considering the possibility of leaks.

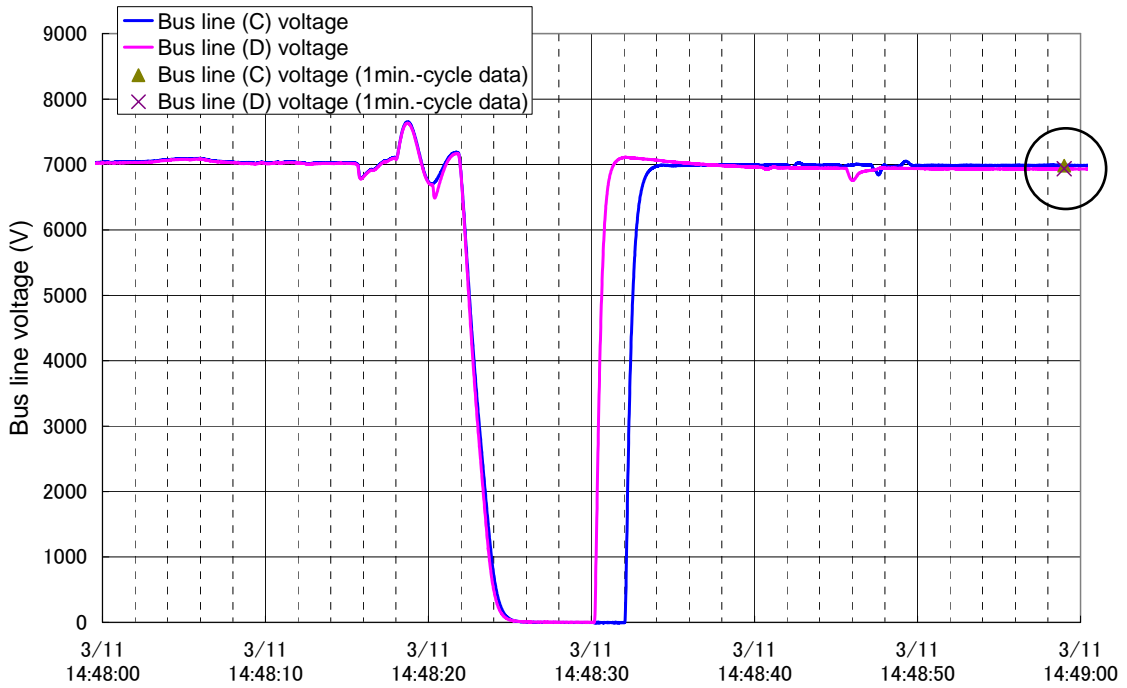
Figure 7 Comparison of 10-ms-cycle data and one-minute-cycle data by transient recorder

There is a big gap between the amount of information in the 10-ms-cycle and the one-minute-cycle. Figure 7 compares the voltage changes of bus lines C and D using these two data sets at around 14:48 on March 11th, when DGs started up upon loss of the external power supply. The 10-ms-cycle data show the voltage fluctuations and drops of bus lines as well as the subtle difference in start-up timings of DG (A) and DG (B). However, the information in the one-minute-cycle during this time period is available only for one time point at 14:48:59 (marked in the circle in Figure 7). Neither the bus line voltage loss nor the successful start-up of DGs can be explained from this single piece of information. From this background, the one-minute-cycle data were considered meaningless in analyzing transient behavior.

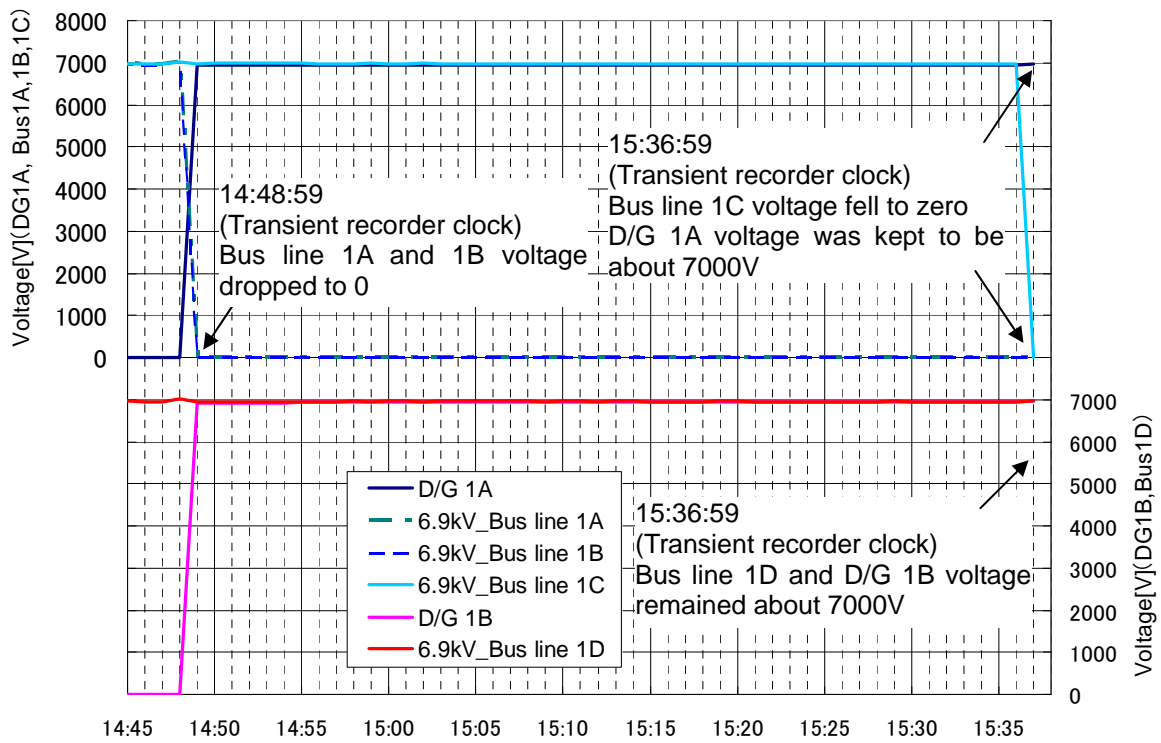
Figure 8 Voltage changes of bus lines and DGs

Figure 8 presents voltage changes of bus lines and DGs. Voltage changes of bus lines A, B, C and DG (A) are plotted at the top, while voltage changes of bus line D and DG (B) are plotted at the bottom. First to note is that the voltage of bus lines A and B, which were not connected to DGs, dropped to zero upon loss of the external power supply. It can also be confirmed that DG (A) and DG (B) started up following the loss of the external power supply, because their voltages rose from zero to about 7,000V. Bus lines C and D were connected to DG (A) and DG (B), respectively, and therefore they maintained their voltages by receiving electricity from each DG even after loss of the external power supply. As mentioned earlier, no information is visible in one-minute-cycle data concerning the voltage drops upon loss of external power supply and voltage gains upon DG start-up. When the data around 15:37 when the tsunami arrived at the site are looked into, the voltage drop of bus line C down to zero can be seen (in the one-minute-cycle data chart the voltage dropped between 15:35:59 and 15:36:59). On the other hand, voltages of bus line D, DG (A) and DG (B) were maintained at about 7,000V as of 15:36:59 and it is after 15:37 when they lost their functions. It should be noted that the DGs can maintain their voltage by themselves even if the recipient lost its voltage.

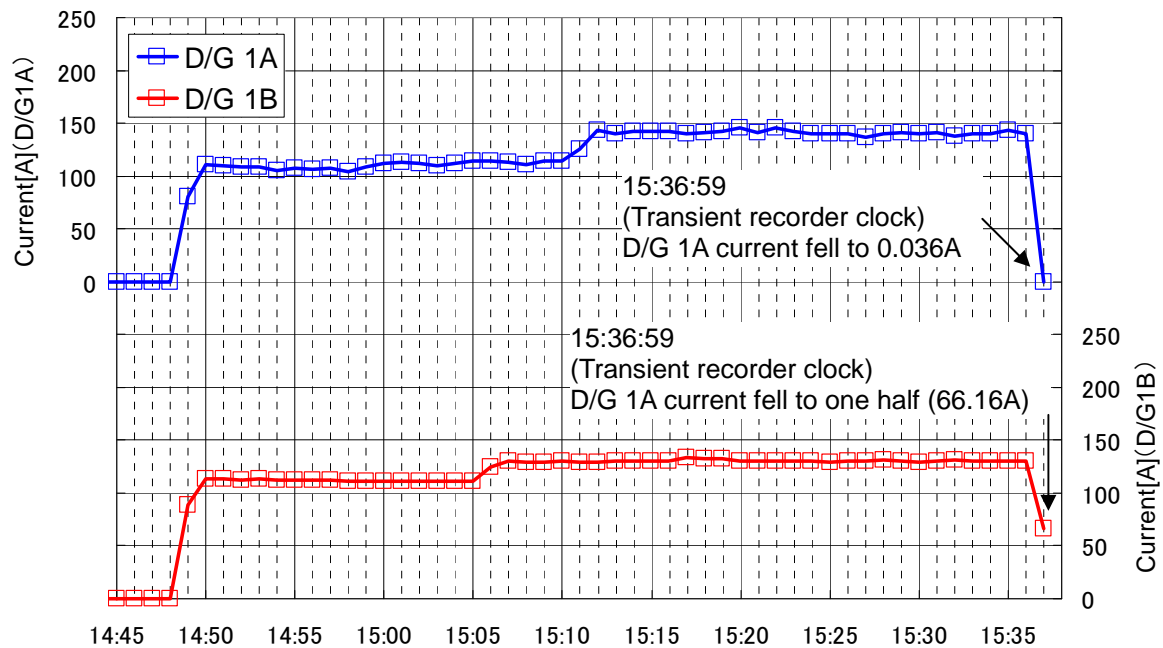
Figure 9 Changes of DG (A) current and DG (B) current

Finally, Figure 9 shows the current changes of DG (A) and DG (B). The increase of currents at the DG start-up and at the time of containment cooling system (CCS) start-up for suppression pool water cooling can be confirmed from the figure. Looking at the changes at the time of tsunami arrival, it can be seen that the voltage of DG (A) connected to bus line C dropped to zero, and so did the current as well. At the same time, some decrease in current on bus line D can also be recognized, which maintained the voltage of about 7,000V. This can be presumed as due to the loss of its load such as the loss of functions of seawater pumps, which were installed in low elevation areas of the site.

Based upon the deliberations above, the tsunami impacts on power sources can be presumed to have proceeded from the seaside as in the following sequence and the loss of power supplies was reconfirmed to have been caused by tsunami.
