Progress Status and Future Challenges of Mid-and-long-Term Roadmap toward the Decommissioning of Units 1-4 of the TEPCO's Fukushima Daiichi Nuclear Power Station (Outline)

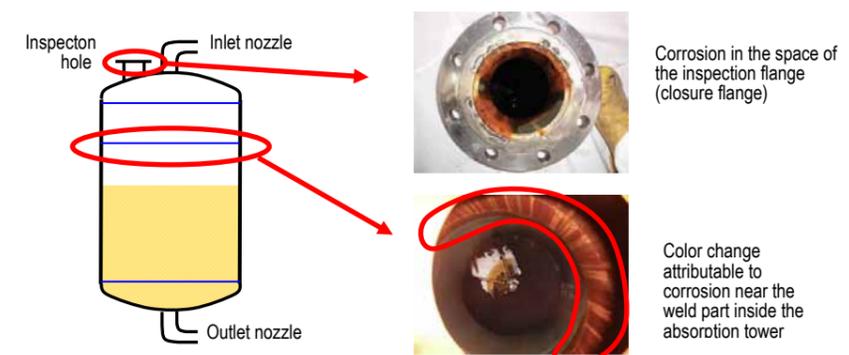
Figure 1: Status of the multi-nuclide removal facility absorption tower 6A

- During the suspension, the inside of the adsorption tower 6A of System A was inspected and a color change was detected, which may be attributable to corrosion (August 2) (see Figure 1). Based on the corrosion detected inside adsorption tower 6A, the investigation scope was expanded. The results of the horizontal investigation of Systems A and B (stopped due to planned suspension on August 8) confirmed corrosion on the weld parts of the absorption tower downstream of the absorption tower 6A. In the next step, the cause and recurrence prevention measures will be examined as well as considering repair methods.

- After performing these recurrence prevention measures, hot tests will be resumed in mid-September for System C, mid-October for System A and after November for System B respectively.

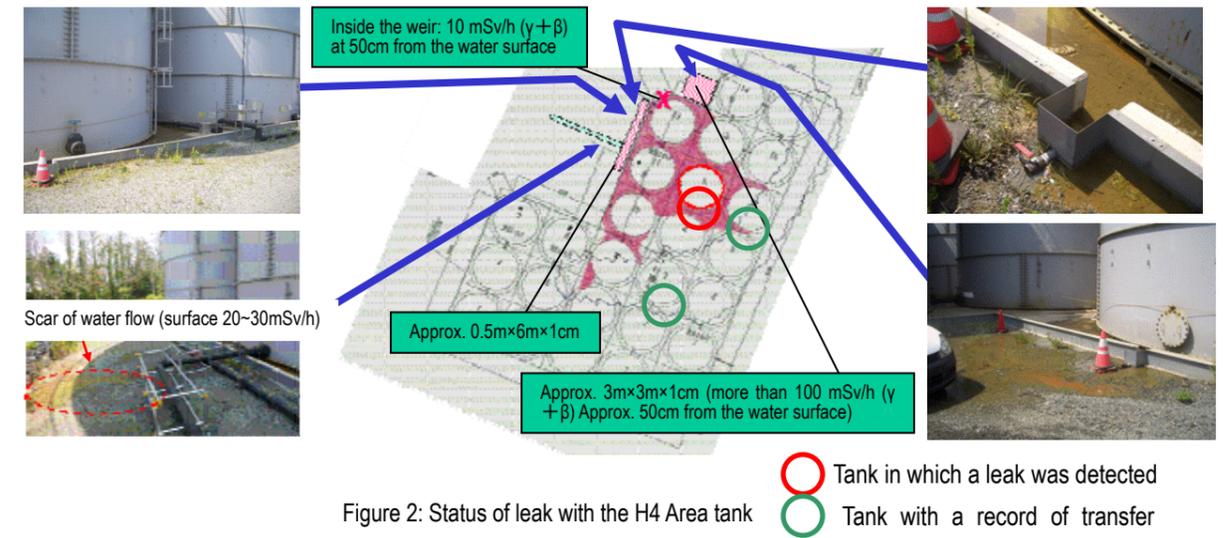
Figure 2: Status of leak with the H4 Area tank

- Puddles were detected with the tank weir in the H4 Area storing contaminated water and outside the drain valve of the weir (August 19, see Figure 2). As there was water spread at the bottom of No. 5 tank, a bolt-fixed type, in the same area, the water level of the relevant tank was checked. The result showed that the water level had decreased by approx. 3m compared to neighboring tanks (equivalent to approx. 300m³) and a leak of high density contaminated water was confirmed (August 20).

- Water was transferred from No. 5 tank in which the leak was detected (August 19-21).
- Overhaul (visual inspection of appearance, check for any leak by radiation dose measurement) was conducted regarding 305 bolt-fixed type tanks for accumulated water storage of Units 1 to 4 (August 22). By this overhaul high density points of radiation dose were detected near the bottom of the tank (2 points). These two points were dry and no outflow was detected to outside the weir. In addition, no change was detected with the water level within the tank.

- Initially, 3 tanks including No. 5 tank, with which leak was detected, were installed in H1 Area. It was revealed that these tanks were removed due to a depression having occurred with its foundation (August 24). The same as No. 5 tank, water was transferred from the tanks which were retransferred after the first transfer.

- It was confirmed that the weir around the bolt-fixed type tanks was not contaminated (August 22). On the soil outside H4 Area with which leak was detected, additional soil was applied and shield sheets were placed (August 20).

- Drainage valves are closed in general (from August 28)
 - Possibility of reinforcement by placing concrete at the bottom of the tank is examined
 - Water level gauges will be installed to the tank (within 3 months), water levels will be checked using thermometers until installation of the water level gauges

- Frequency of patrol was increased to 4 times per day (from August 26)
 - The procedure was changed to measuring radiation dose for each tank and recording the results in the patrol check sheet

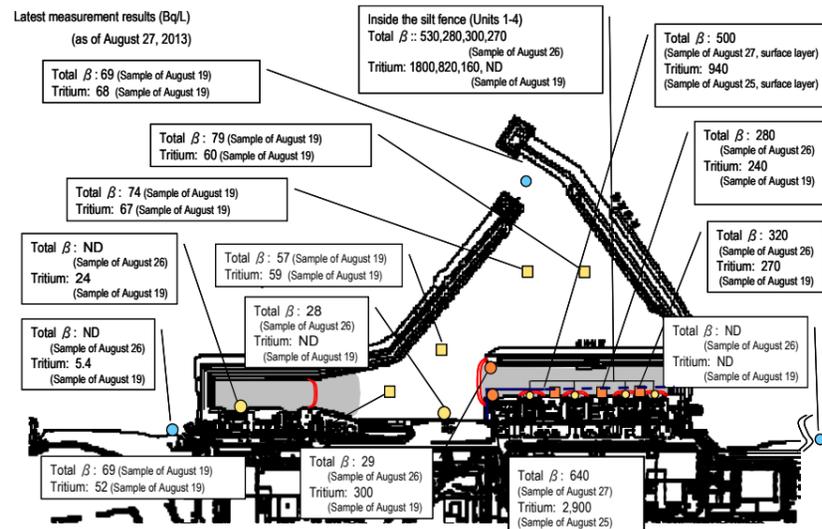
Figure 3: Seawater monitoring results

- A significant increase in radioactive materials density was detected within the intake open canals for Units 1 to 4 only. While the density near the port boundaries (port canals, north and south discharge canals) increased, the rise was within the normal range of fluctuation over the past 2 months. No significant increase was detected in the offshore measurement results, hence there was little impact on the outside of the port (see Figure 3).

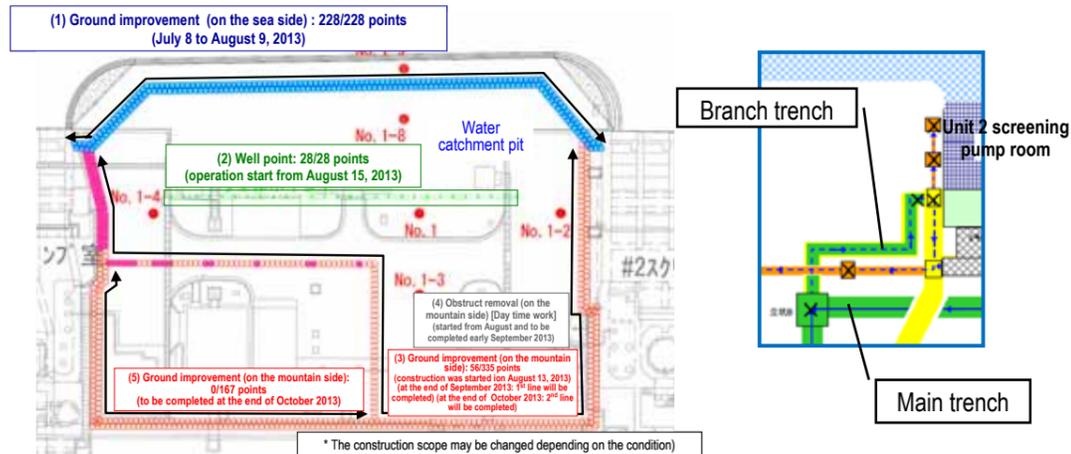
Figure 4: Layout of underground water measures between Units 1 and 2

- **Measures to tackle the issue of increased density of radioactive materials in groundwater on the sea side and in seawater**
 - Analytical results of data such as on the density and level of groundwater on the east (sea) side of the Reactor Buildings showed that contaminated groundwater had leaked into the seawater.

- As measures to prevent the spread of contamination out to sea, the following will be implemented (see Figure 4):
 - (1) Preventing leak of contaminated water

- Ground improvement behind the bank protection to prevent the expansion of radioactive materials. (Between Units 1 and 2: completed on August 9, Units 2 and 3: from August 28 and to be completed late November, Units 3 and 4: from August 23 and to be completed late September)

- Pumping of groundwater into contaminated area
By installing catchment pits and well points (compulsory pumping equipment by vacuuming), the groundwater level is reduced (catchment pit: transfer started on August 9, well point: part of the transfer started on August 15 and the full transfer was started on August 23). By pumping groundwater, the water level was reduced below the levee crown height of ground improvement (O.P.+2.20m), mitigating the risk of groundwater outflow into the port.

- (2) Keeping groundwater away from the contamination source
 - Enclosure by improving the side ground foundation
Between Units 1 and 2, efforts to improve the ground foundation commenced on August 13 and were completed in mid-October.

- To prevent rainwater introducing, the ground surface will be paved with asphalt (to commence mid-October)
 - (3) Removing the contamination source
 - Removal and closure of contaminated water such as branch trench
Contaminated water in the branch trench of Unit 2 and vertical shaft B to the branch trench was transferred to the Unit 2 Turbine Building (August 22-24). Subsequently, the trench will be closed (from August 28 to mid-September).

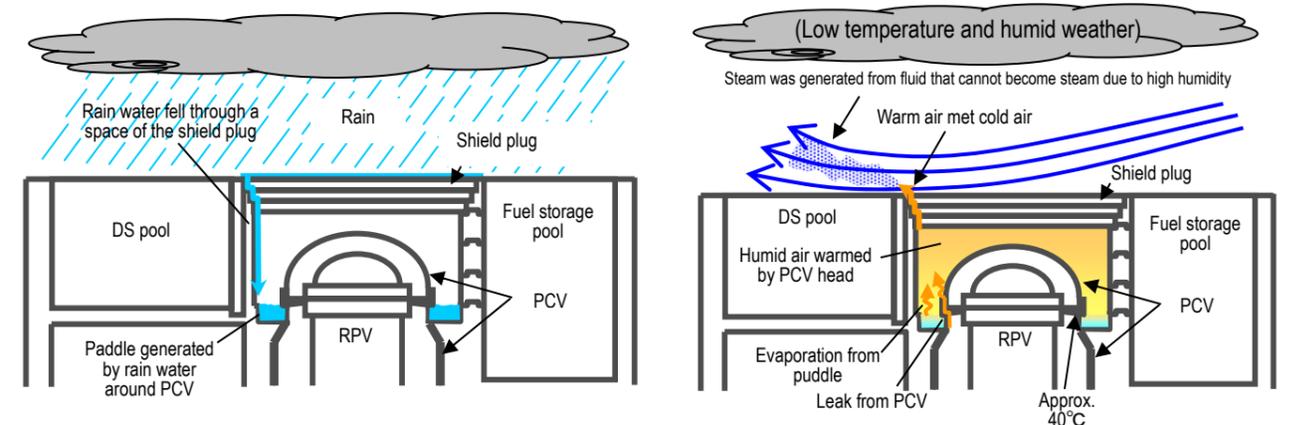
Figure 6: Mechanism of steam generation

- On July 18, 23, 24 and 25, steam was detected near the center of on the 5th floor of Unit 3 Reactor Building (on the equipment storage pool side). After the detection of steam, no significant release is detected in the results of dust measurement.
- Mechanism of steam generation (see Figure 6)
 - Humid air accumulated in the lower part of the shield plug was released on the operation floor through a space of the shield plug.
 - The released air contacted with air on the operation floor which was at low temperature and humid (approx. 20°C, 92%, respectively) and its temperature decreased below the dew point.
 - Fluid exceeding the saturated steam turned into particles and became visualized as steam (mist).

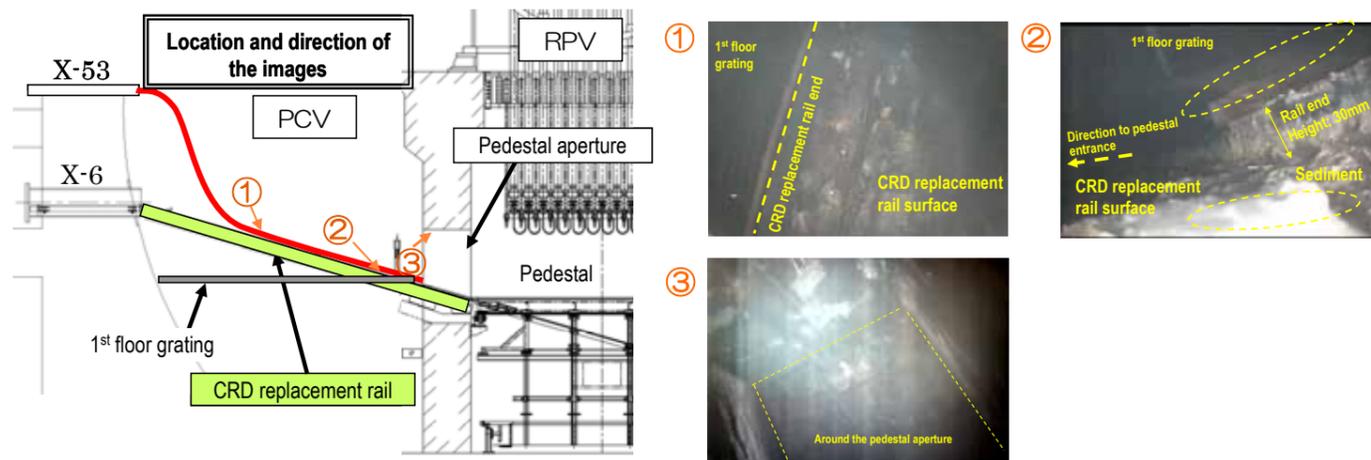
Figure 7: Status inside Unit 2 PCV

- To investigate the status inside Unit 2 PCV, the investigative equipment was inserted from the through-hole of the PCV (X-53) (March 19), but the investigation near the pedestal could not be conducted. Reinvestigation was conducted (August 2 and 12), which involved the investigative equipment being led to the CRD replacement rail to investigate up to a point near the pedestal aperture (see Figure 7). The camera images will be analyzed and the results reflected in the investigation plan for the inside pedestal; to be conducted through the X-6 through-hole (located below the X-53 through-hole) in the next step.

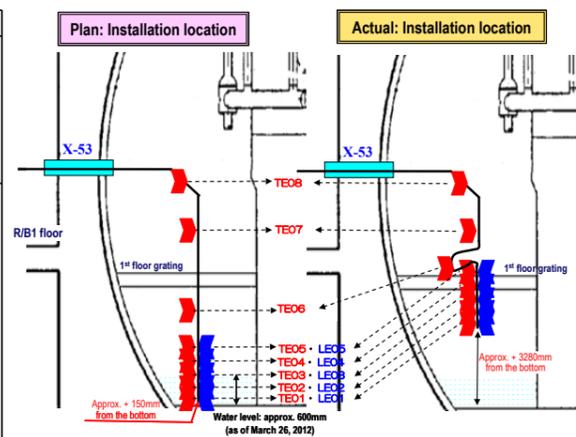
Figure 8: Installation status of permanent monitoring meters in Unit 2 PCV

- Via the X-53 through-hole, monitoring meters (8 thermometers and 5 water level gauges) were inserted to install them into the PCV. However, due to interference with the existing grating, these meters could not be installed into the planned locations except for 2 thermometers (August 13) (see Figure 8). In the next step, after identifying the cause, reinstallation in the initially planned locations will be examined.
