Main decommissioning works and steps

All fuel had been removed from Unit 4 SFP by December 22, 2014. Work continues toward fuel removal and debris (Note 1) retrieval from Unit 1-3.

Summary of TEPCO data as of February 27, 2019

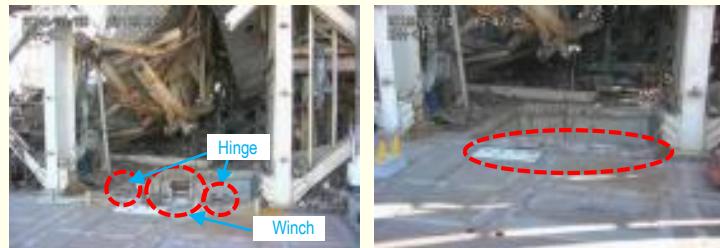
From March, the floor opening will be covered to remove small rubble around the SFP.

Before removing winches and hinges

After removing winches and hinges

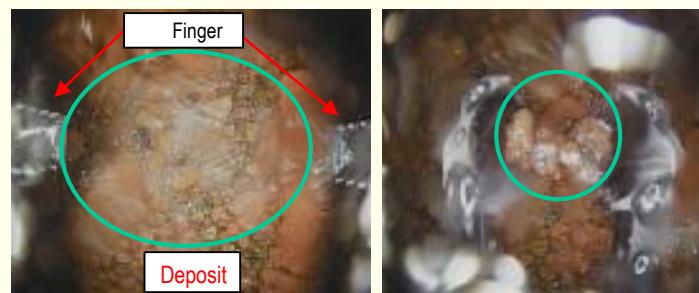
The results of this investigation will be utilized in the internal investigation in the 2nd half of FY2019, examination of the retrieval method, etc.

Before touching the deposit

While touching the deposit
