Suspension of the Second Cesium Adsorption Apparatus (SARRY) at Fukushima Daiichi Nuclear Power Station

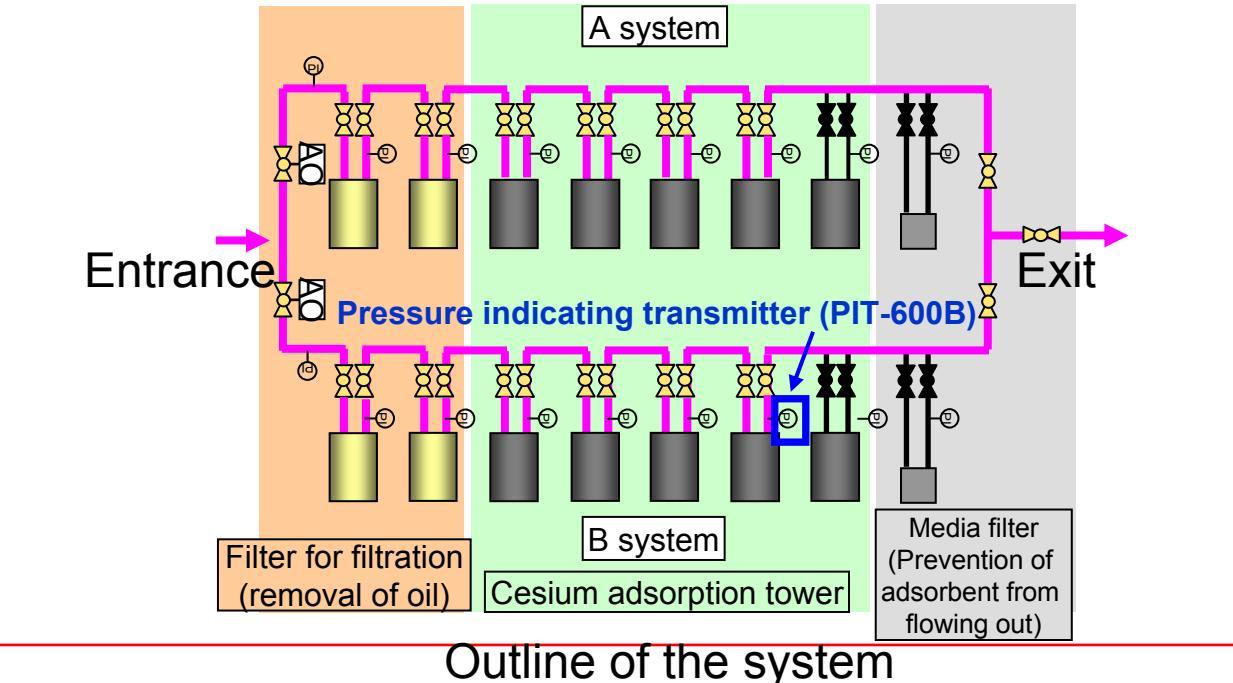
At around 9:53 AM on July 30, an alarm went off indicating the suspension of a booster pump and the detection of leakage. Then the second cesium adsorption apparatus (SARRY), which was under treatment operation, was suspended automatically. No leakage was found as a result of site investigation.

As a result of analysis on trend data of pressure gauge, the cause is estimated to be indication failure of a pressure indicating transmitter (PIT-600B), which monitors a pressure of the cesium adsorption tower.

- Condition of PIT indication amount of B system at SARRY will be confirmed by letting filtrated water through (PIT indication amount of A system will also be confirmed as a reference).

- PIT-600B, which has the indication failure, will be exchanged (scheduled on August 1).

- Since it is considered that there is no problem on a pressure indication amount of A system, it is possible to operate the A system (approx. 20m³/h) currently. However, operation will be restarted at both A and B system after exchange of the PIT-600B, since there is no problem on water level of the building.
