Measures for rainwater around the tanks/ contaminated water at Fukushima Daiichi Nuclear Power Station

July 24, 2014 Fukushima Daiichi D&D Engineering Company Tokyo Electric Power Company

Outline of measures for rainwater around the tanks / contaminated water

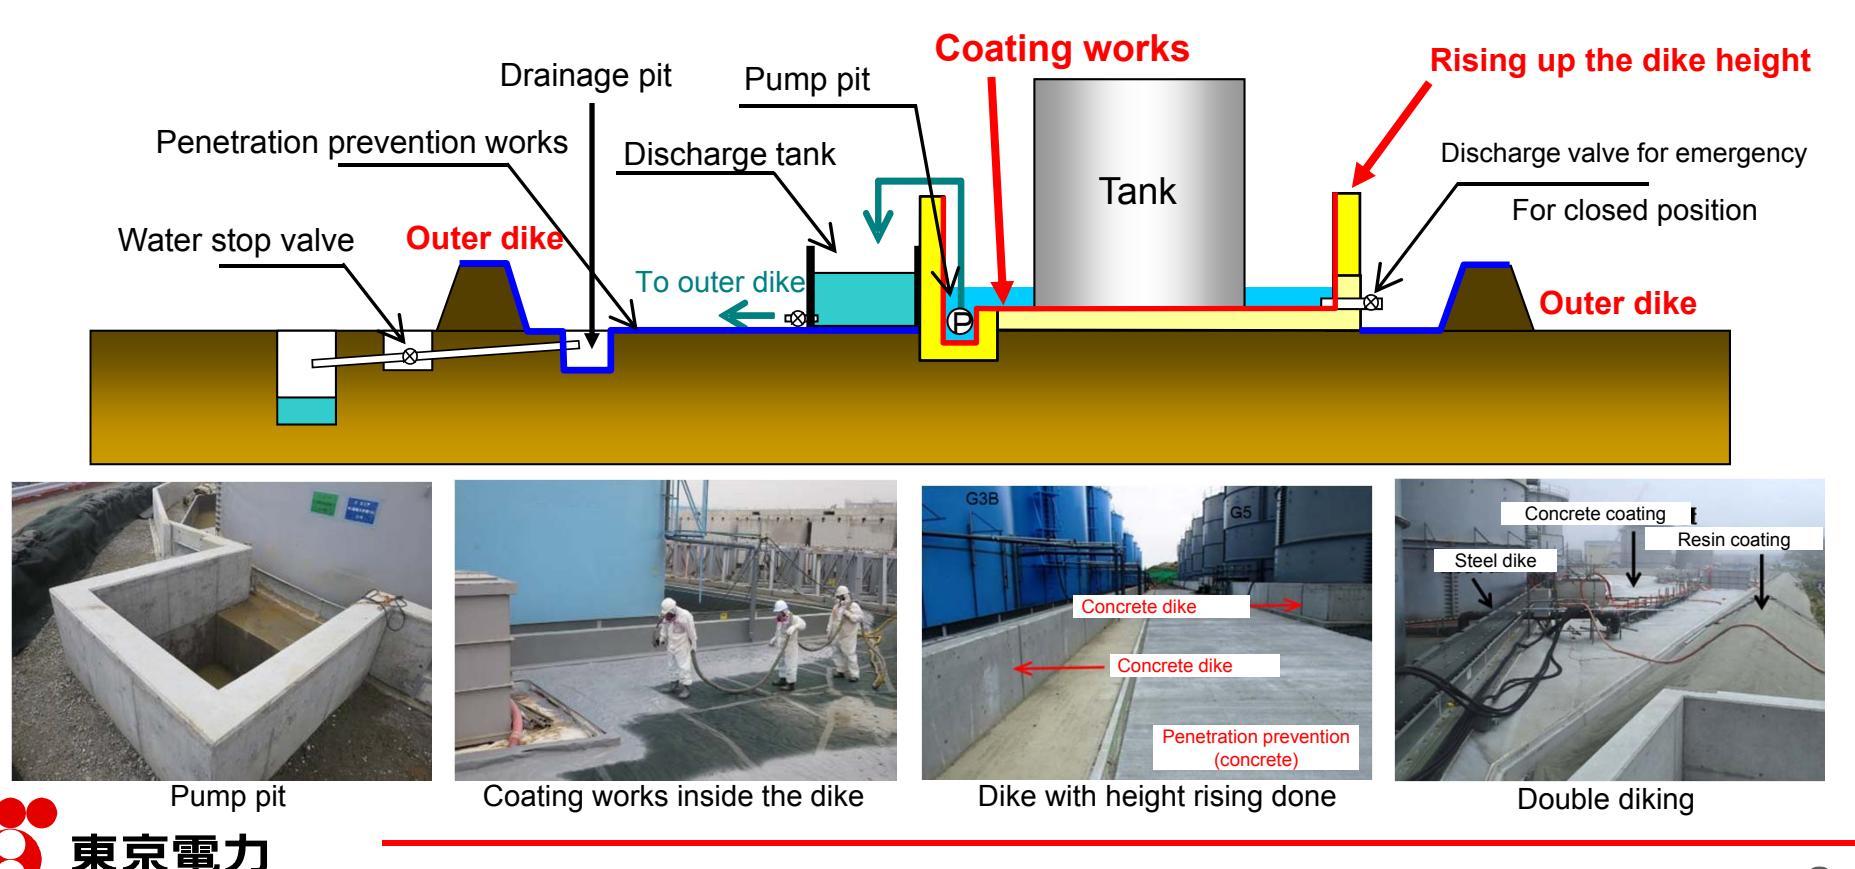
1. Rising up the height of dike and double diking

The rising up the dike height for existing tank areas has been done in order to reduce leakage risk of contaminated water flowing outside the dike.

Dikes for the areas of D, G7, J1, J2, J3, J4, and J5, which are currently under construction, are to be built in order in accordance with the installation of tanks.

As further measures, coating inside the dike and building outer dike are to be addressed. Also, a pit is added to the dike to make it easier the rainwater remained inside the dike to be discharged, thus, for the outer dike, a drainage pit with motor valve is installed just within.

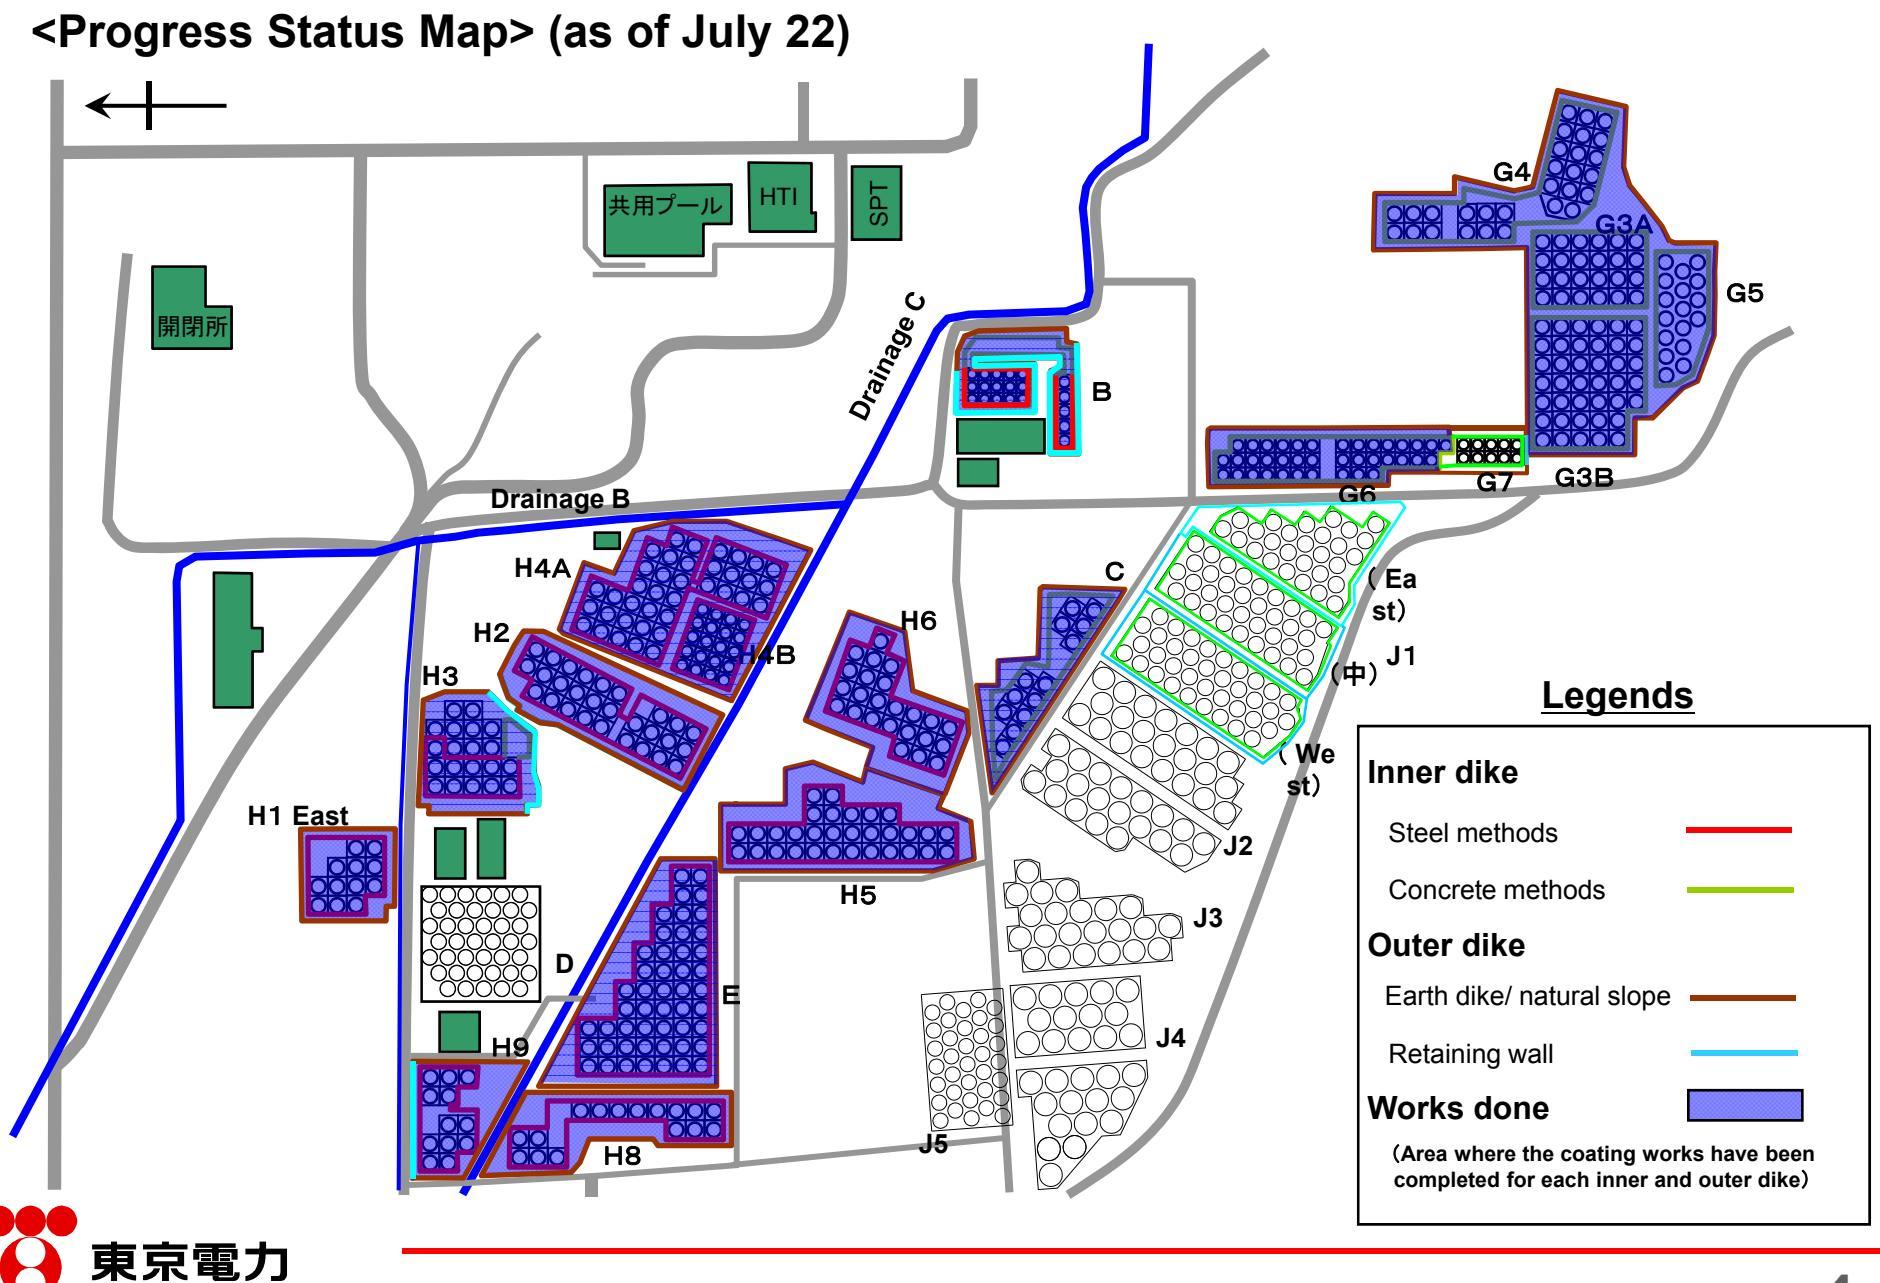
1. Rising up dike height and double diking

Countermeasures works have been completed for all tank areas
