Correlation between neutrons detected outside the reactor building and fuel melting

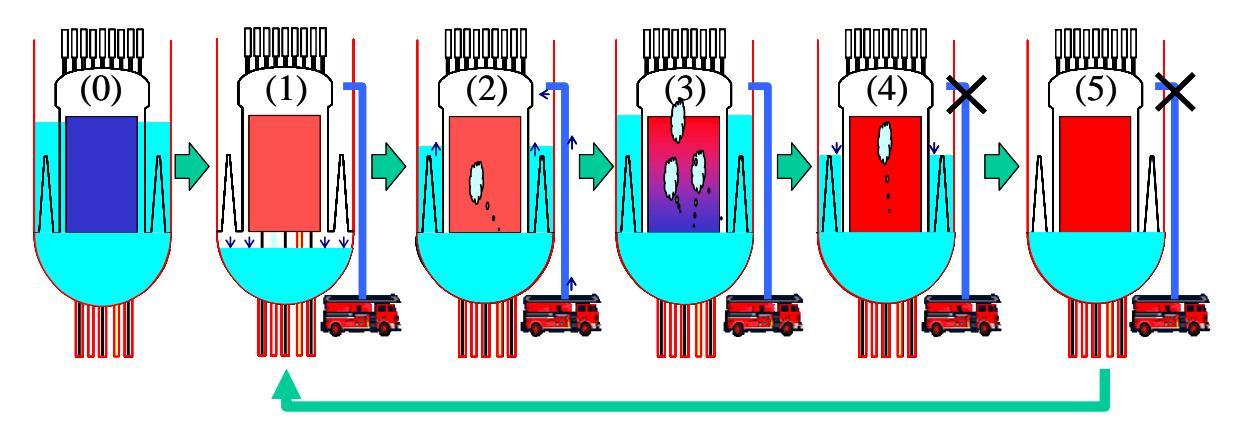
- Water injection starts at Stage 1 by fire engines, the water injected around the outside of the shroud reaches the core and steam starts to be generated (Stage 2).
- The water level increases due to continued water injection and steam increases accordingly (Stage 3).
- Steam generated contributes to the cooling of fuel, but the overheated fuel cladding leads to water-zirconium reactions, producing large amounts of hydrogen gas and energy.
- This increases the reactor pressure, exceeding the fire engine pump discharge pressure of about 1MPa, and thus the injected water fails to reach the reactor.
- As a result, the reactor water level decreases, and the steam generation is reduced (Stage 4).
- When the reactor water level drops below BAF, steam generation almost completely stops and the reactor pressure starts to decrease (Stage 5).

When the reactor pressure decreases to a level low enough to allow water injection by the fire engines, the reactor status returns to Stage 1 and the same sequence is repeated. This is considered to be the mechanism of the repeated pressure increase and decrease during the night of March 14th to the dawn of March 15th. During the transition from Stage 3 to Stage 4, water-zirconium reactions release large amounts of energy in a limited time, and fuel temperatures are considered to rise sharply. This is probably when fuel melting occurred.

Figure 1 Steam generation and pressure increase after the water injection

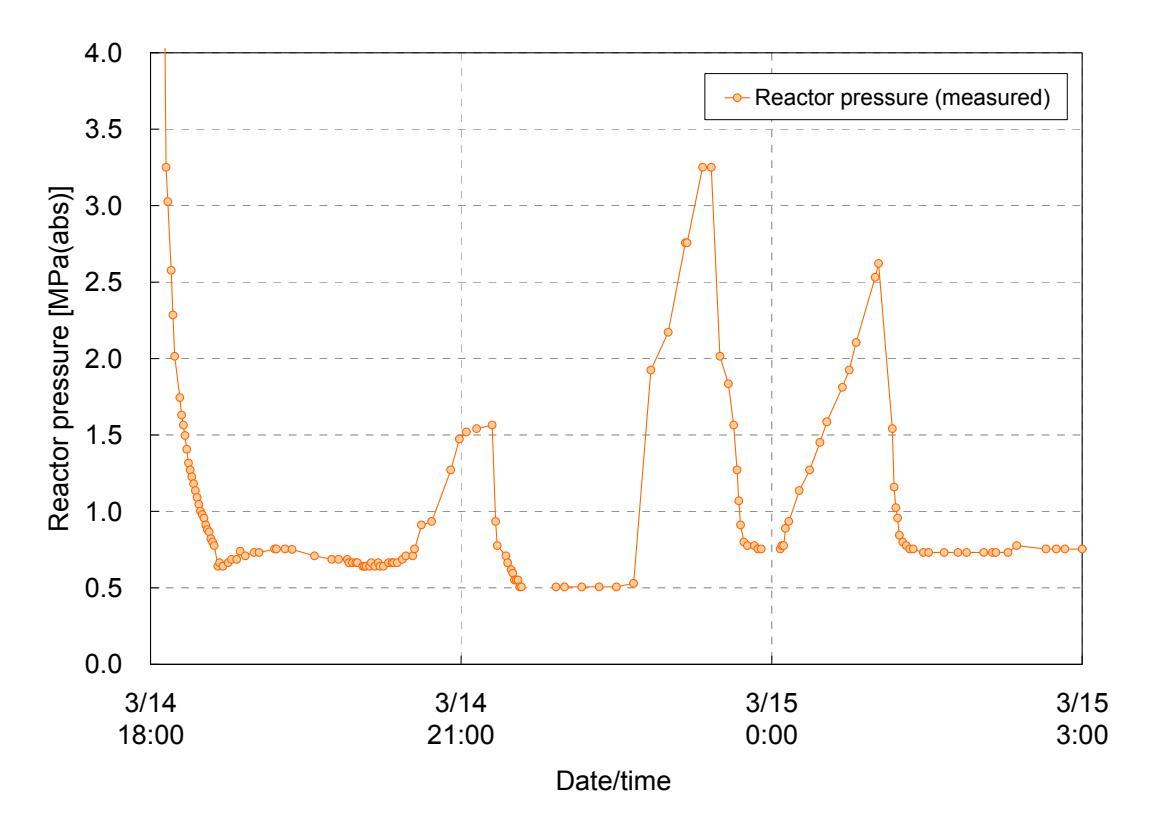
- Reactor depressurization started at 18:02 on March 14th by opening the main steam safety relief valve (SRV). The reactor pressure was lowered to about 1 MPa by around 18:30.
- Accordingly, the reactor water level decreased from just below the top of active fuel (TAF) at TAF-1.1m (designated as stage 0 in Figure 1) before depressurization at 18:00 to below the bottom of active fuel (BAF) at TAF-3.9m (stage 1) at 18:30.
- After fire engines resumed water injection at 19:54, the reactor pressure started to increase at around 20:15.
- Later the reactor pressure decreased, while the PCV pressure increased from a stable level, over the time period including 21:20, when the SRV opening operation was recorded.
- Also between 22:40 and 23:25 on March 14th, and between 00:06 and 01:02 on March 15th, the reactor pressure increase and decrease were observed to have started as shown

in Figure 2.

Figure 2 Observed intermittent increase in reactor pressure in Unit-2.

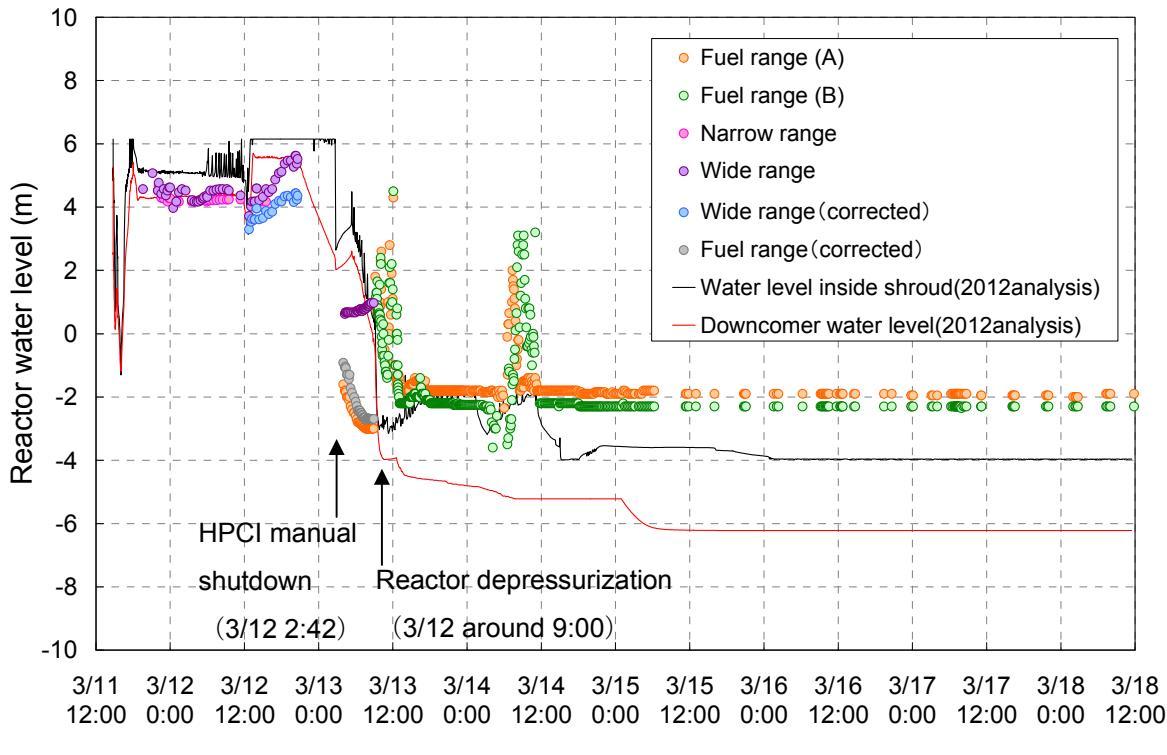
Figure 3 shows the correlation between the measured reactor water level in Unit-3 and that obtained by the MAAP analysis which TEPCO published in March 2012. As already reported in "Unit-3/Issue-3," the estimated water injection by HPCI could not have provided sufficient water into the reactor before the operator manually shut down the HPCI. As a consequence, the reactor water level might have been at or near the TAF level at the time when the HPCI was manually shutdown. The reactor water level was almost constant at BAF+0.7m from 07:35 on March 13th to the time of reactor depressurization, as measured by the fuel range water level indicator (Figure 4). It is unlikely, though, that the reactor water level would remain constant when decay heat was continually releasing energy. The actual water level can be estimated as below BAF, since the apparently constant water level is likely to have overestimated the actual value due to the evaporated water head in the reference condensing water chamber side piping.

Figure 3 Reactor water level changes in Unit 3

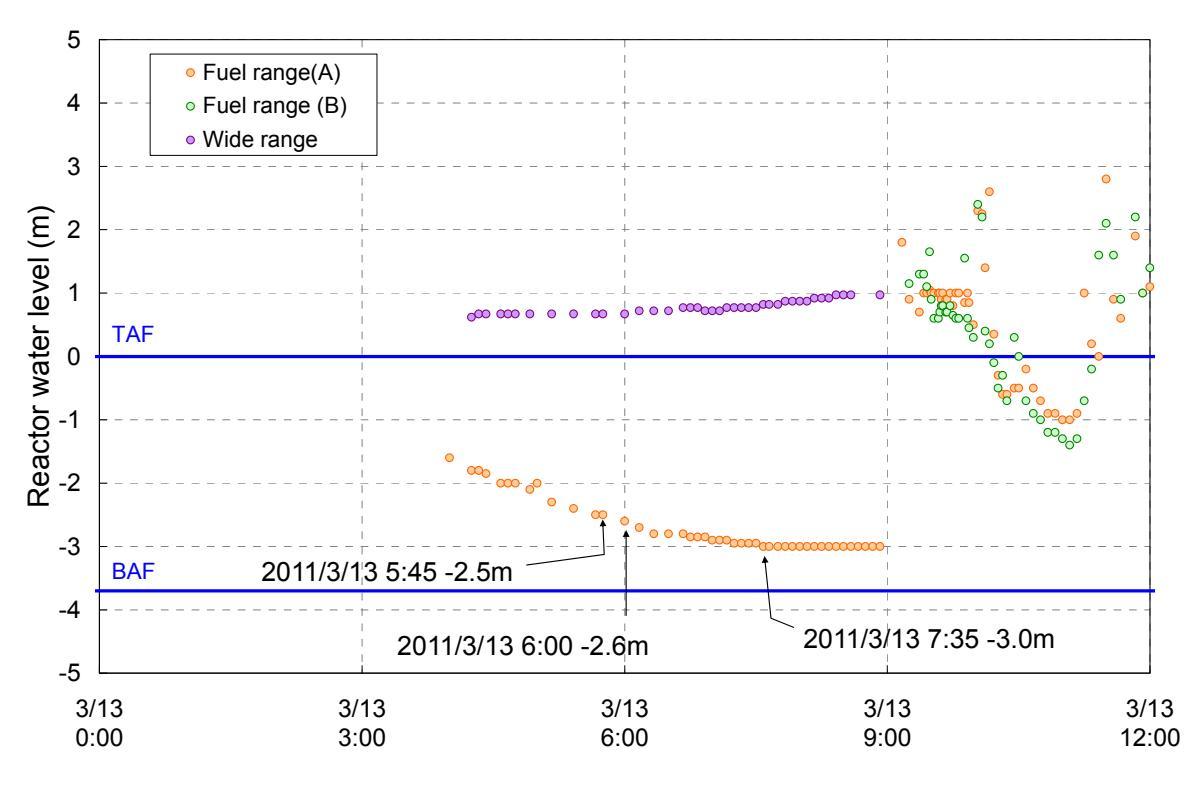
As seen above for Unit-3, in the accident progression the reactor water level can be estimated to have gradually decreased due to boiling, while its pressure remained high, down to the BAF level and then the fuel was completely uncovered, as had occurred in Unit-1. While the water level is gradually decreasing, the fuel cladding temperature rises remain more or less limited by the steam flow from below (steam cooling). But as the water level decreases, the area of the exposed fuel surface to be cooled increases and the amount of steam for cooling decreases. Thus the fuel cladding temperatures are considered to increase gradually. The cladding material Zr reacts with

steam and forms oxides. The oxidation progresses rapidly due to positive feedback once the cladding temperature exceeds 1200 deg C. Therefore, if this rapid oxidation had progressed during the reactor water level decrease, fuel might have started melting, due to the large amounts of energy released during the time period of 05:00 to 07:00 on March 13th, depending on the oxidation history before then and the decay heat.

Figure 4 Reactor water changes in detail in Unit-3

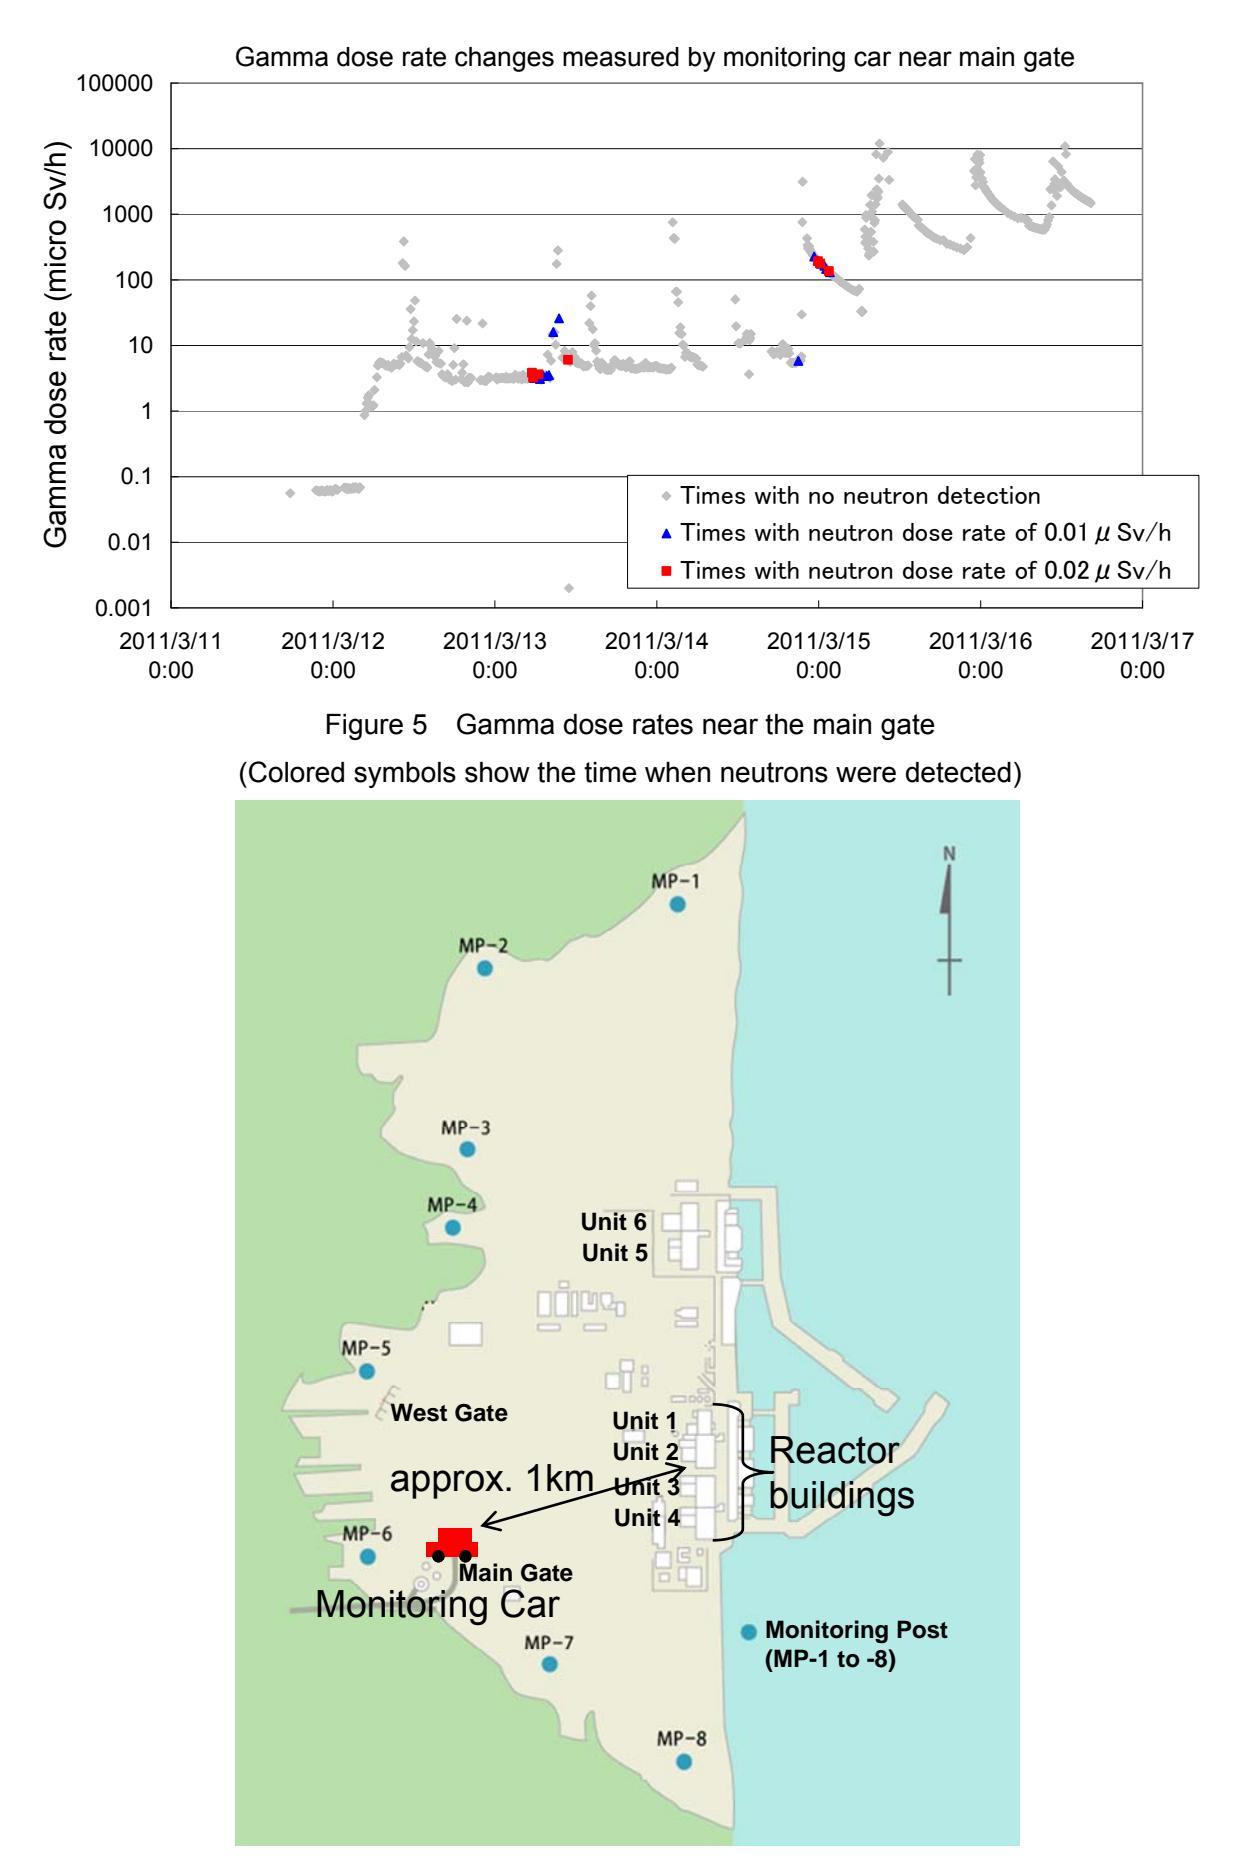
The main gate where neutrons were detected is, as shown in Figure 6, about 1km from the

reactor buildings. Therefore, it is unlikely that neutrons from the reactors were directly detected. Furthermore, BWRs are designed to maintain their chain reactions by neutrons moderated by water. Therefore, it is considered that the neutrons detected are not the neutrons, which originated from those neutrons generated in the chain reactions for criticality in the reactor, in view of the following conditions.

Figure 6 Locations of deployed monitoring car and reactor buildings of Unit-1 to Unit-3

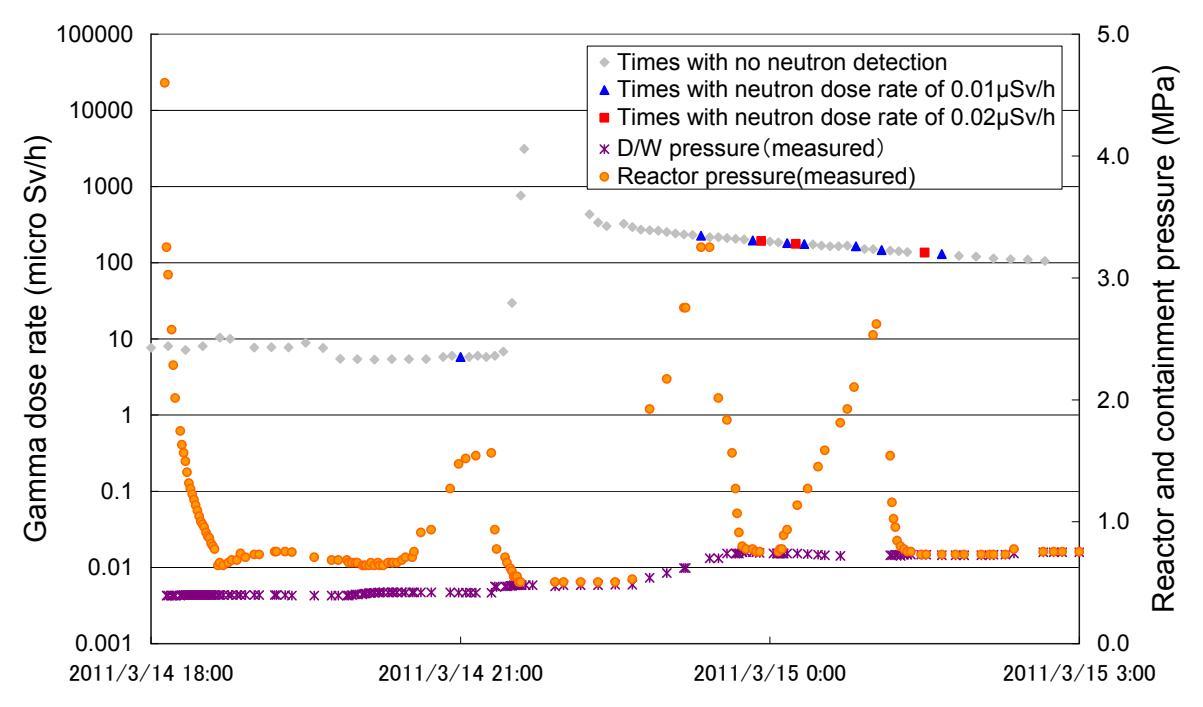
Figure 7 shows the correlation between the times when neutrons were detected and the reactor/PCV pressures. Neutrons were detected after the reactor pressure started to increase. As discussed earlier, this reactor pressure increase is considered to be due to steam generated by the water injected by fire engines arriving at the core region. At the same time, large amounts of energy are considered to have been released due to zirconium-water reactions, leading to fuel melting. In other words, some of the actinide elements such as uranium and plutonium released into the gaseous phase by fuel melting during this time period may have leaked out of the reactor building through a path, different from that of the FPs which caused gamma dose rate increases, and the neutrons emitted by spontaneous fissions of plutonium, curium, etc. may have been detected.

Figure 7 Correlations between times when neutrons were detected and reactor/PCV pressures
