## “High Alarm” from Plastic Scintillation Fiber monitor (PSF monitor) monitoring the wharf drainage channel at the Fukushima Daiichi Nuclear Power Station

### 【Overview】

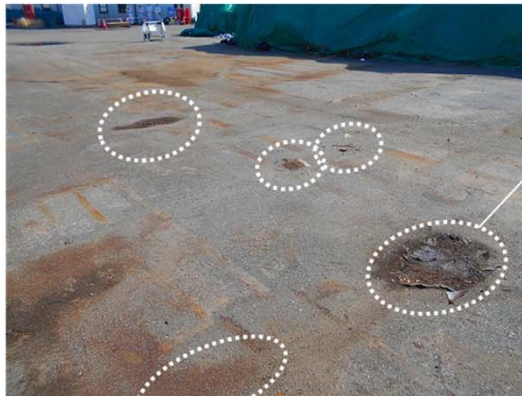
- Furthermore, on March 22, clumps of a gel-like substance emitting high beta rays were found on the surface of temporary storage area W2. Therefore, on March 24, the aforementioned gel-like clumps were collected along with soil from the spots in temporary storage area W2 where beta ray doses are high after which a decontaminating agent (coating stripper decontamination agent) was scattered on the surface of the surrounding area, and the area was covered with tarps and sandbags.

① Prior to removal

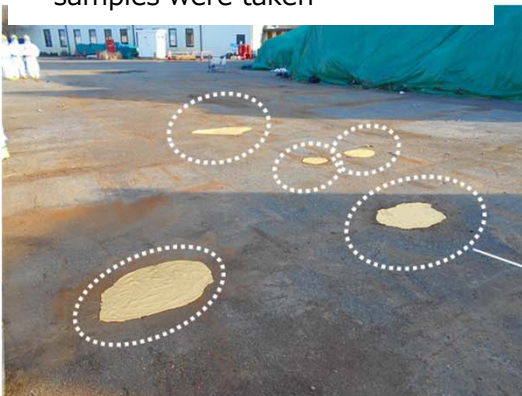
③ Stripper applied to areas where samples were taken

On March 24, after the gel-like clumps (gel-like substance mixed with soil) and surrounding soil was collected, the surrounding surface was sprayed with a decontaminating agent (coating stripper decontamination agent), and covered with a tarp, upon which sandbags were placed.

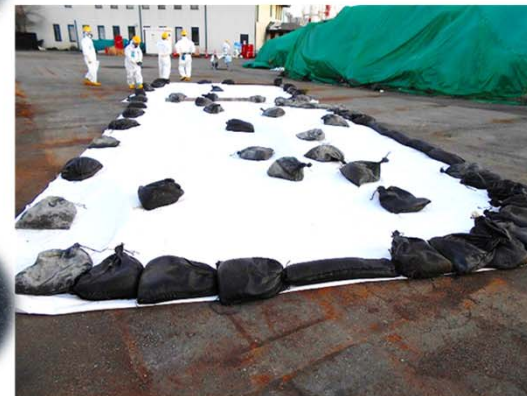
④ Sampled area covered with a tarp

As soon as preparations have been completed, the asphalt will also be stripped to decontaminate the area.
