Fukushima Daiichi Nuclear Power Station Progress with Preparations for Unit 1 Fuel Removal from the Spent Fuel Pool

March 27, 2025

Tokyo Electric Power Company Holdings, Inc.

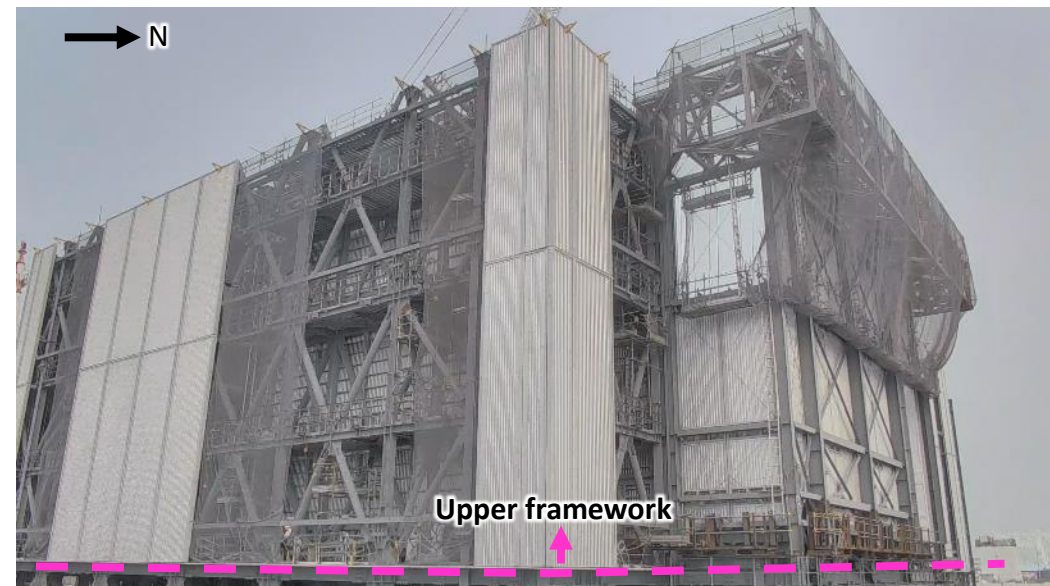
On-site conditions (Southeast side)
(Photographed on March 26, 2025)

- Installation of the upper framework is underway. (10 out of 12 blocks completed)
- Currently, dust dispersion prevention agents to be regularly scattered, the crane to spray water, and a mist spraying device are used to prevent the dispersion of dust. However, once the east side upper framework installation is completed, use of the mist spraying device will be suspended. Dust dispersion prevention agents will continue to be regularly scattered and the use of the crane to spray water when dust is churned up will continue until completion of the large cover.

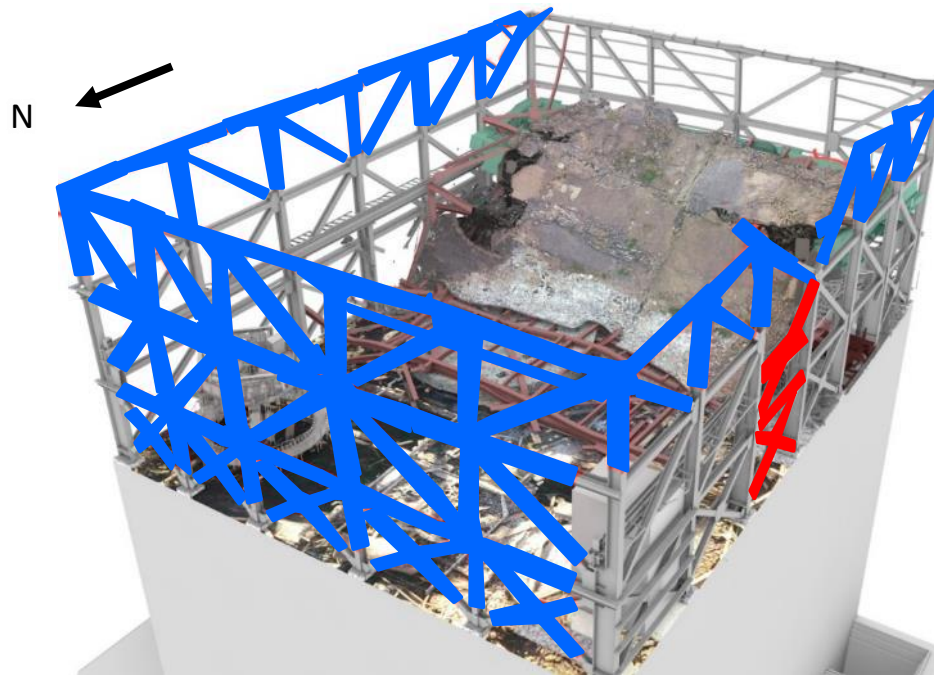
■ Portions that have already been removed (as of March 25, 2025)

■ Planned the scope of removal

※ The scope of removal may change in accordance with work plans/field conditions

- Portions of the outer frame are being removed in order to reduce the risk of contact with the large cover and to improve seismic resistance.
- Removal of portions of the frame on the east and north sides have been completed, and the removal of a portion of the frame on the west side is underway.

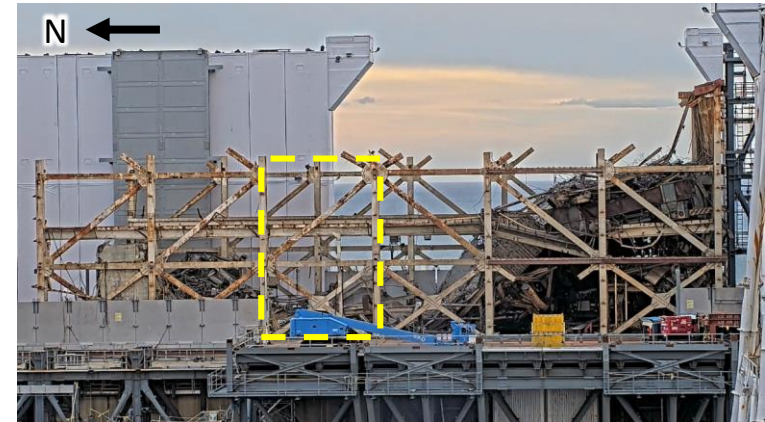
Entire structure (photographed on March 11, 2025)

■ Area left to be removed

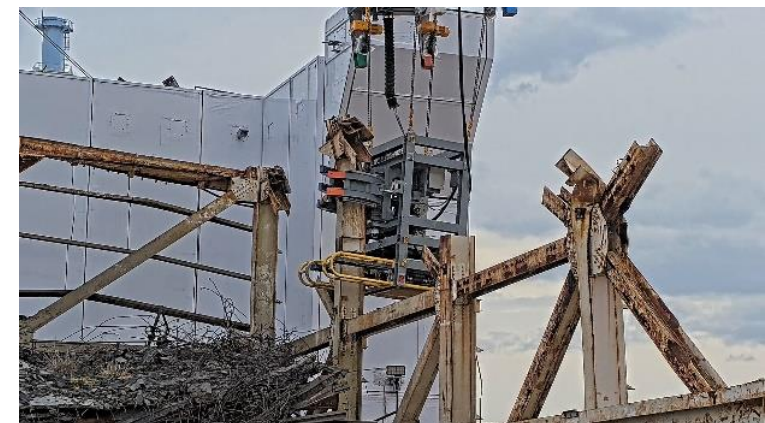
Work status (photographed on March 11, 2025)

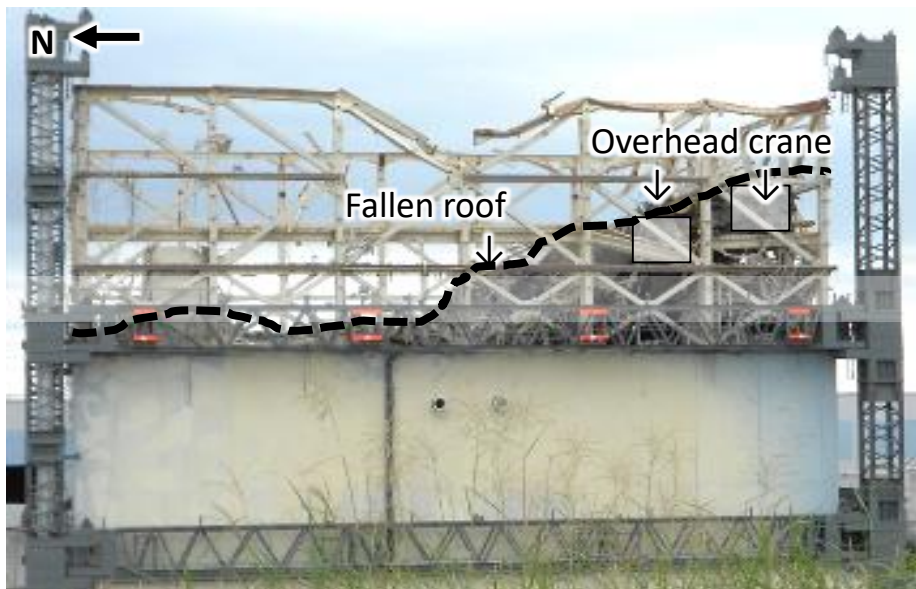
Photo of Unit 1 from the west (rubble conditions)

- Prior to Unit 1 fuel removal, rubble will be removed from under the large cover.
- The auxiliary hoist for the fuel handling machine (FHM) is wedged between a section of the fallen roof and the FHM. It is currently in a stable position, but there is a risk that it might fall as rubble is removed.
- If it were to fall on top of the existing spent fuel pool (SFP) gate cover ※¹, the SFP gate may incur damage, therefore additional countermeasures are being implemented.

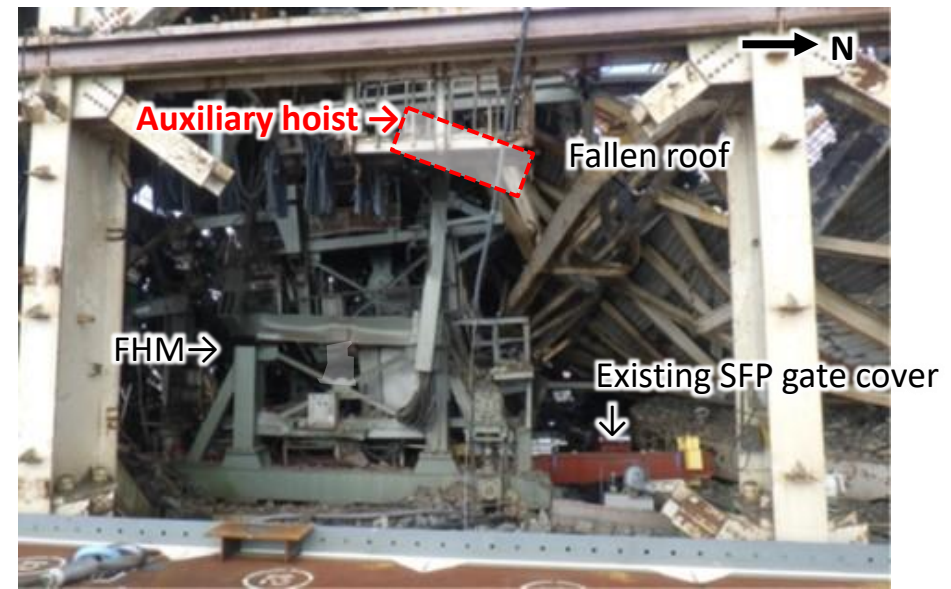
Photo of the Unit 1 operating floor from the east

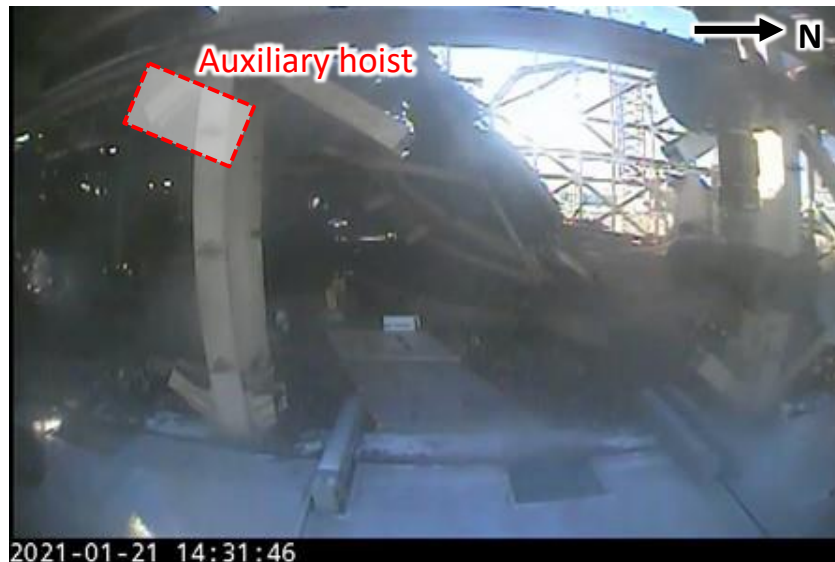
Prior to earthquake (January 21, 2021)

- The rubble on top of the auxiliary hoist is layered such that the rubble on the top pushes down on the rubble below thereby holding the auxiliary hoist in a stable position. No significant change was seen in the position of the auxiliary hoist even after the seismic intensity 6 lower (max. seismic intensity felt in Okuma Town and Futaba Town) earthquakes that occurred on February 13, 2021 and March 16, 2022.

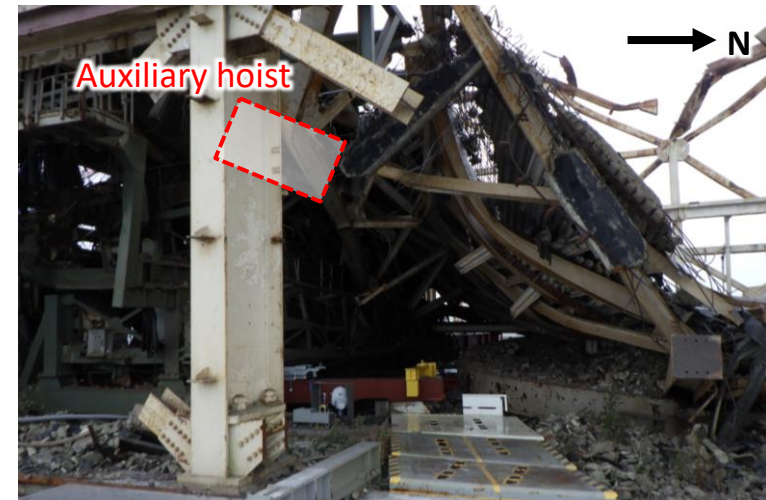
After Feb. 13 earthquake (February 15, 2021)

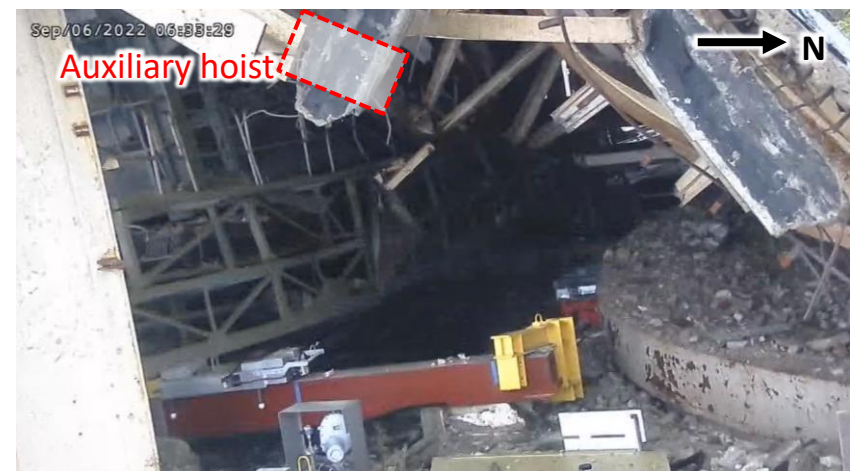
After Mar. 16 earthquake (September 6, 2022)

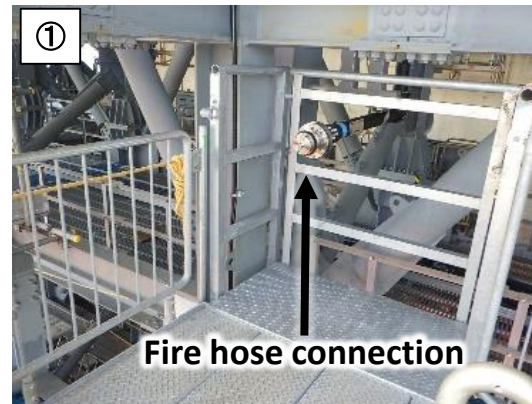
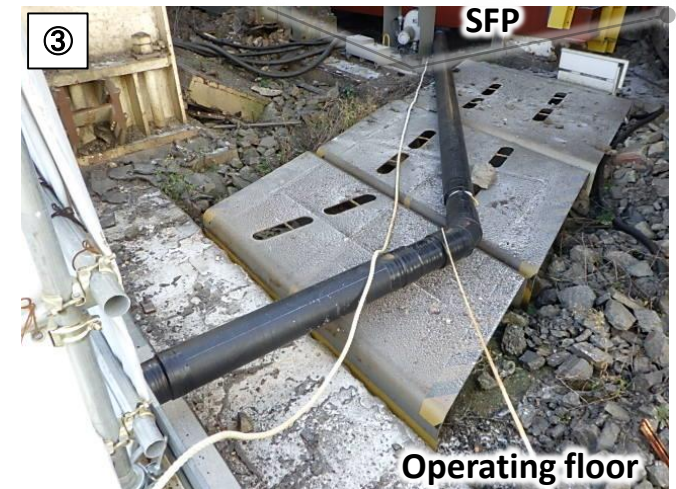
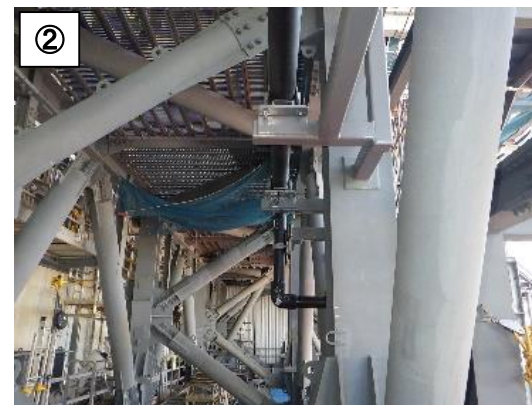
Alternative cooling water injection line installation status (photograph on February 26)

- In conjunction with installation of the upper framework of the large cover, a new means of cooling water injection (alternative cooling water injection line) has been installed since it would be difficult to inject cooling water into the SFP using concrete pump trucks.
- Existing SFP cooling equipment continues to be used for cooling water injection, and the installation of this new line is merely a means for diversifying cooling water injection methods.

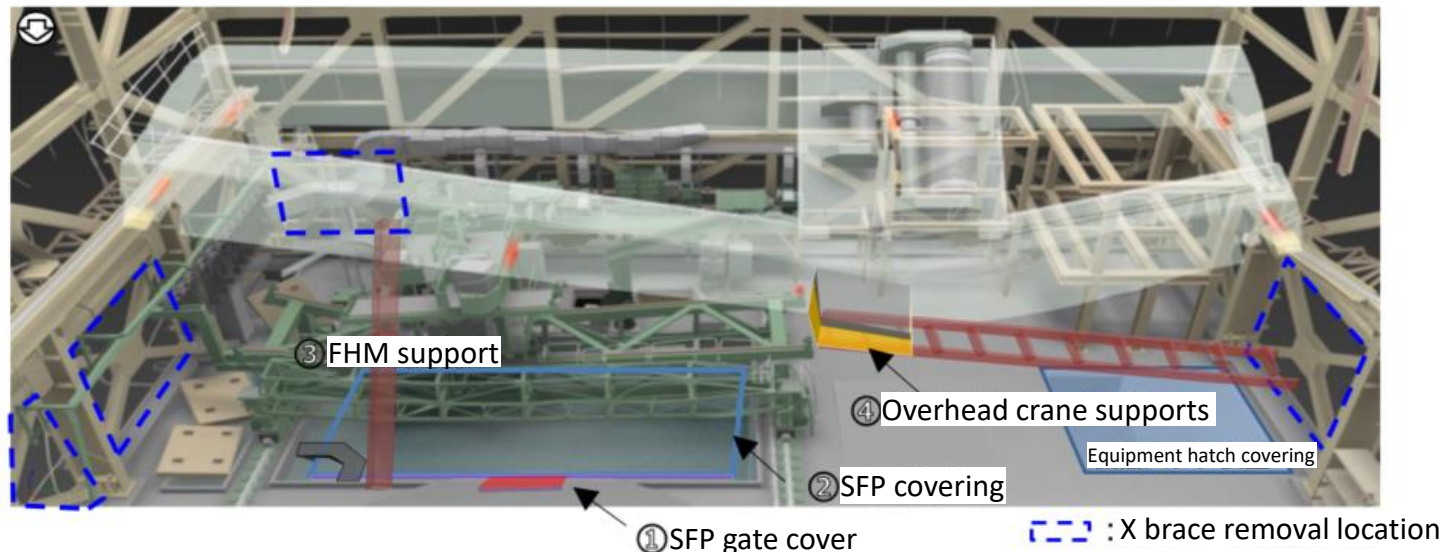
Falling rubble prevention/mitigation measures overview

- The following falling rubble prevention/mitigation measures* were implemented (completed on November 24, 2020) in order to reduce, as much as possible, the risk of roof frames and rubble, etc. falling into the SFP as the portion of the fallen roof on the south side is being removed.

- * ① SFP gate cover (installed in March 2020)
 - Reduces the risk of decreases in water level caused by the SFP gate being knocked out of place or damaged by roof frames/small rubble, etc., falling onto the SFP gate.
- ② SFP covering (installed in June 2020)
 - Reduces the risk of damaging the integrity of fuel, etc. if roof frames/small rubble, etc. were to fall into the SFP.
- ③ FHM supports (installed in October 2020), overhead crane supports (installed in November 2020)
 - Reduces the risk of damaging the integrity of fuel, etc. and the risk of dust dispersion caused by falling of the overhead crane resulting from the overhead crane/FHM being knocked out of place, or imbalances in a hoisted load, caused by roof frames/small rubble, etc. removal.
