Fuel debris grasping work at the Fukushima Daiichi Nuclear Power Station Unit 2

2-2. Workplan for retrieval fuel debris with the telescopic device (Condition of platform around opening 2 in the PCV)

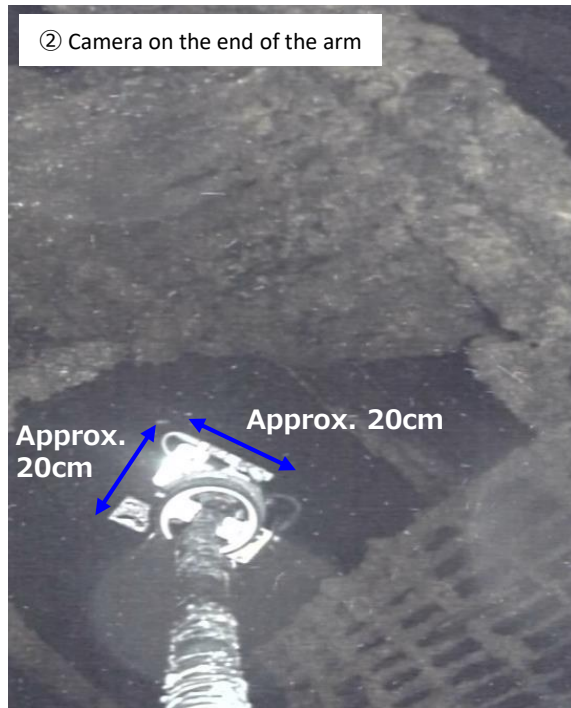
Above the opening 2

- At 10:00 a.m. on April 17, it was determined that the bottom of primary containment vessel could be accessed through the opening 2, and at 10:52 a.m. fuel debris was grasped below the opening 2. Thereafter, at 11:38 a.m. the telescopic device with fuel debris sample in hand was retracted to the position it was in prior to commencement of this task.
(Completion of fuel debris grasping work)
- Going forward, the guide pipes will be withdrawn and the telescopic device will be retracted into the enclosure. When the fuel debris sample is brought into the enclosure, its dose measurements will be taken.

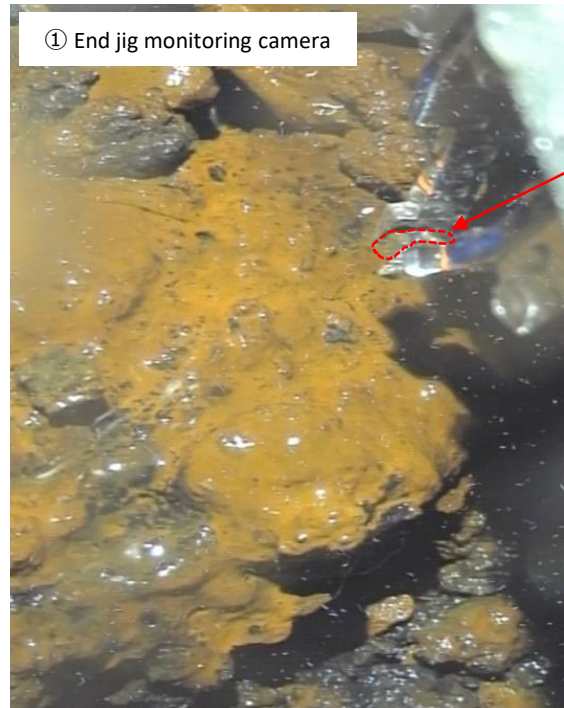
Grasping fuel debris below the opening 2

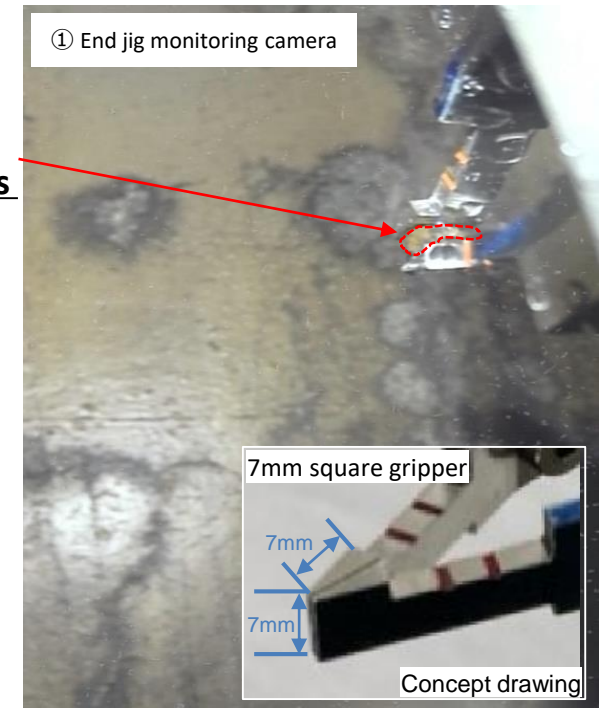
Completion of fuel debris grasping work

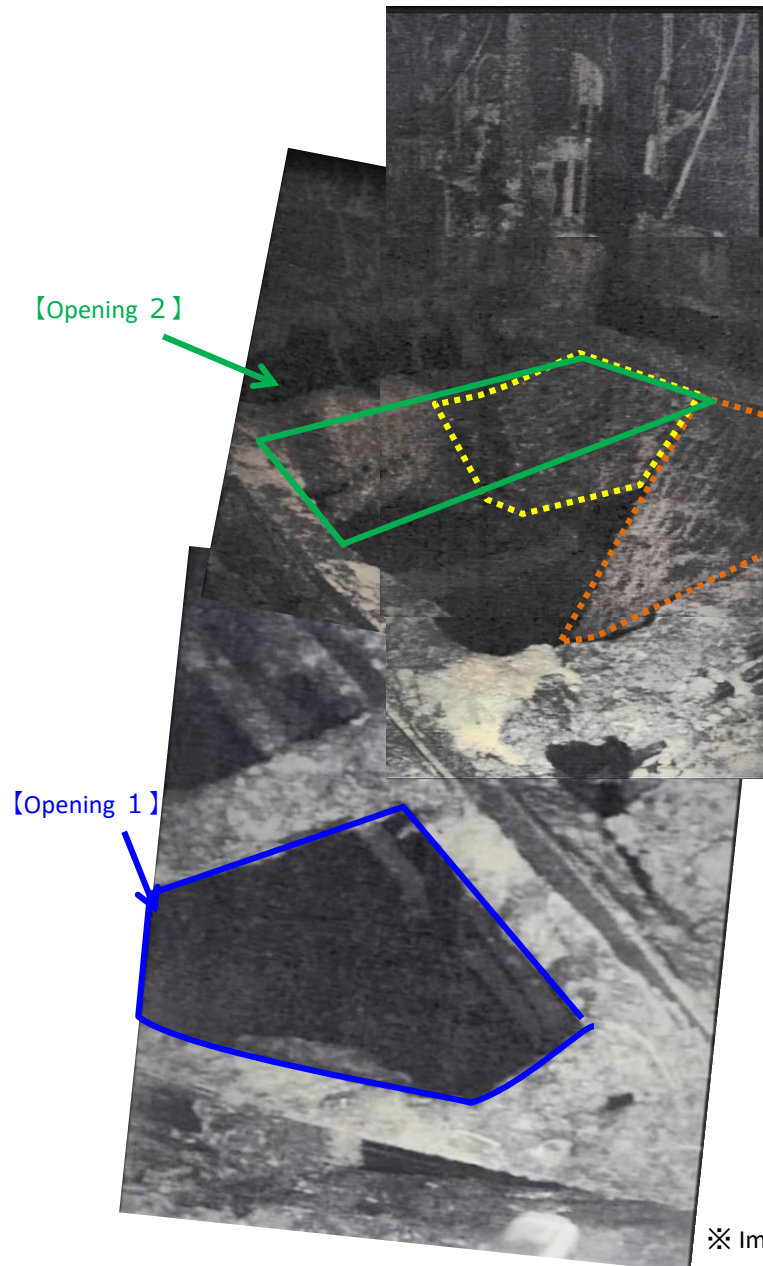
- The conditions of opening 2 (shown in green on the left) were confirmed using photos taken with the telescopic device camera during work in September 2024.
- Grating shown in the yellow dotted area on the left can be seen around opening 2.
- However, it's difficult to see the borders of the grating and the outline of it can be just barely seen by the light reflecting off of it.
- If the grating completely fills in the yellow dotted area, that will mean that the grating will obstruct almost half of opening 2.
- We have confirmed that grating still exists right in front of opening 2 in the area shown by the orange dotted line.

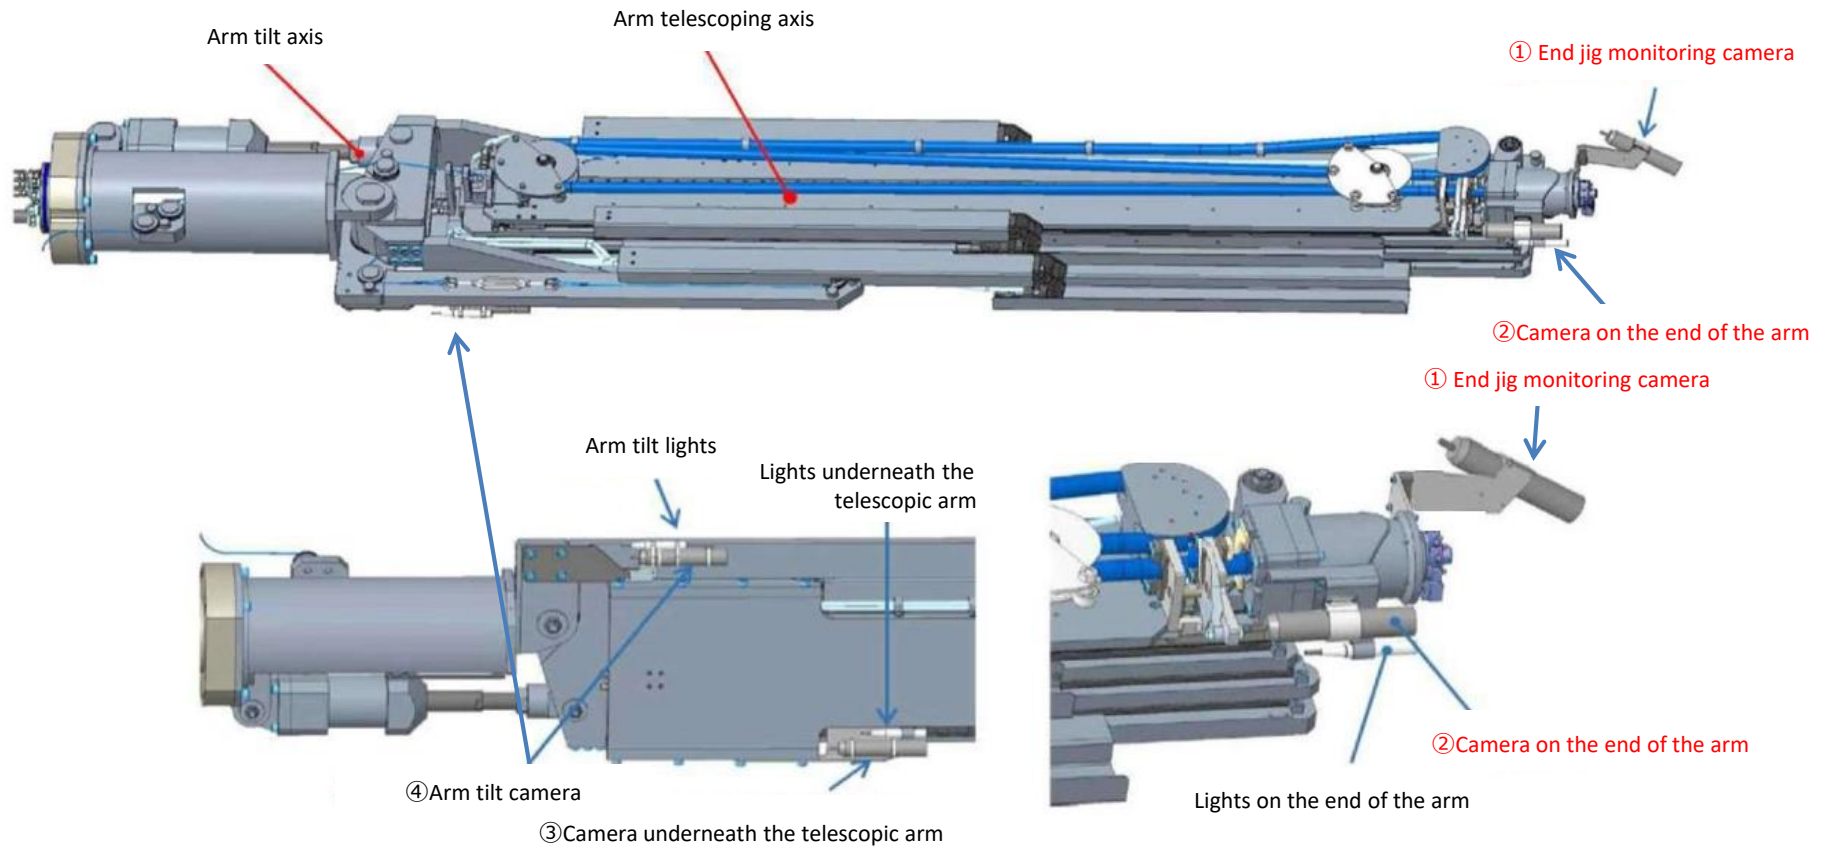
Status of cameras installed on the telescopic device
