- In preparation to remove rubble from the operating floor of the Unit 1 reactor building, a large cover will be installed around the building in order to improve the reliability of dust dispersion countermeasures and prevent rain from entering the reactor building. Rubble will then be removed from underneath this cover.

- Therefore, an additional cover will be installed over the SFP gate as a countermeasure to protect the SFP gate from being damaged if the auxiliary hoist falls. This task will be commenced today, June 26, if the preparations was made.

Exposure reduction countermeasures and countermeasures for foreseen risks during installation

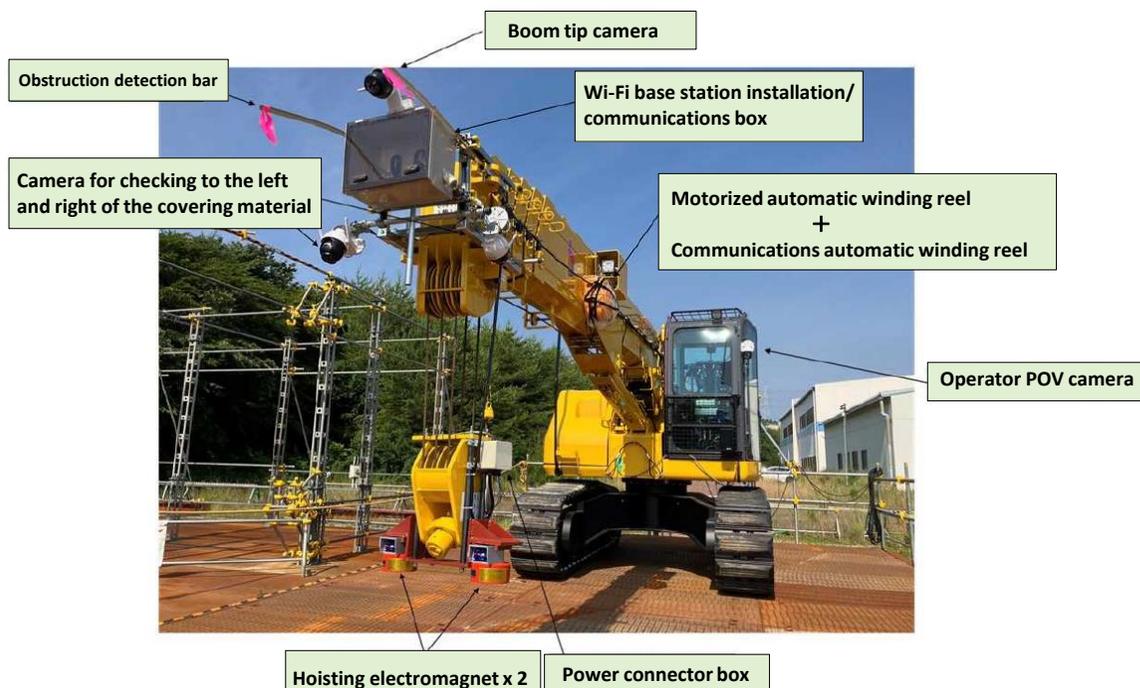
Crane (prior to shielding installation)
(photographed on June 12, 2024)

- In order to reduce exposure, the operator's cabin of the crane that will be used to install the additional SFP gate cover has been shielded with lead and flint glass has been placed around the windshield, etc.
- A camera has been installed on the crane so that potential obstructions can be identified early since there is the risk of the crane jib or installation material coming in contact with obstructions (rubble, etc.) during installation of the additional cover.

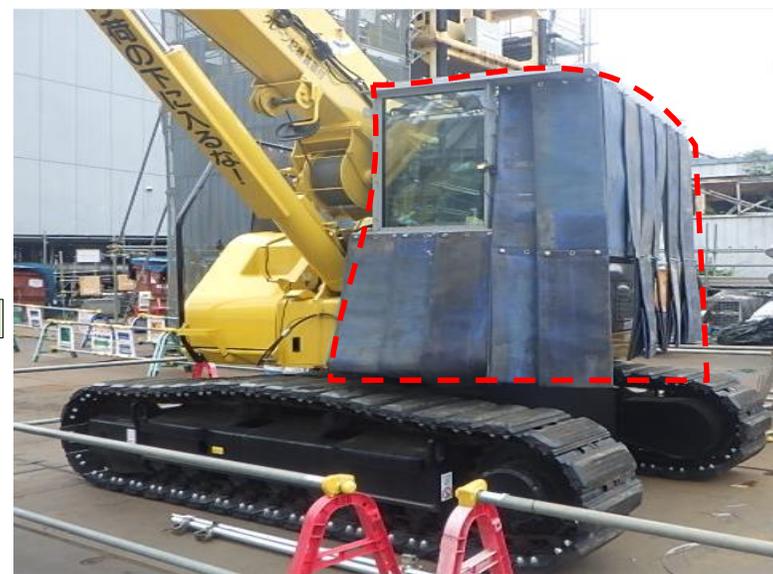
Crane after installation of lead shielding and flint glass
(photographed on May 22, 2025)

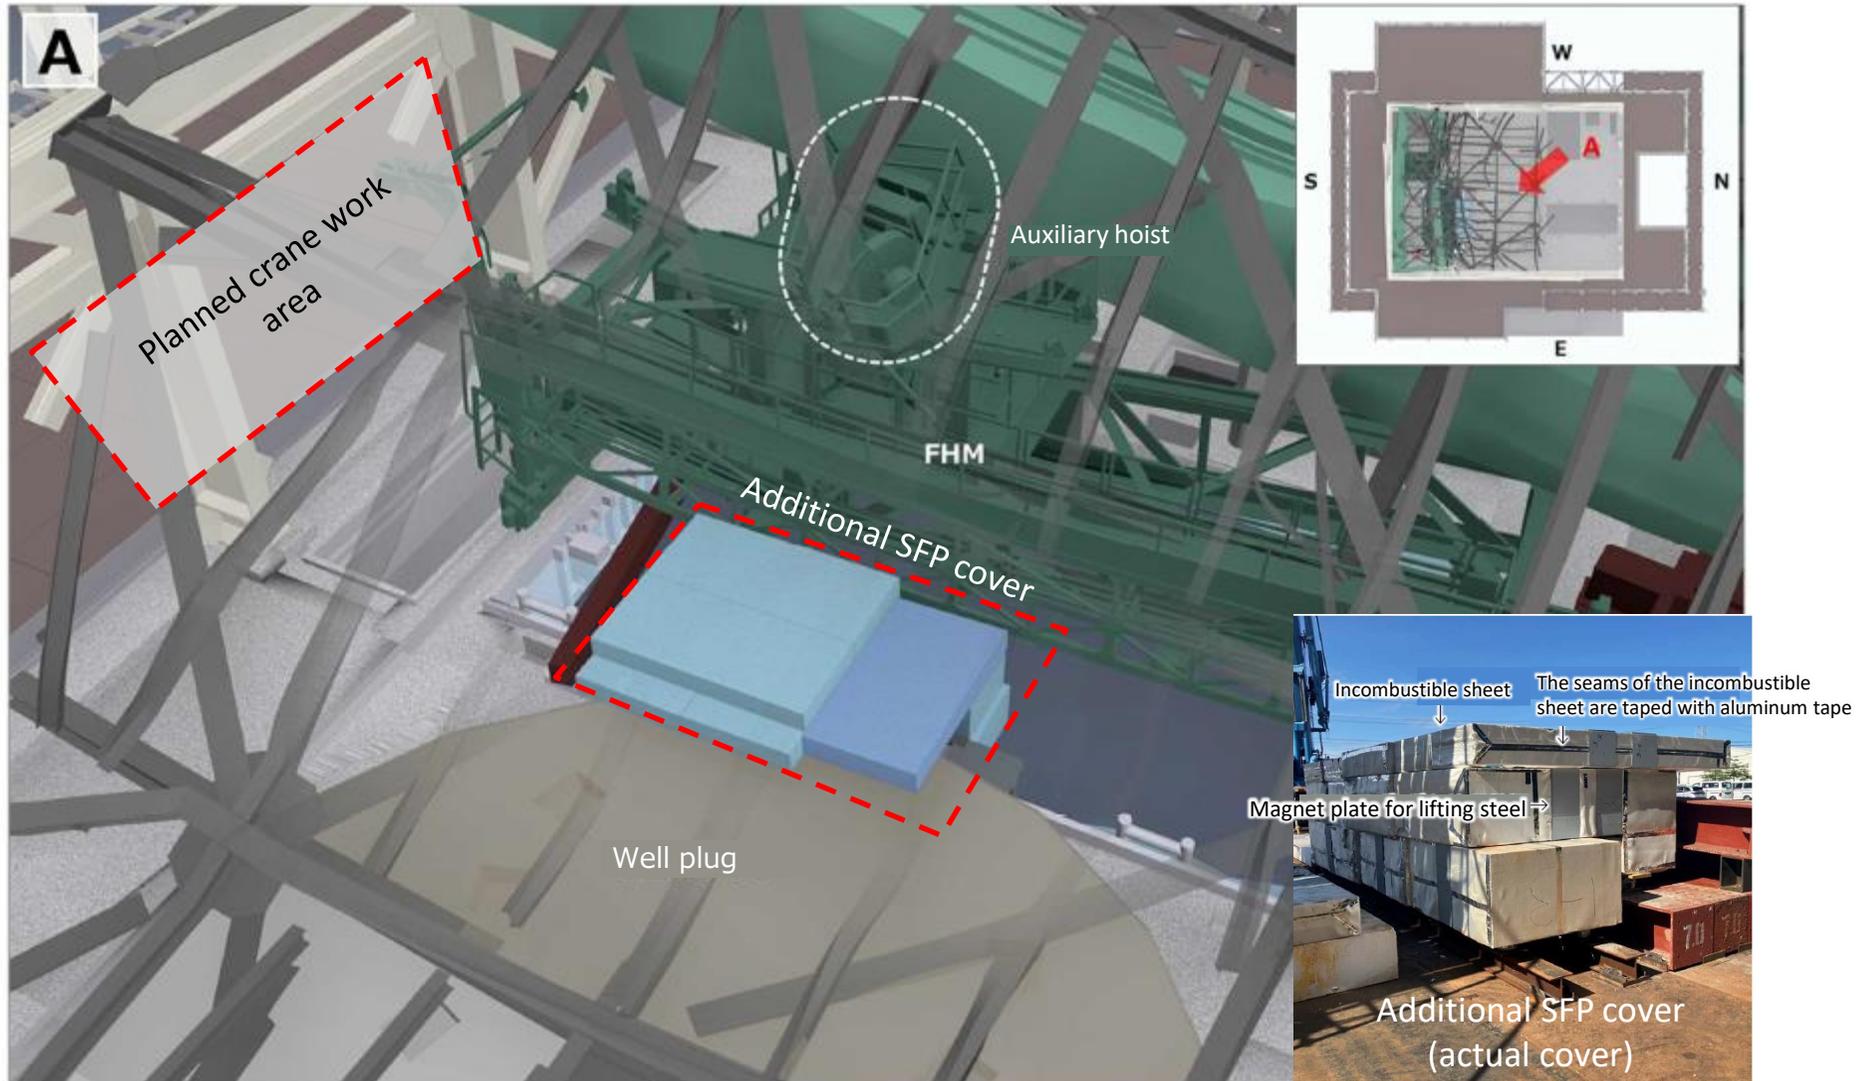
[Reference] Image of additional SFP gate cover installation

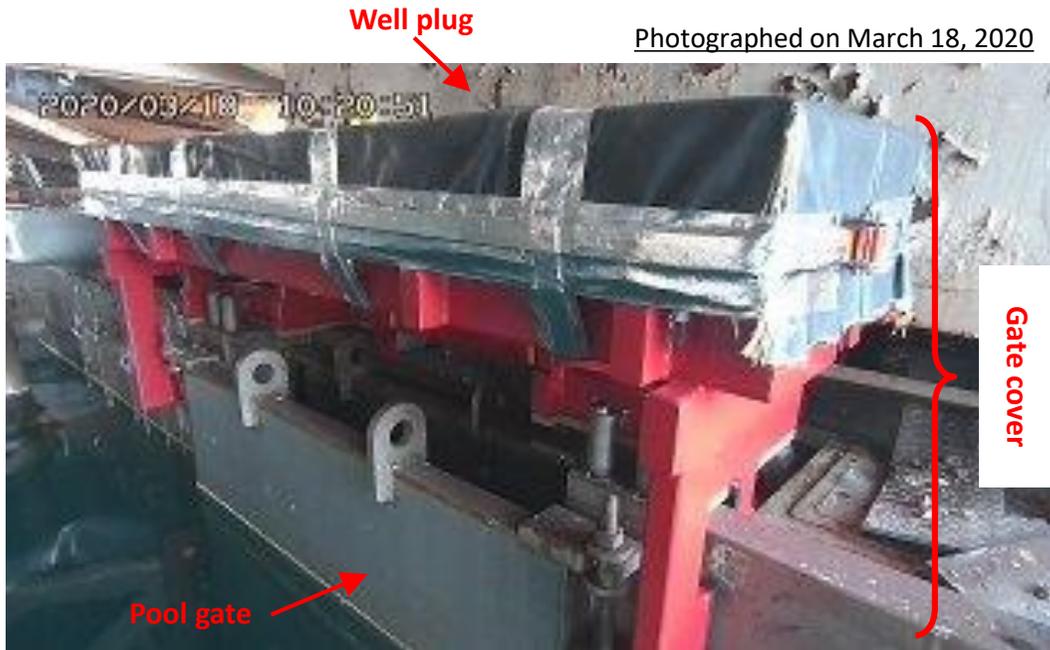
- The SFP gate cover was installed above the pool gate on March 18

Installation photo
(Direction of photograph:
Southeast to Northwest)

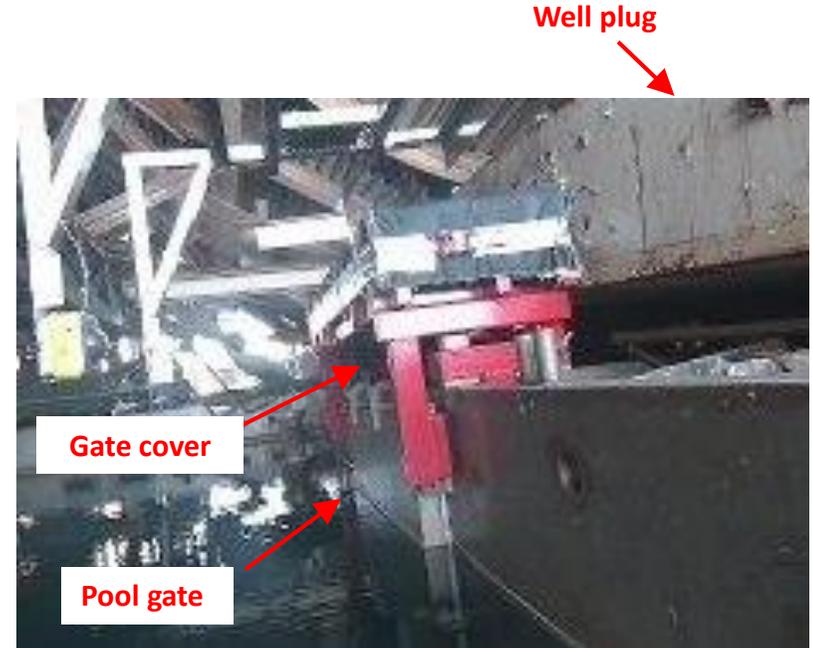
Installation photo
(Direction of photograph: East to West)

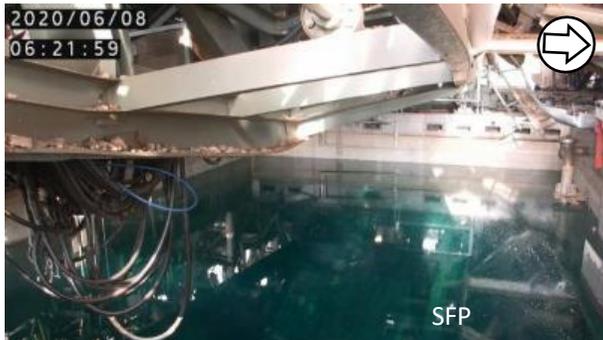
Prior to cover bag insertion
(Photographed on June 8, 2020)

- A cover bag was positioned to protect to the fuel inside the SFP
- June 8, 2020: Cover bag was inserted and spread
- June 11, 2020: Air mortar was inflated into the cover back
- June 17, 2020: Spacers installed to secure the cover back
- June 18, 2020: SFP water level restored and circulated cooling restarted there by marking completion of SFP cover installation

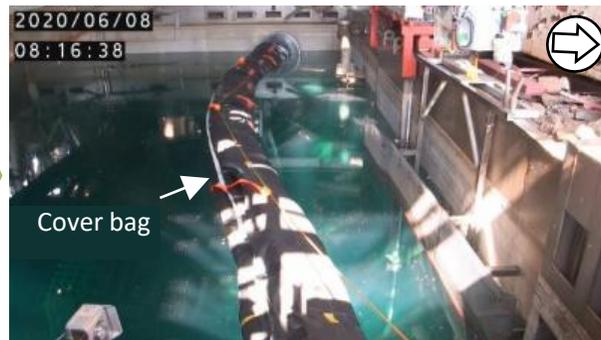
Cover bag insertion
(Photographed on June 8, 2020)

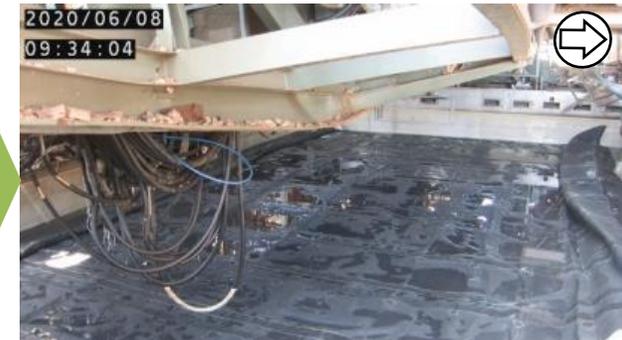
Cover bag was spread
(Photographed on June 8, 2020)

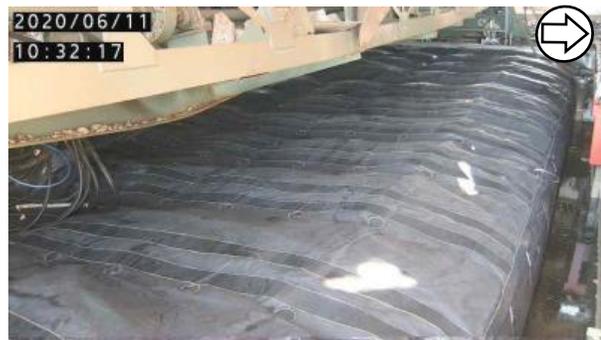
Air mortar was inflated
(Photographed on June 11, 2020)

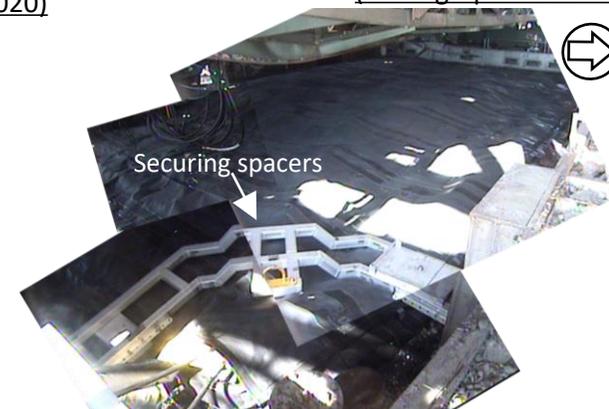
Securing spacer installation
(Photographed on June 17, 2020)
