Groundwater Observation Hole at Fukushima Daiichi Nuclear Power Station

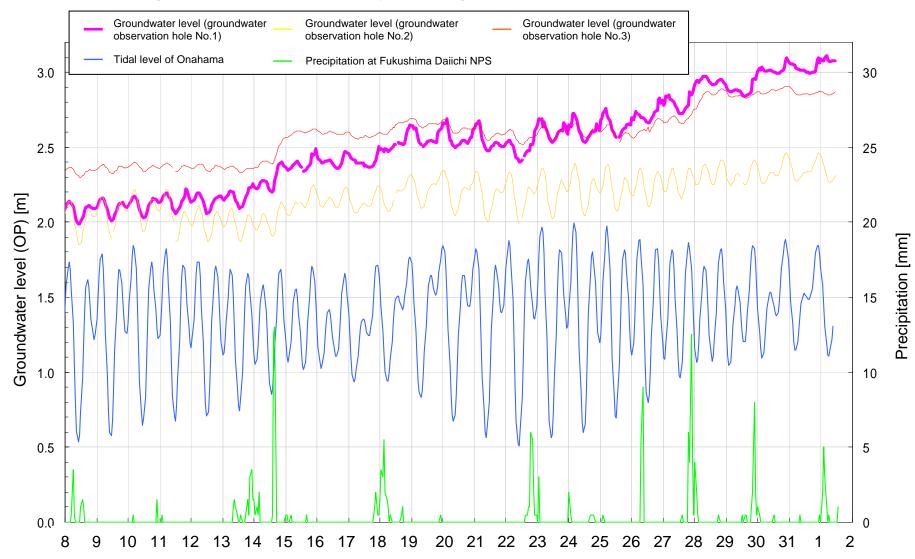
■Transition of the groundwater level (July 8 - August 1)

Water level of the groundwater observation hole (O.P. mm) ^(Note 1)			
	No.1-1	No.1-2	No.1-3	No.1-4
Jul 9, 2013 10:00 AM	1.80	1.82	-	1.83
Jul 11, 2013 10:00 AM	1.91 ^(Note 2)	1.91	1.96	1.94
Jul 16, 2013 10:00 AM	1.94 ^(Note 2)	2.22	2.22	2.25
Jul 18, 2013 8:00 PM		2.89	2.50	2.46
Jul 19, 2013 5:00 AM		2.74	2.39	2.44
Jul 19, 2013 8:15 PM		2.42	2.38	2.37
Jul 20, 2013 7:30 PM		2.39	2.39	2.35
Jul 21, 2013 4:45 AM		2.44	2.42	2.43
Jul 22, 2013 6:30 PM		2.42	2.39	2.30
Jul 23, 2013 4:00 AM		2.53	2.55	2.50
Jul 23, 2013 7:30 PM		2.52	-	2.44
Jul 24, 2013 4:00 AM		2.53	2.55	2.52
Jul 24, 2013 8:00 PM		2.48	2.48	2.47
Jul 25, 2013 5:00 AM		2.56	2.57	2.52
Jul 25, 2013 6:30 PM	_ (Note 3)	2.50	2.53	2.45
Jul 26, 2013 4:00 AM		2.58	2.59	2.54
Jul 26, 2013 8:00 PM		2.65	2.67	2.64
Jul 27, 2013 5:00 AM		2.68	2.70	2.68
Jul 27, 2013 7:30 PM		2.70	2.72	2.73
Jul 28, 2013 5:00 AM		2.77	2.87	3.01
Jul 29, 2013 7:30 PM		2.80	2.81	2.77
Jul 30, 2013 4:45 AM		2.91	2.93	2.98

Jul 30, 2013 7:30 PM		2.92	2.93	2.91
Jul 31, 2013 4:45 AM		2.94	2.94	3.02
Jul 31, 2013 8:30 PM		2.91	2.92	2.95
Aug 1, 2013 4:45 AM		2.98	2.98	3.11

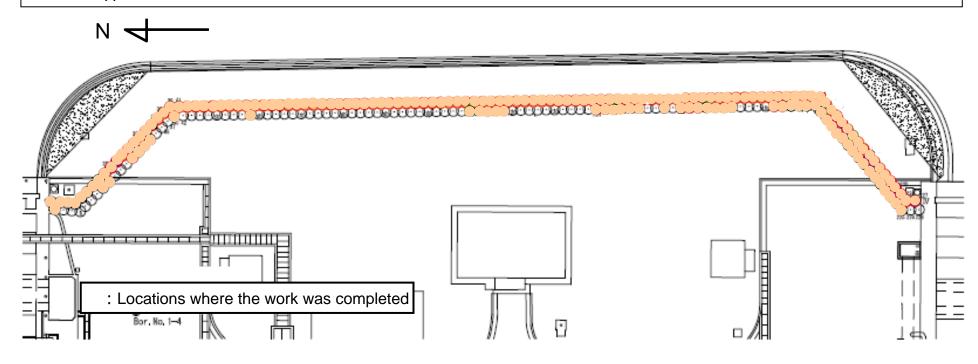
■ Progress Status of Bank Protection Foundation Improvement Work between Water Intakes of Units 1 and 2

- The foundation improvement was started on July 8, and is currently underway by use of ten foundation improvement machines. (The work starts at 7:00 PM each day and ends at 7:00 AM next day.)
- By the morning of August 1, the work was completed in total of 164 locations (114 on the sea side line and 50 on the mountain side line). (The work is planed to cover a total of 228 locations (114 on the sea side line and 114 on the mountain side line))

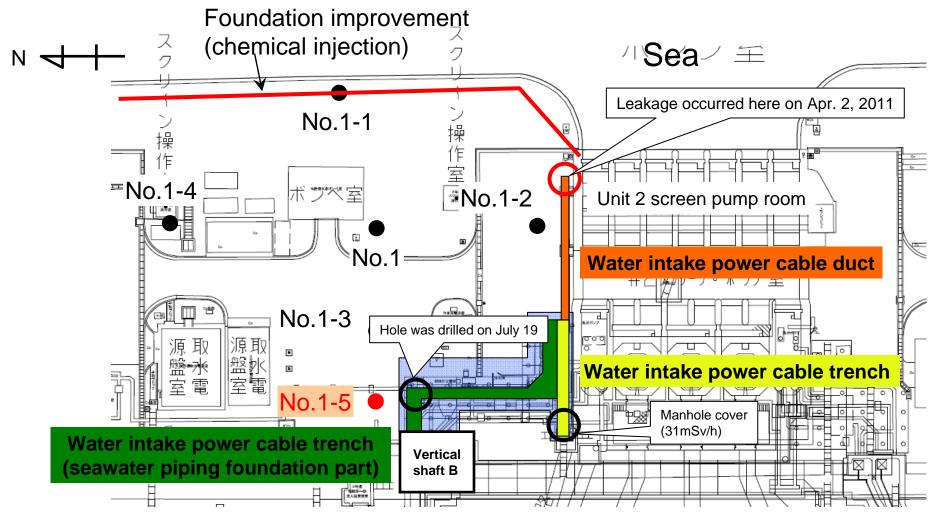
■Position of the groundwater observation hole No.1-5

■This observation hole locates at approx. 15m from the observation hole No.1-3 to the mountain side (near the vertical shaft B at the seawater piping trench).

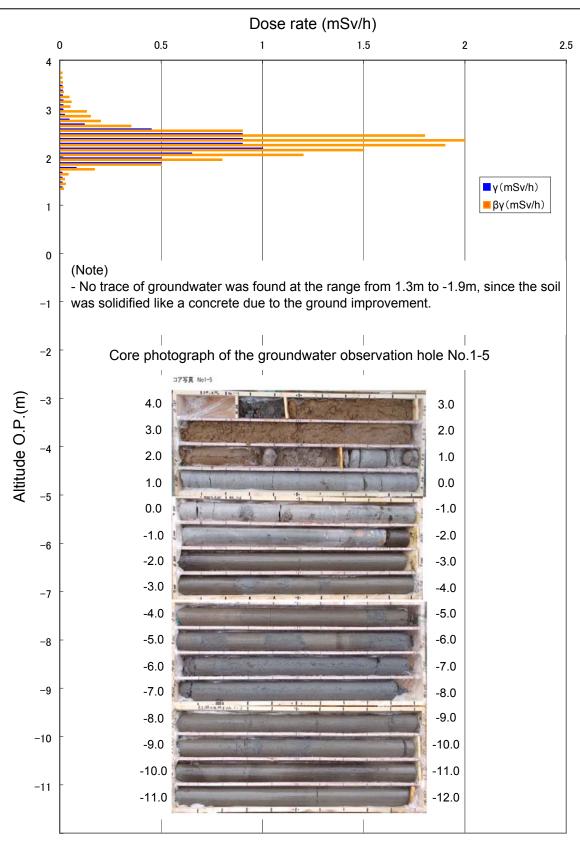
■ Dose Rate Transition of Boring Core of the Grounwater Observation Hole No.1-5 (Remeasurement)

- Remeasurement of boring core (soil) at the groundwater observation hole No.1-5 (near the power cable trench of the groundwater observation hole No.1-3) was performed under a condition that there is a space between each core and no core is affected by the adjacent core. As a result, the highest dose was detected only around O.P.2.5m - 2m, and no significant value was detected under 1.3m deep.
