Condition of the Bank Protection Area at Fukushima Daiichi Nuclear Power Station

<Reference>
September 25, 2013
Tokyo Electric Power Company

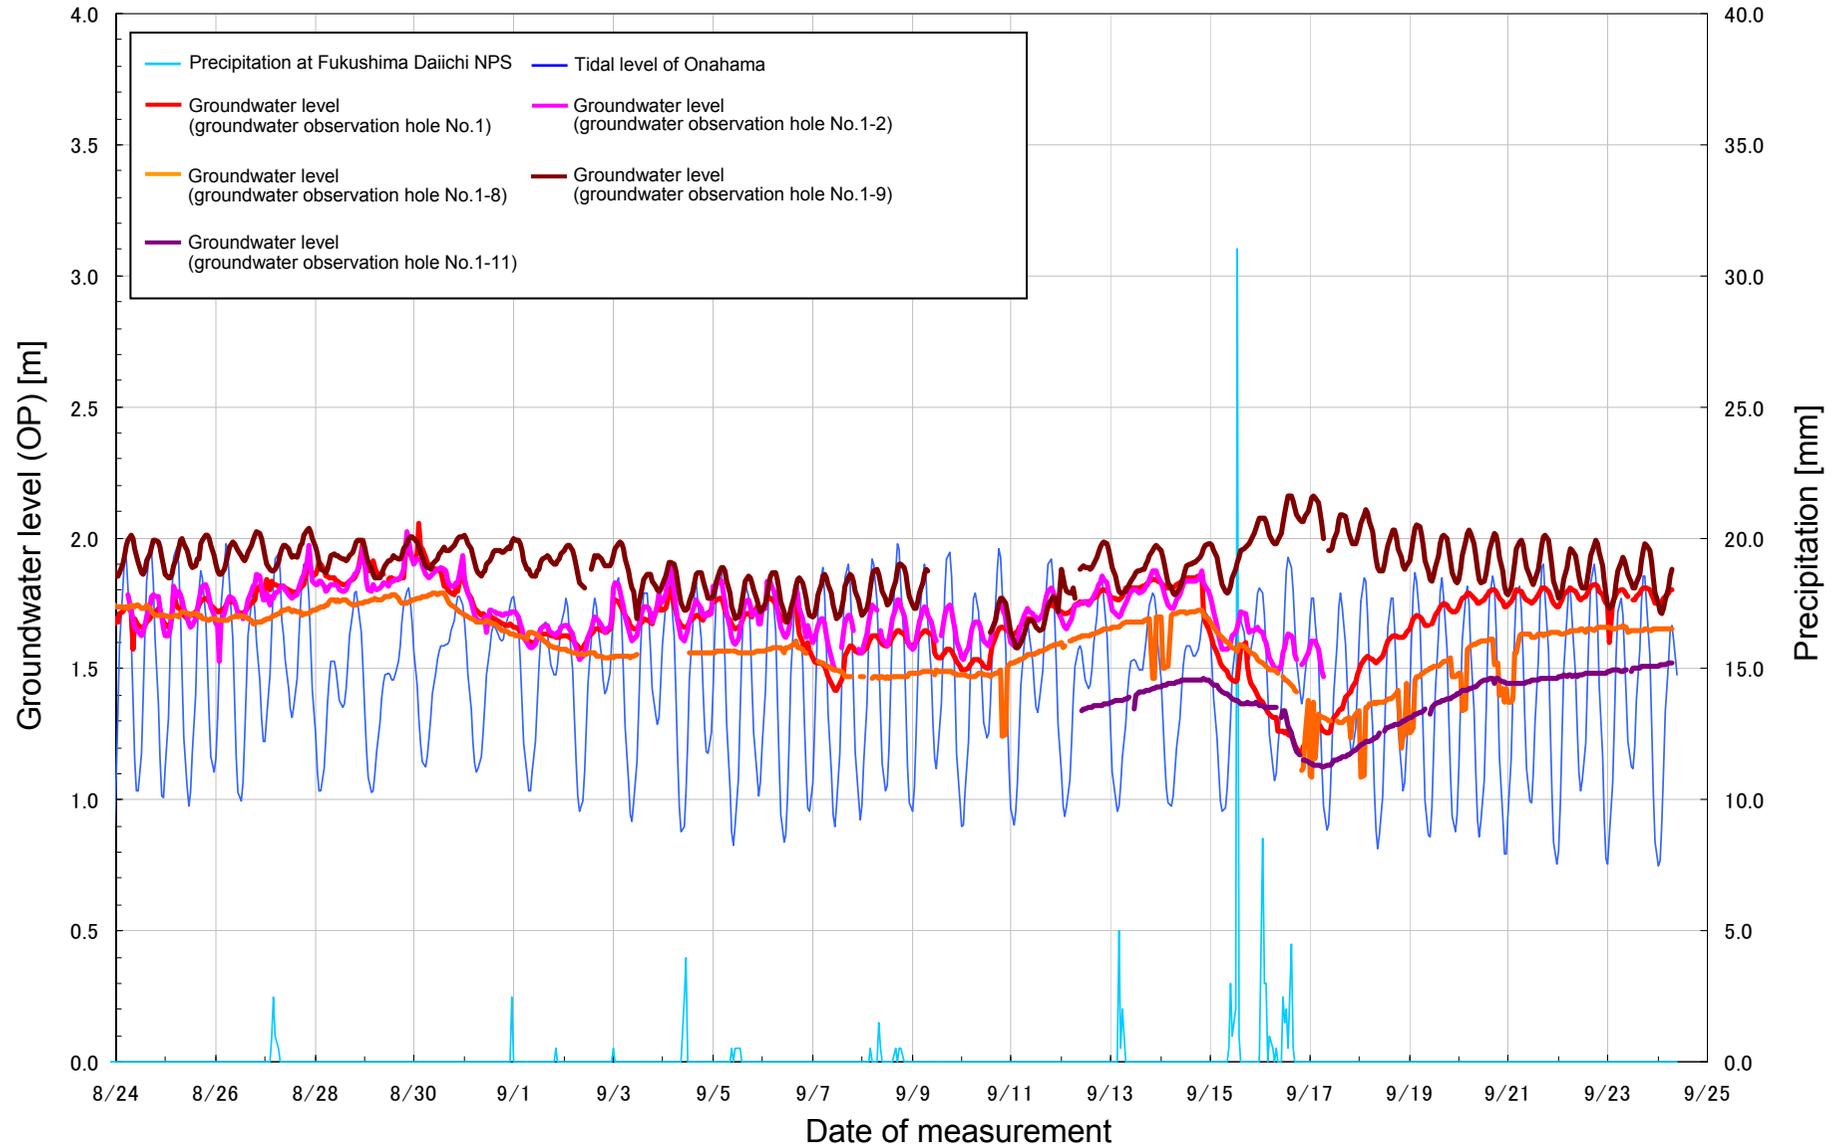
■ Transition of the groundwater level between Unit 1 and 2 (August 24 - September 24)

* Automatic measurement data measured by water gauge

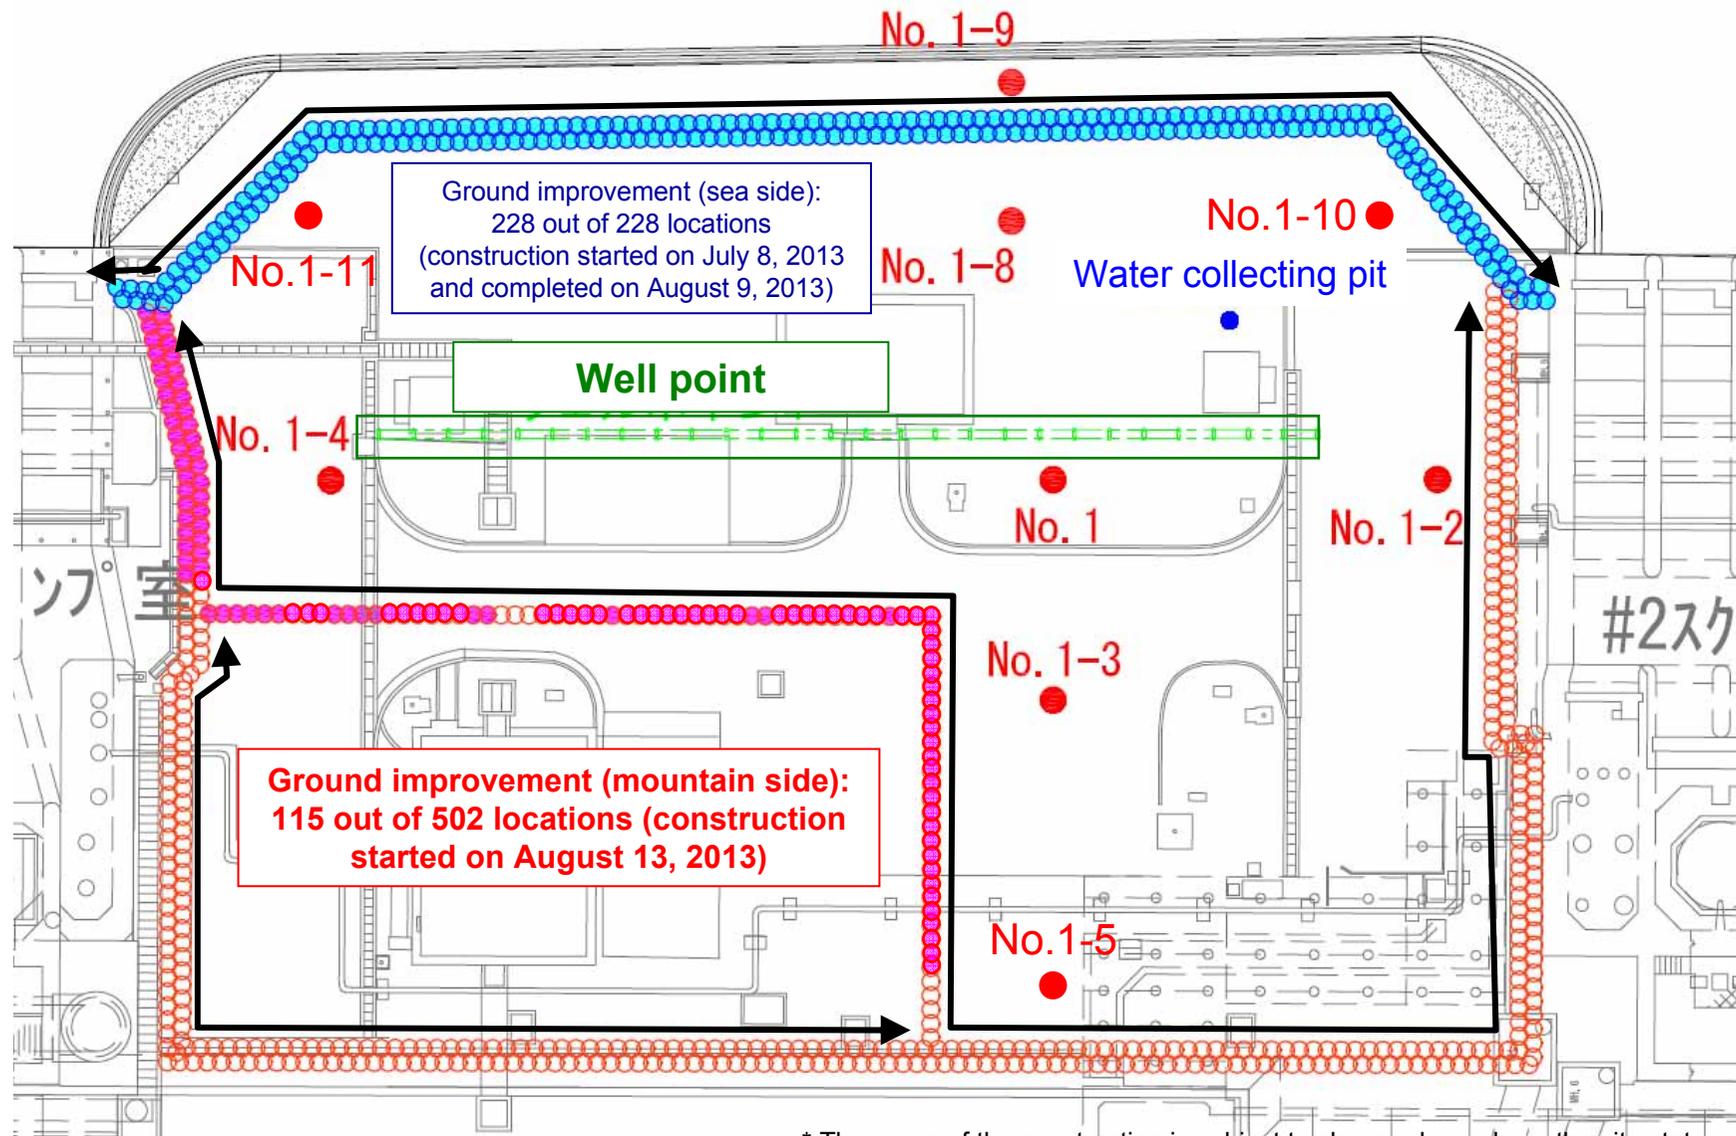
**■Progress Status of Ground Improvement Construction between Unit 1 and 2
(As of the Morning on September 25)**

* The range of the construction is subject to change depends on the site status.

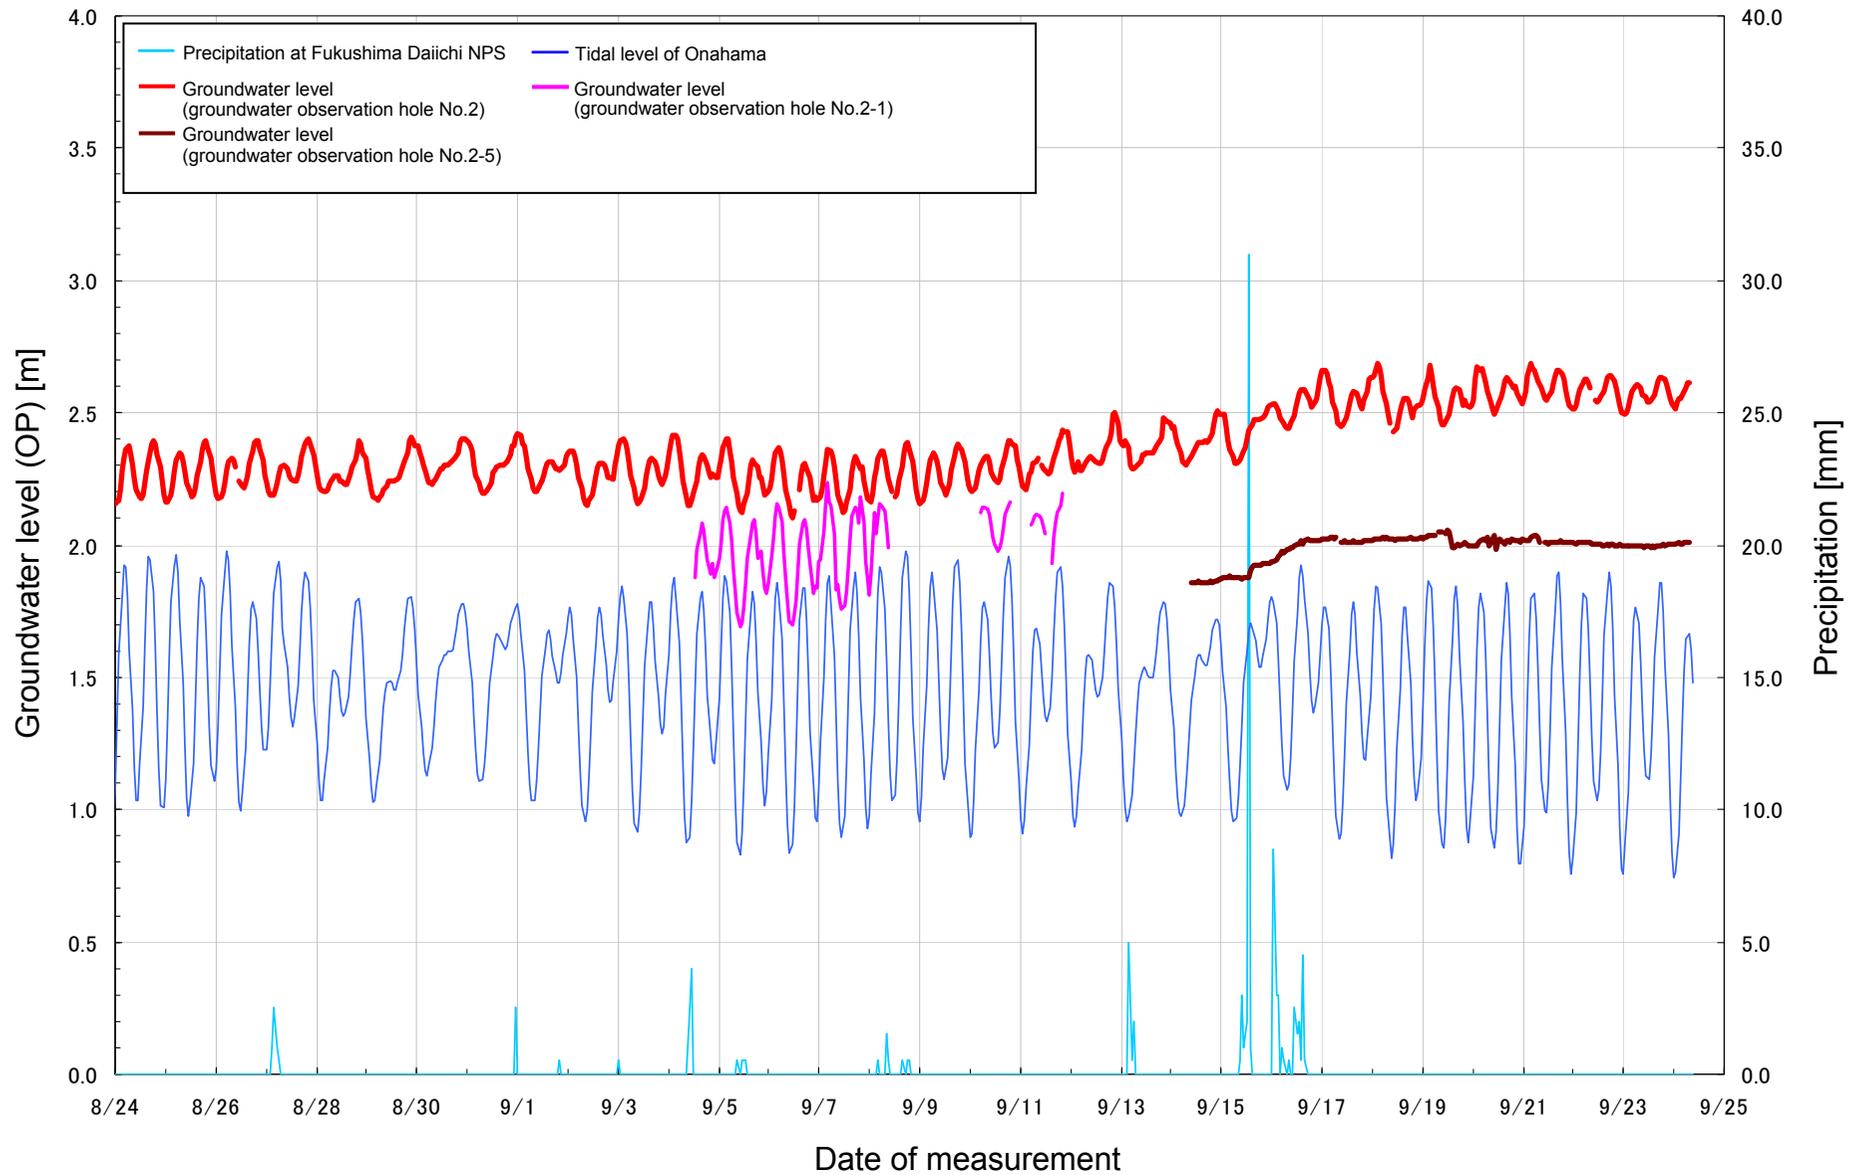
■ Transition of the groundwater level between Unit 2 and 3 (August 24 - September 24)

* Automatic measurement data measured by water gauge

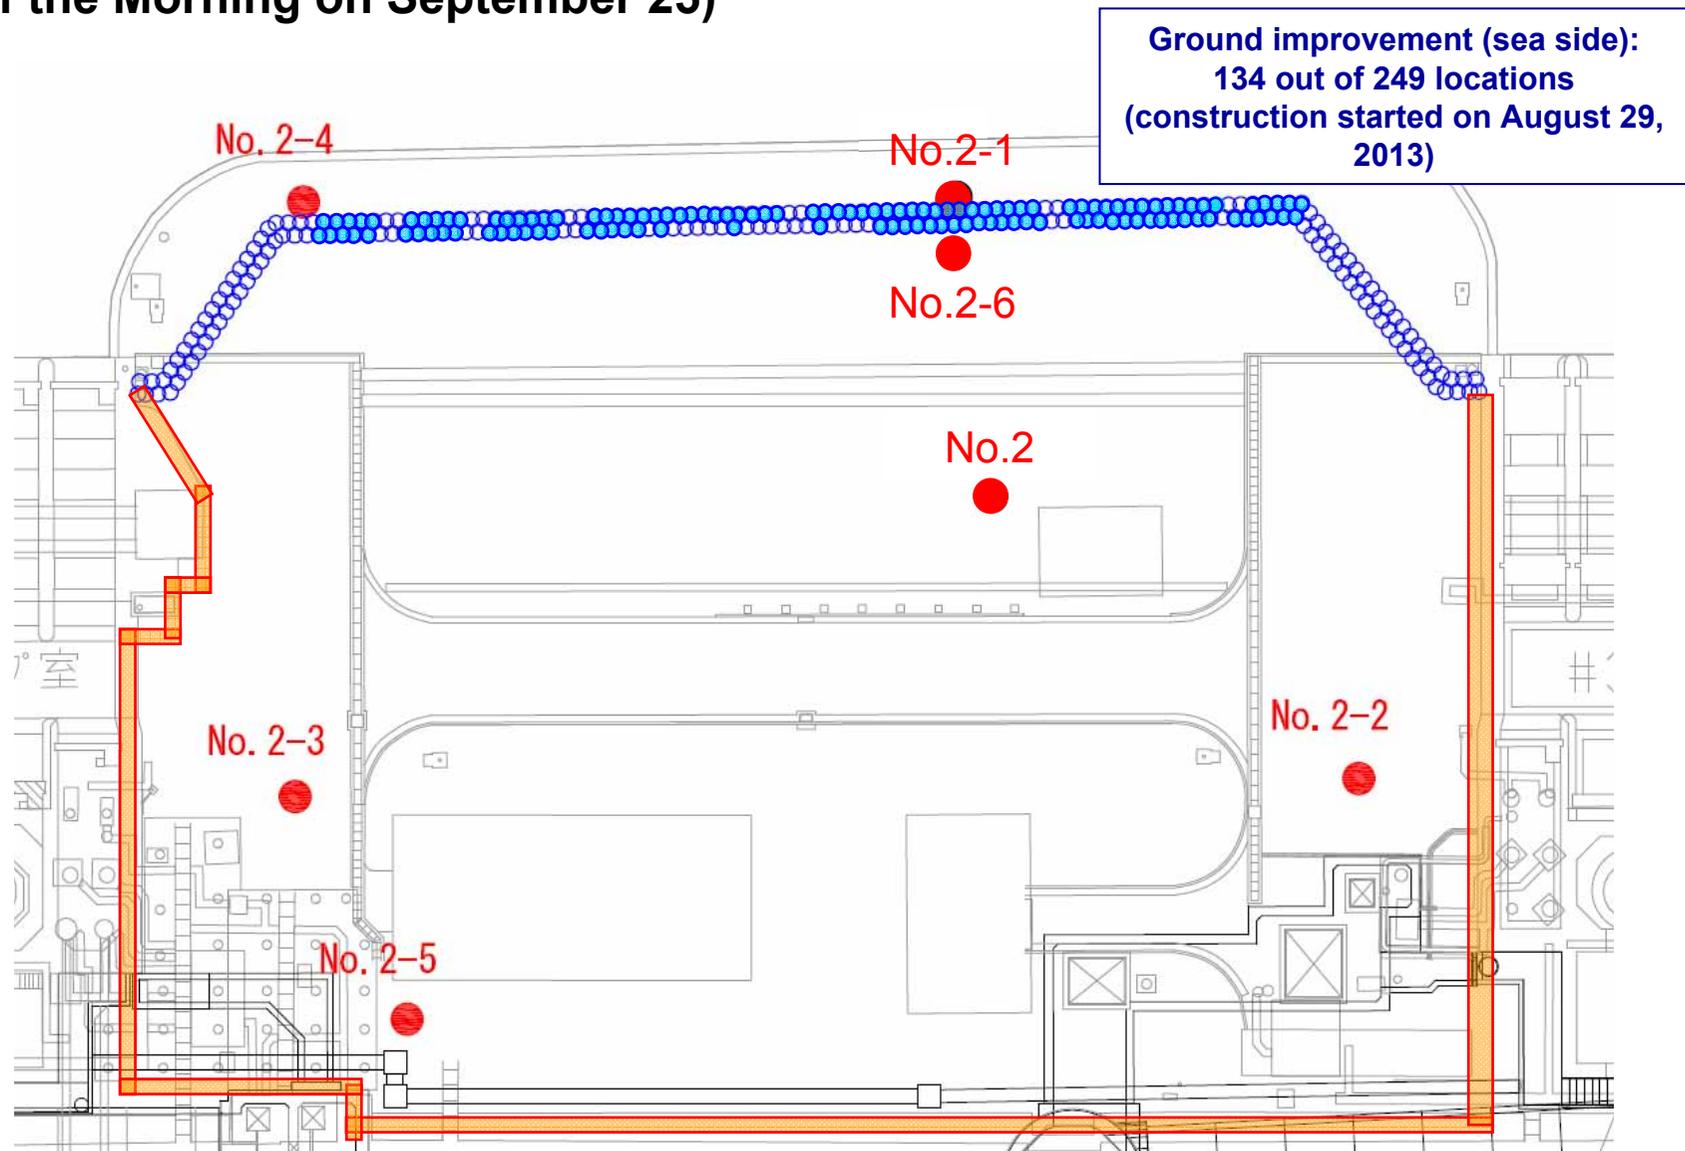
■ Progress Status of Ground Improvement Construction between Unit 2 and 3 (As of the Morning on September 25)

* The range of the construction is subject to change depends on the site status.

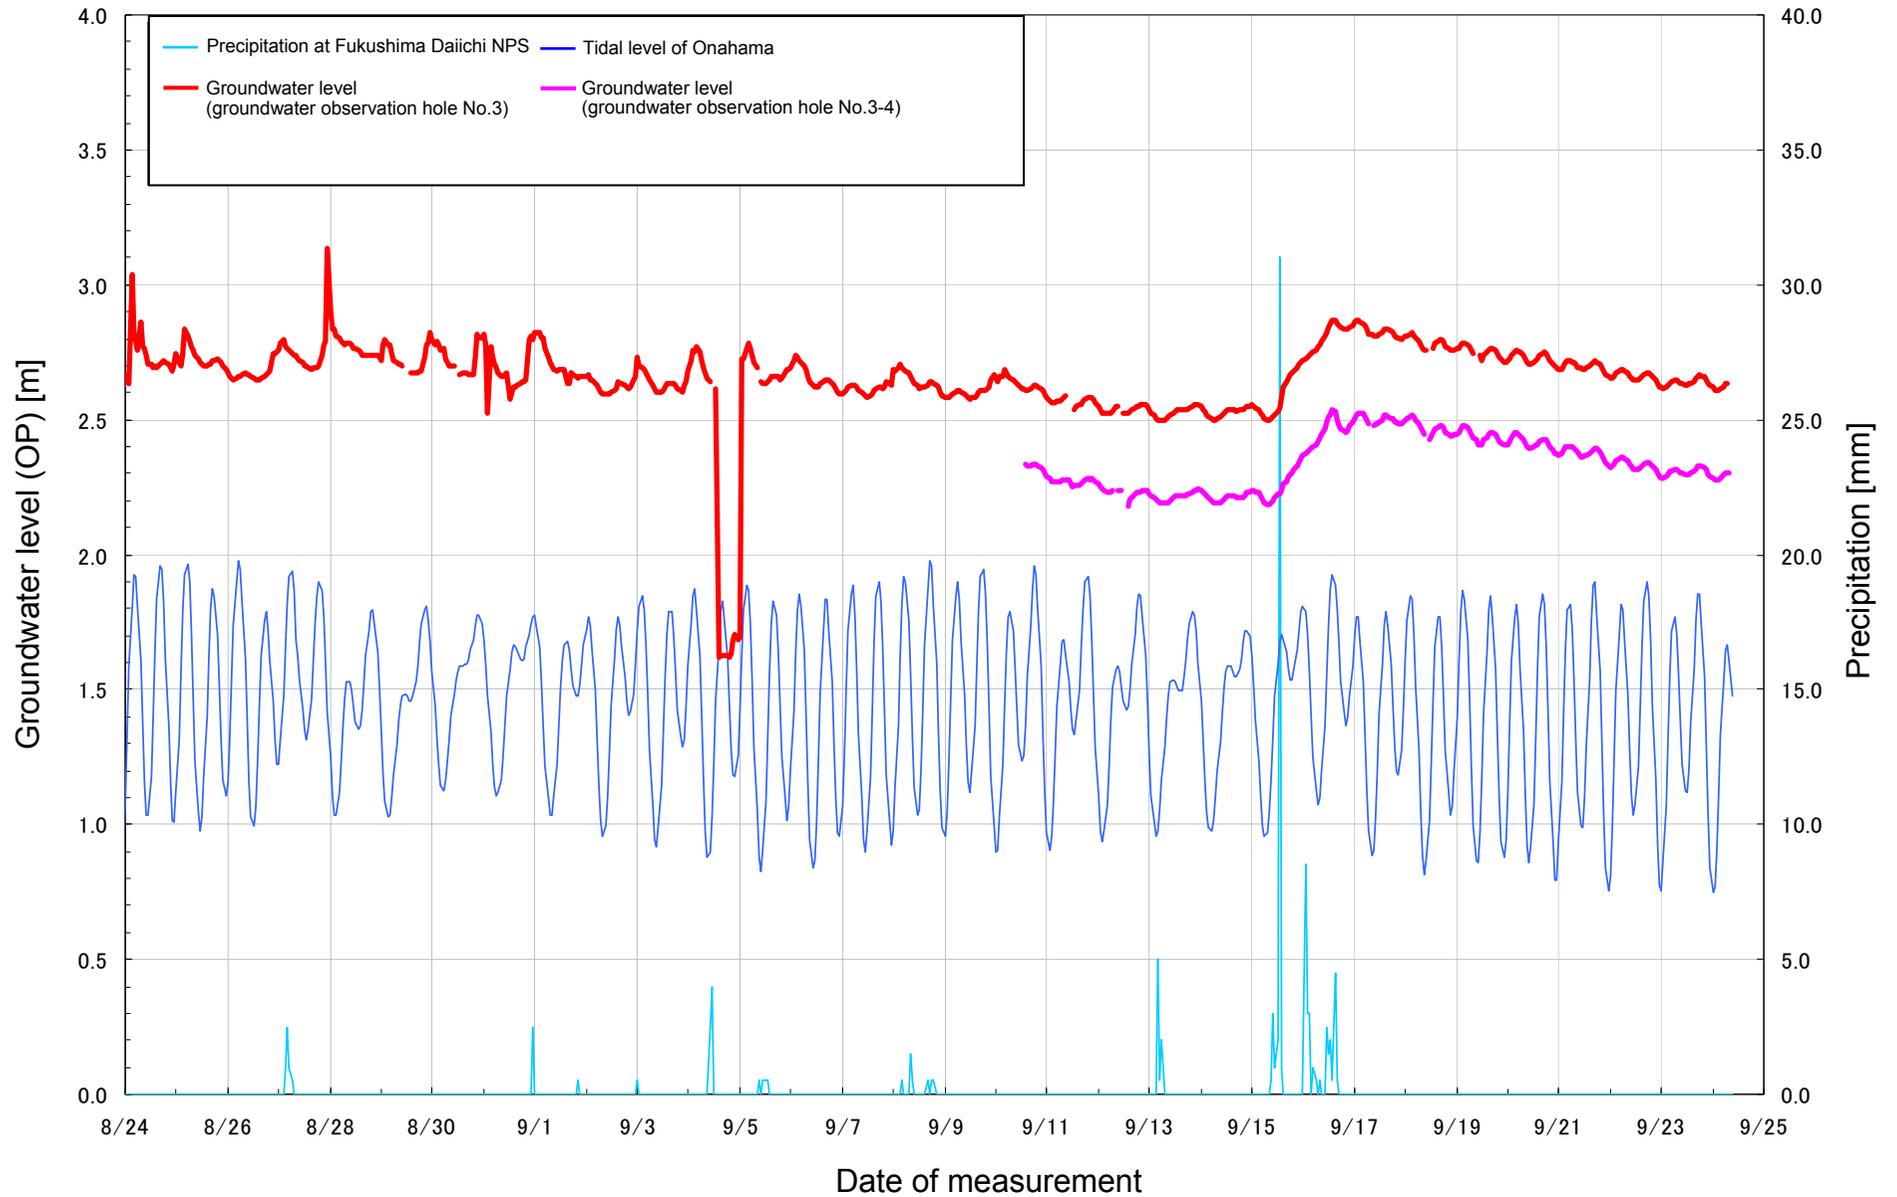
■ Transition of the groundwater level between Unit 3 and 4 (August 24 - September 24)

* Automatic measurement data measured by water gauge

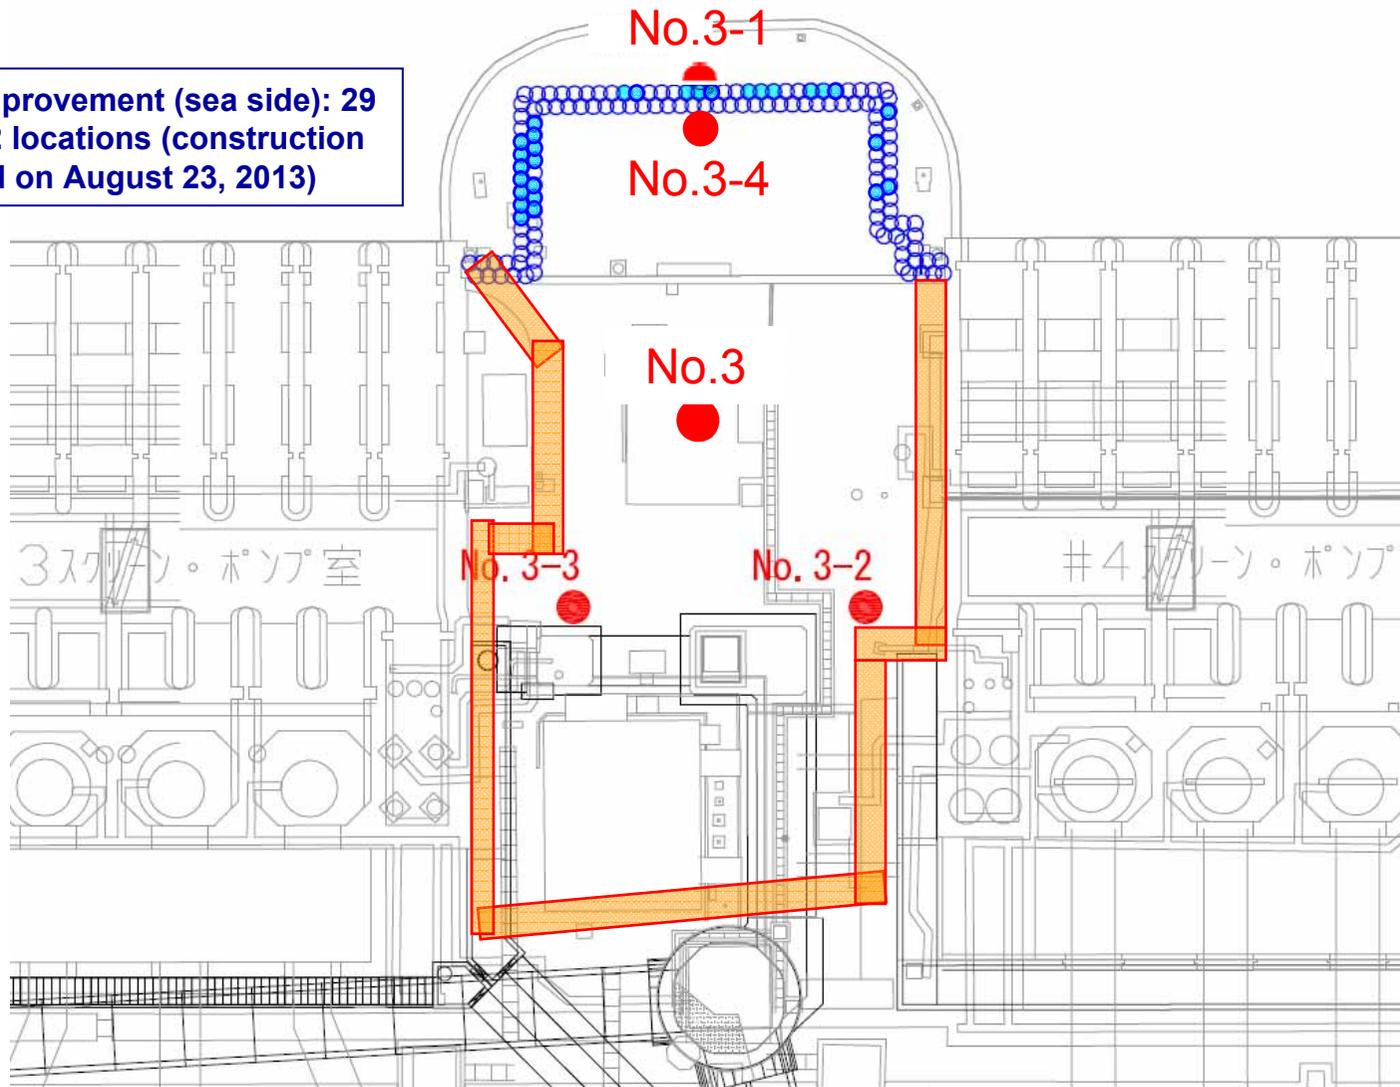
■ Progress Status of Ground Improvement Construction between Unit 3 and 4 (As of the Morning on September 25)

Ground improvement (sea side): 29
out of 132 locations (construction
started on August 23, 2013)

* The range of the construction is subject to change depends on the site status.
