Smoke Coming out of the Control Panel of the Compressed Air System (IA System) at Unit 6 Turbine Building Basement at Fukushima Daiichi Nuclear Power Station (Follow-up)

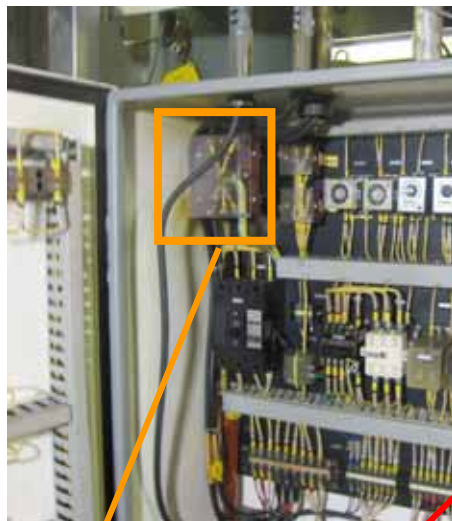
Terminal of the primary winding (Photo taken from above the transformer)

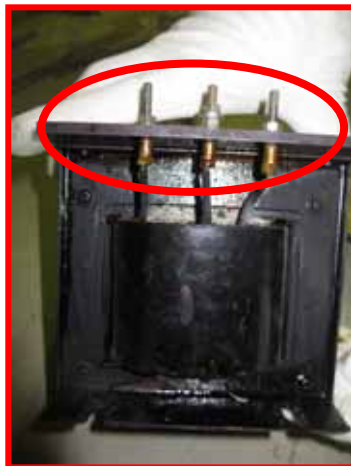
The inside of winding got heated up and insulating varnish is melted

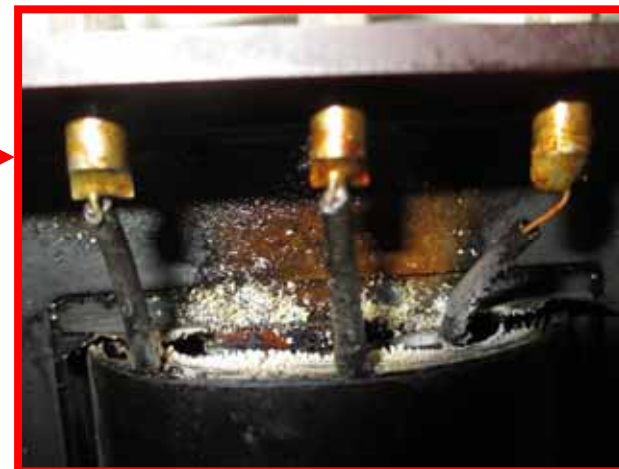
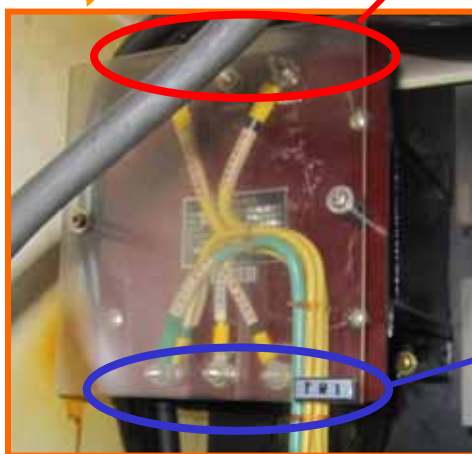
Terminal of the secondary winding (Photo taken from below the transformer)

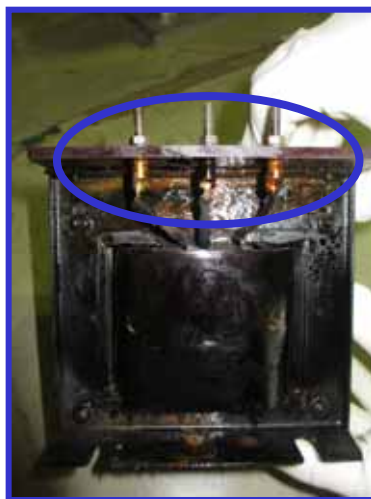
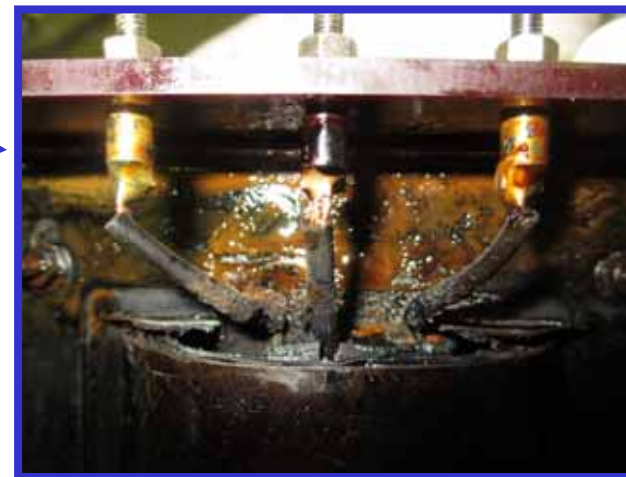
Auxiliary transformer for IA dryer control circuit
