Changes of Full-face Mask Requirement Rules

Results of Radioactivity Density Measurement of the Air within the Grounds of Fukushima Daiichi Nuclear Power Station

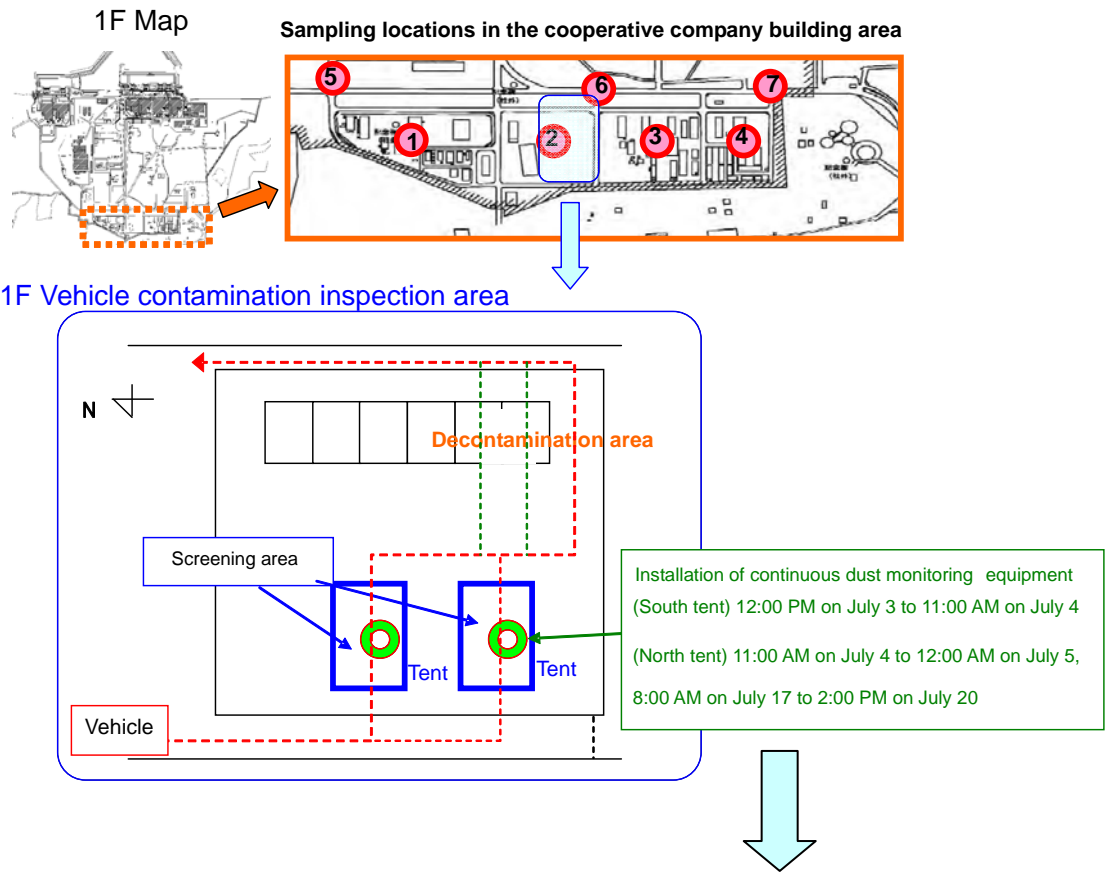
< Continuous dust monitoring results in the screening area >

While the continuous dust monitoring equipment was installed in the screening area, the radioactivity density of the air fluctuated around 10^{-6} Bq/cm³, and the alarm of the monitoring equipment did not go off (The alarm is set to go off when the measurement value reaches 5×10^{-5} Bq/cm³).
