## Findings from the latest analyses using MAAP5

## 1. Latest analysis of Unit-1 by MAAP5.01

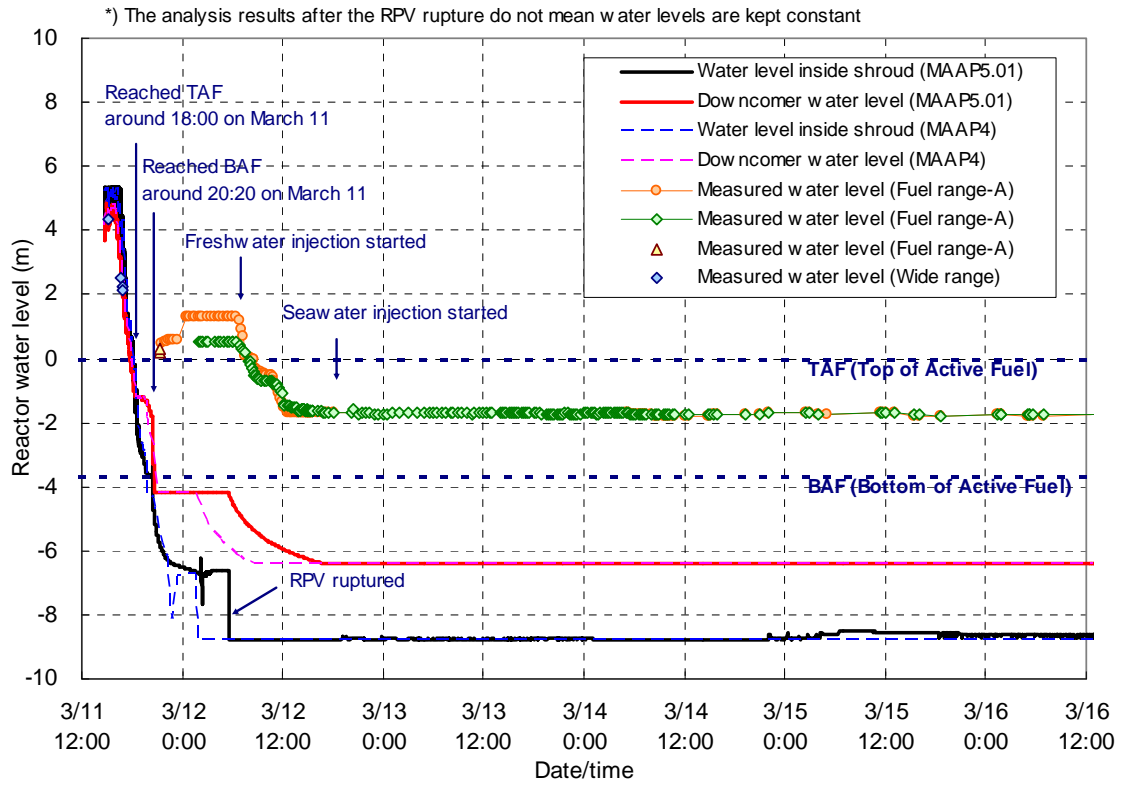
Figure 1-1 Reactor water level changes of Unit-1

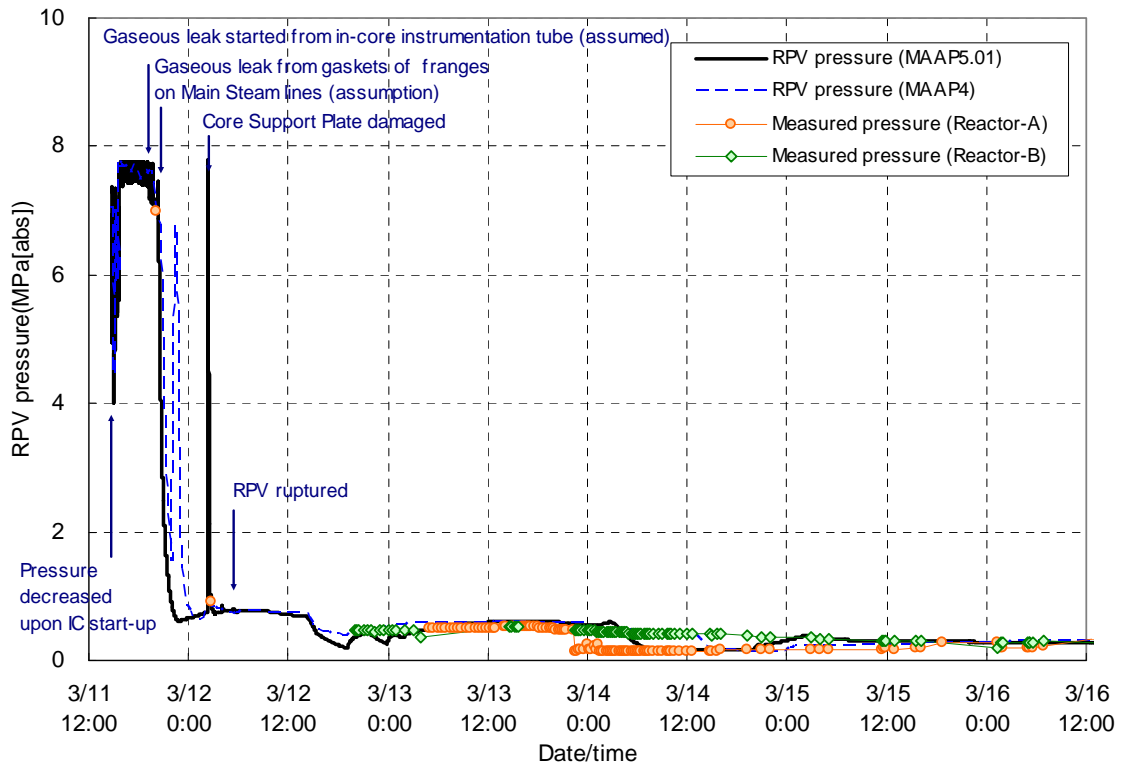
Figure 1-2 RPV pressure changes of Unit-1

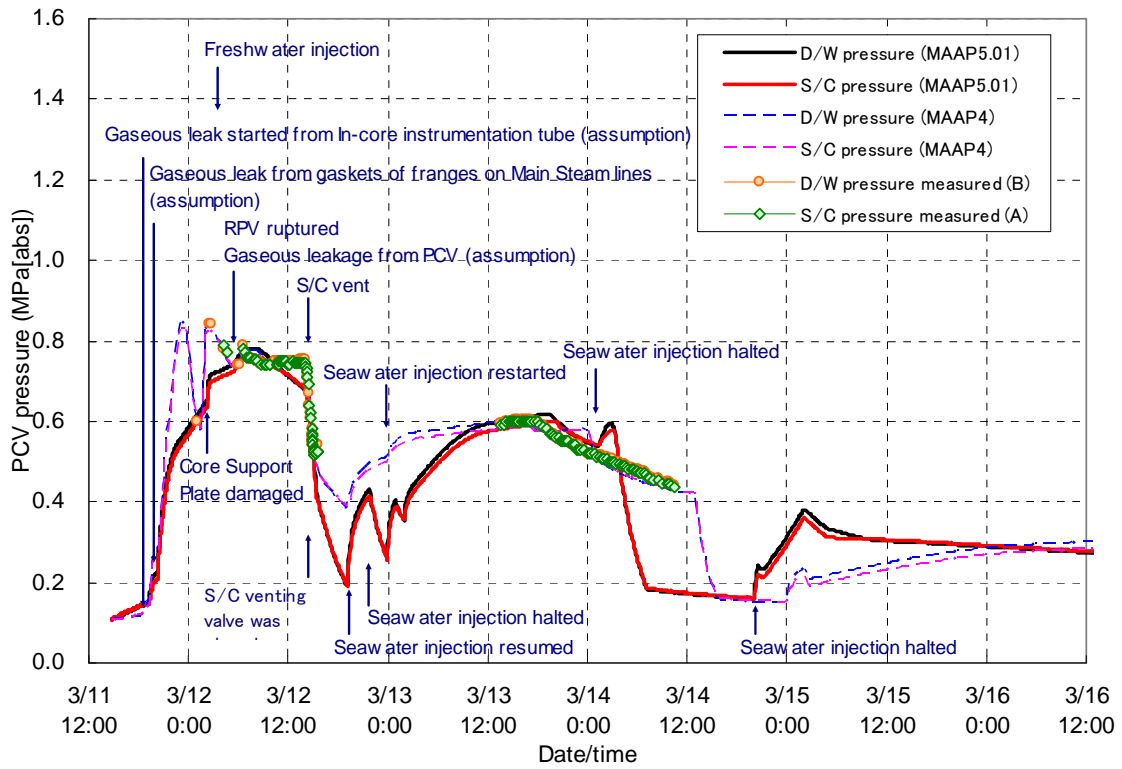
Figure 1-3 PCV pressure changes of Unit-1

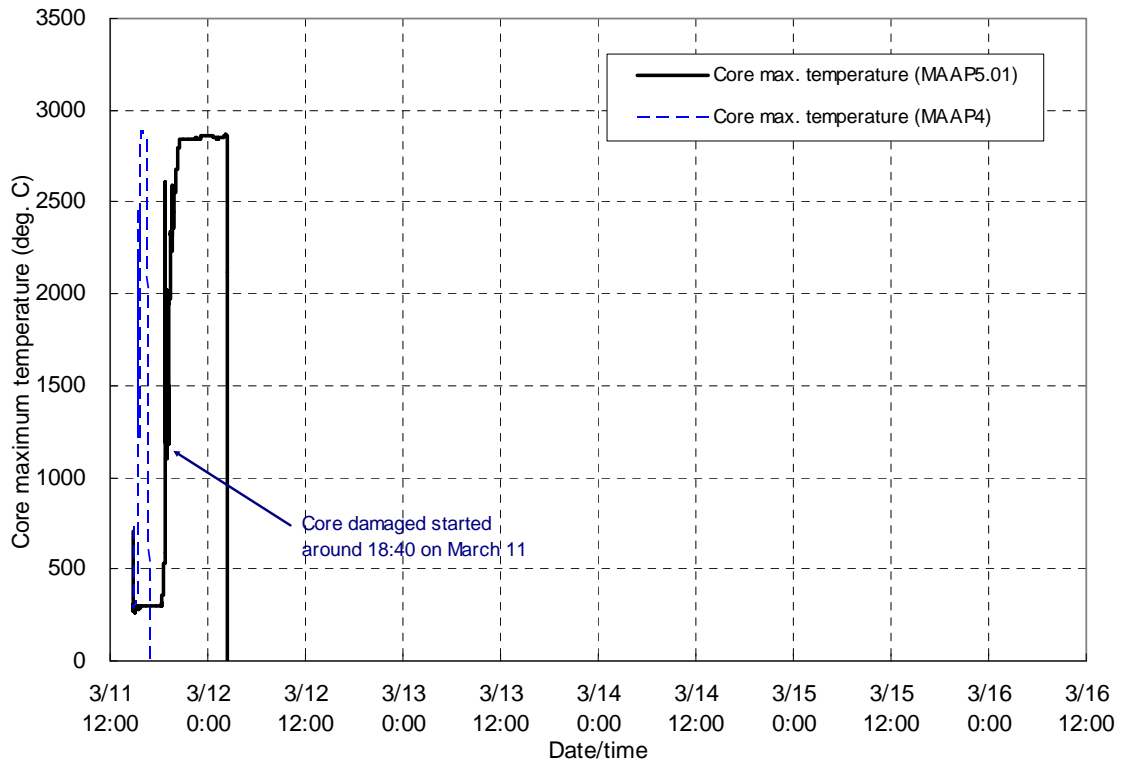
Figure 1-4 Core temperature changes of Unit-1

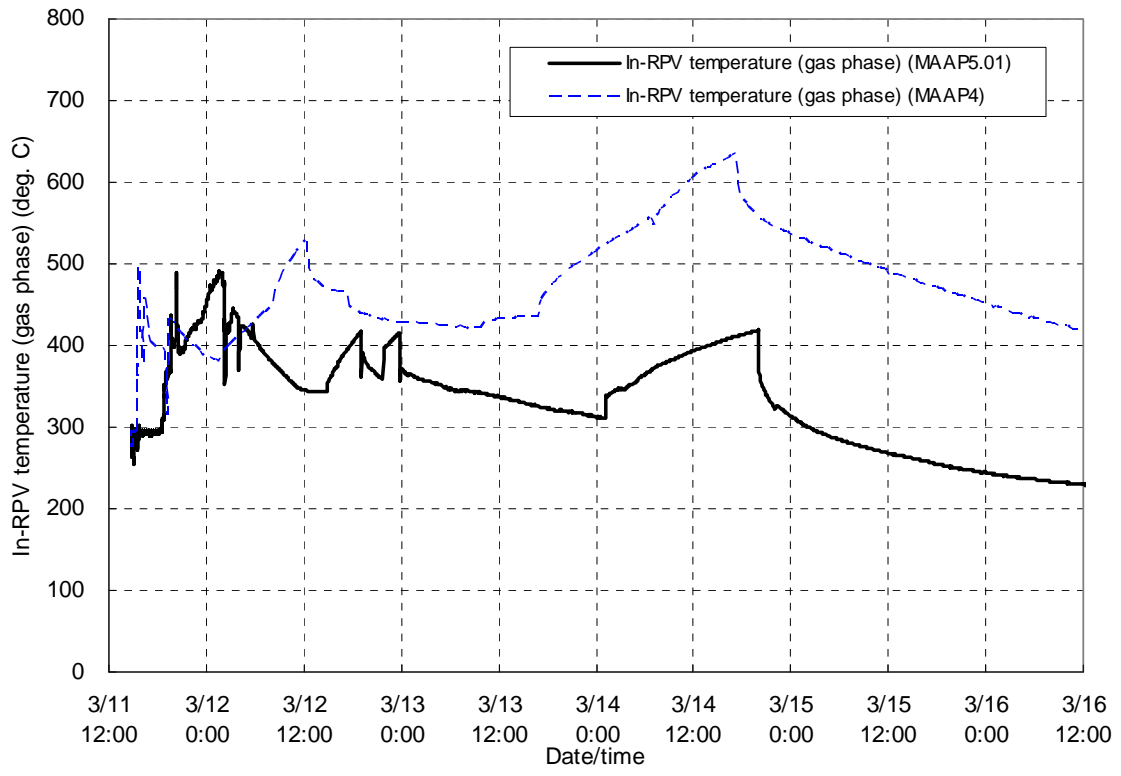
Figure 1-5 Gaseous temperature changes in RPV of Unit-1

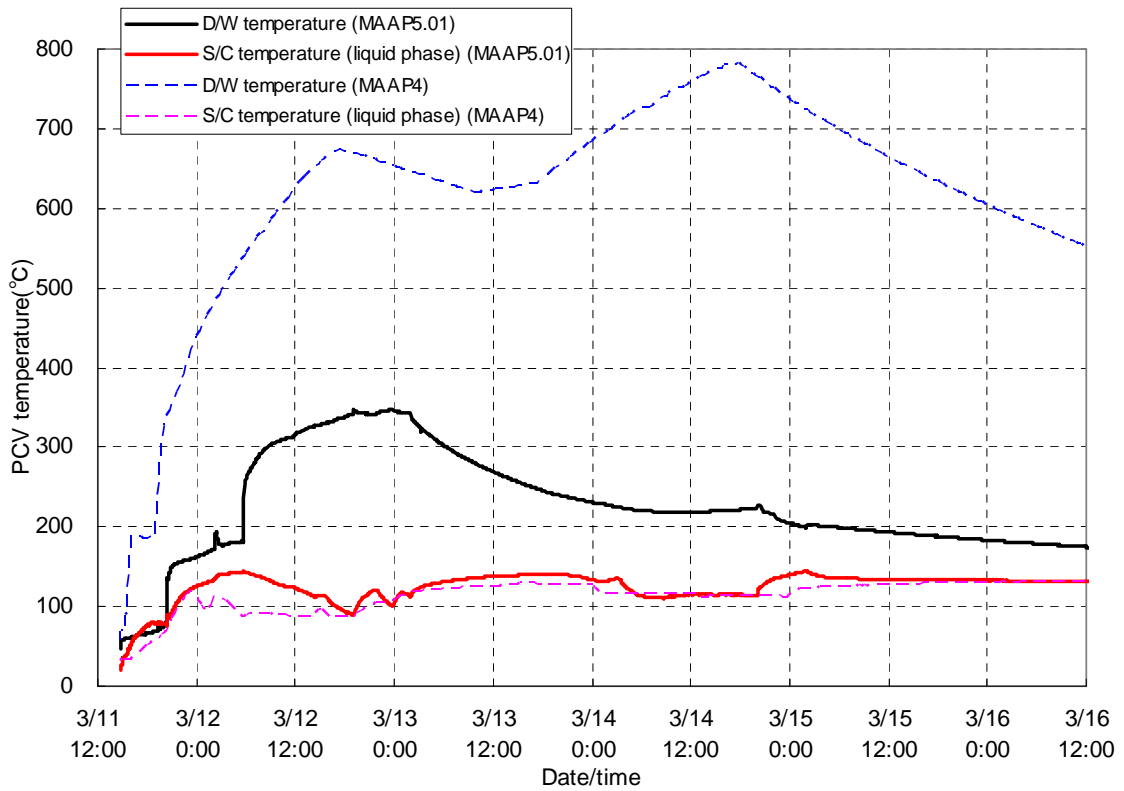
Figure 1-6 PCV temperature changes of Unit-1

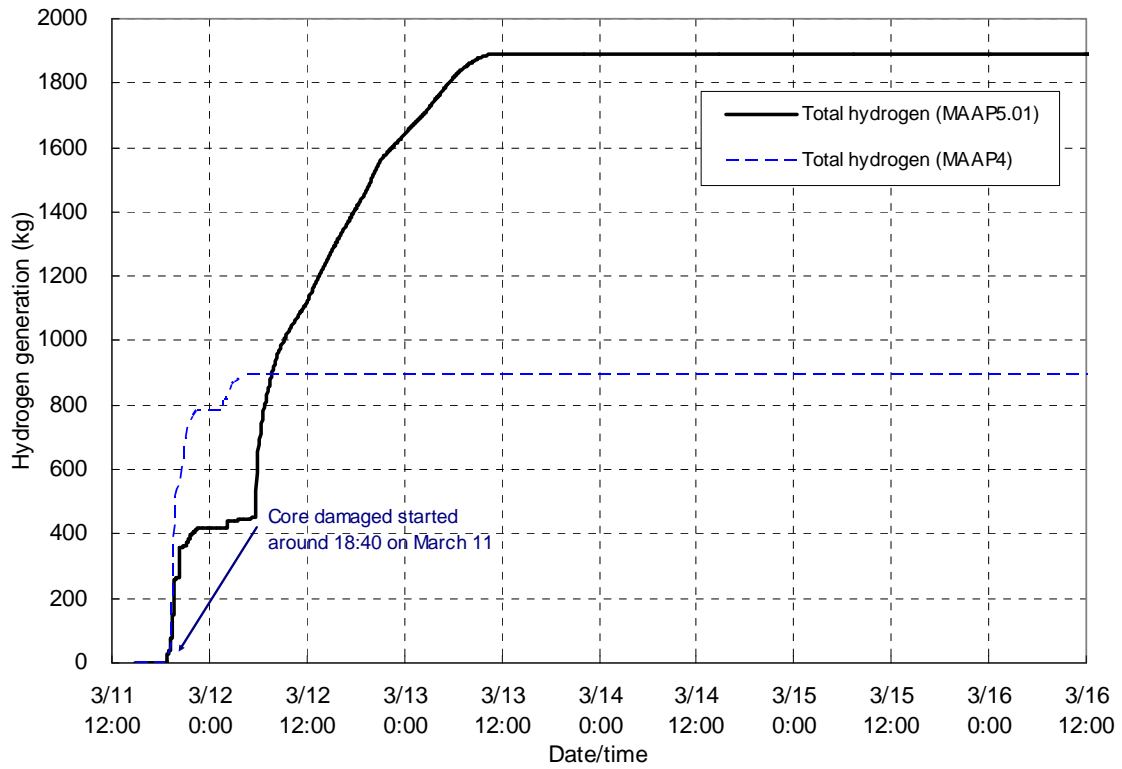
Figure 1-7 Hydrogen gas generation at Unit-1

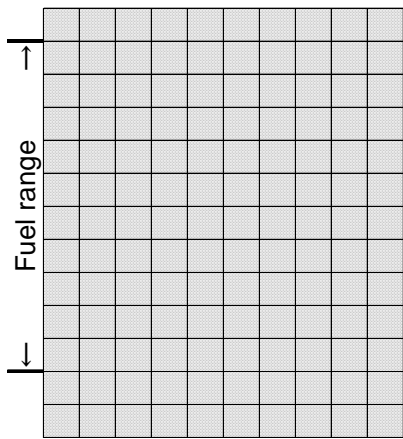
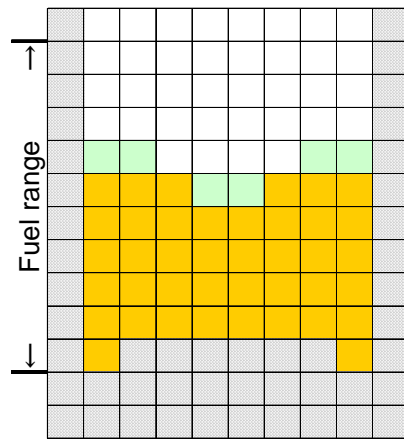
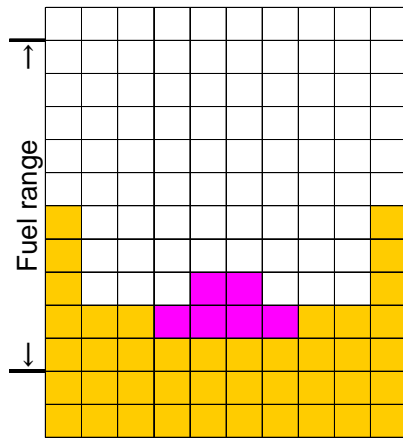
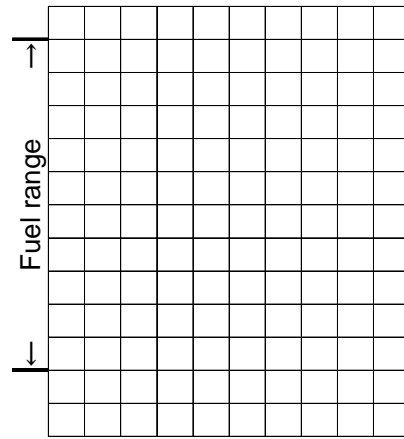
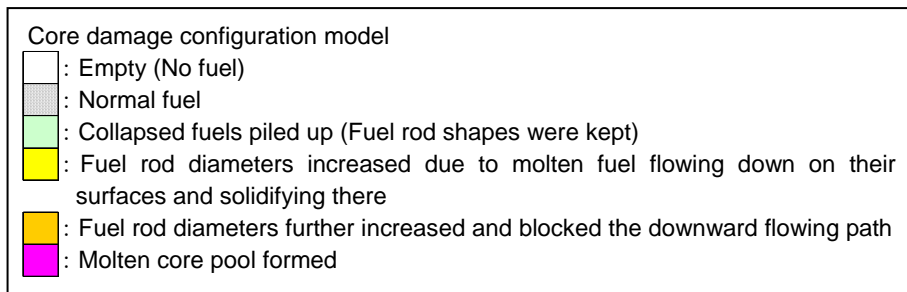
About 3.9 hours after SCRAM

About 5.0 hours after SCRAM

About 11.5 hours after SCRAM

About 12.0 hours after SCRAM

Figure 1-14 Core status of Unit-1

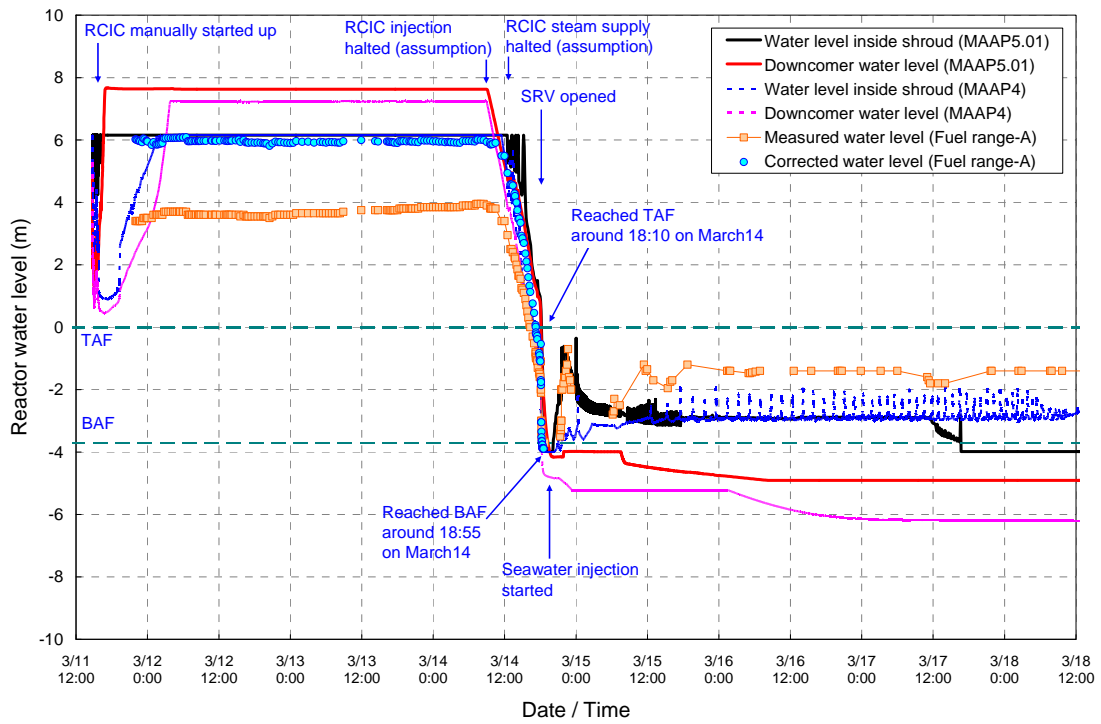
Figure 2-1 Reactor water level changes of Unit-2

- The reactor water level increased earlier because of the increasing RCIC water injection rate after the station blackout.
- After the reactor depressurization, water injection from fire engines into the uncovered core induced the water-zirconium reaction, which resulted in the increase in reactor and containment vessel pressure with one SRV kept opened. However, the simulated increase was still smaller than the observed increase. There are many unclear issues regarding actual SRV workings and water injection rate from fire engines. Further investigation is needed.
- Moreover, RPV was not ruptured in the analysis result, which is strongly affected by water injection rate from fire engines and the uncertainties in its analysis conditions.

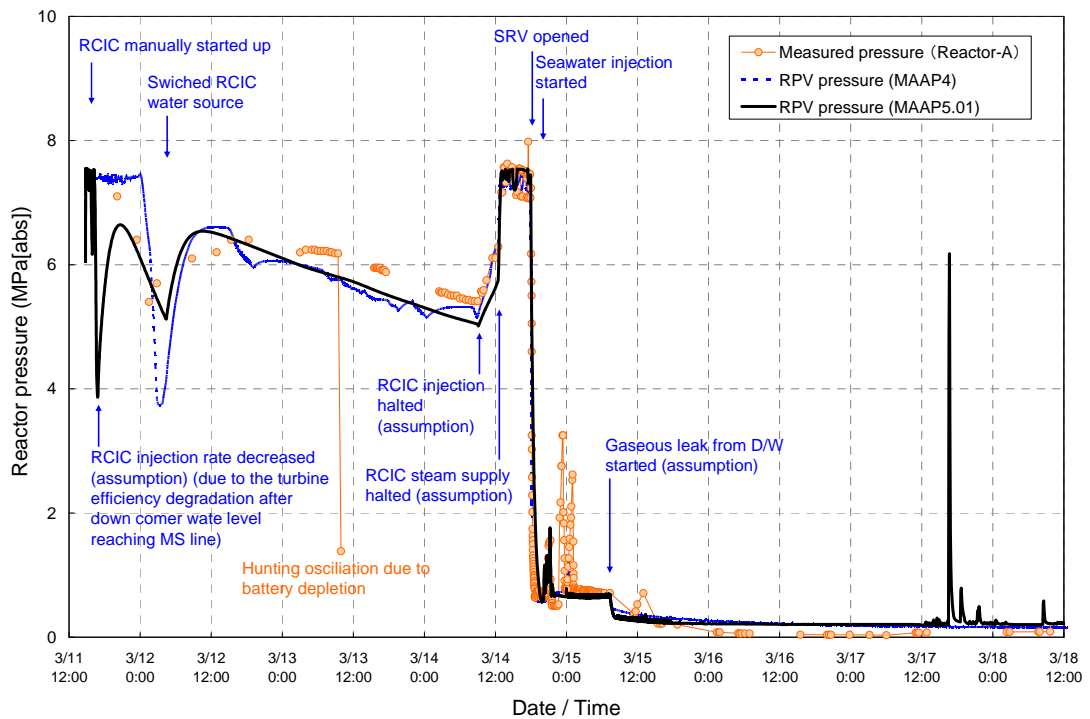
Figure 2-2 RPV pressure changes of Unit-2

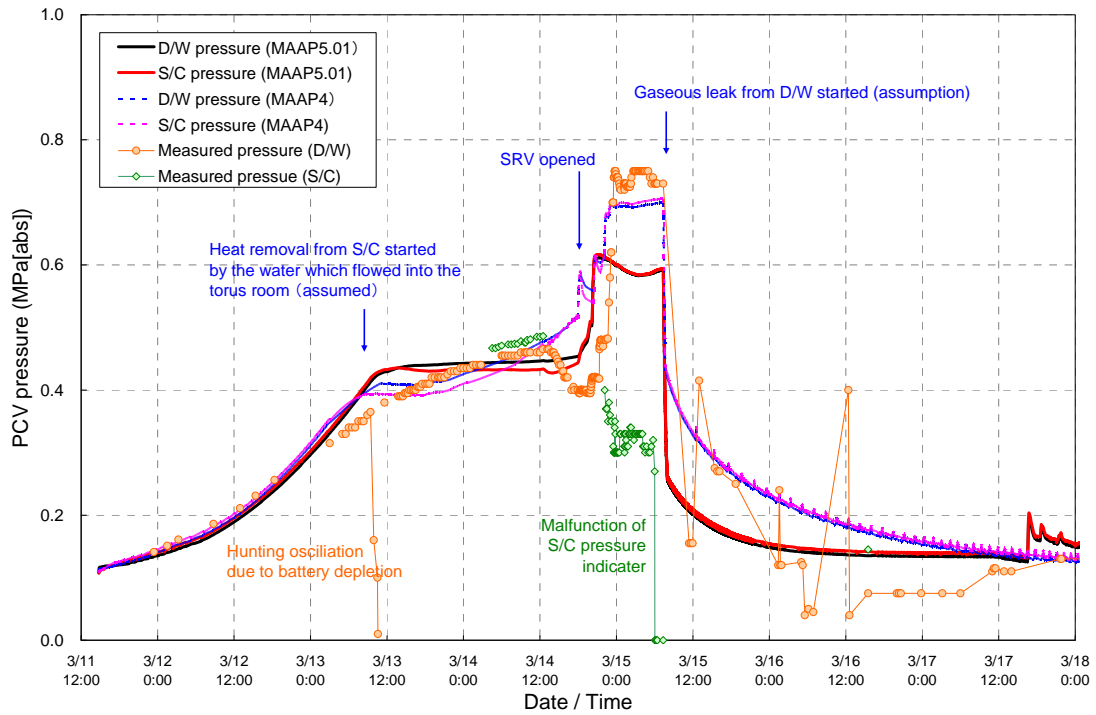
Figure 2-3 PCV pressure changes of Unit-2

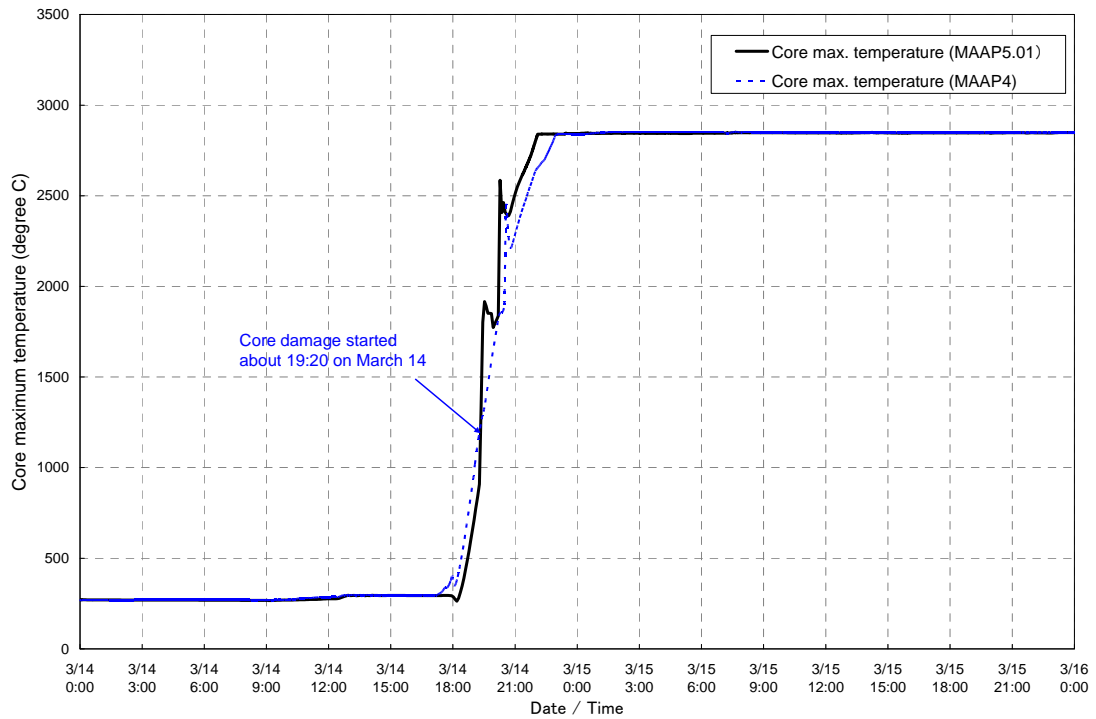
Figure 2-4 Core temperature changes of Unit-2

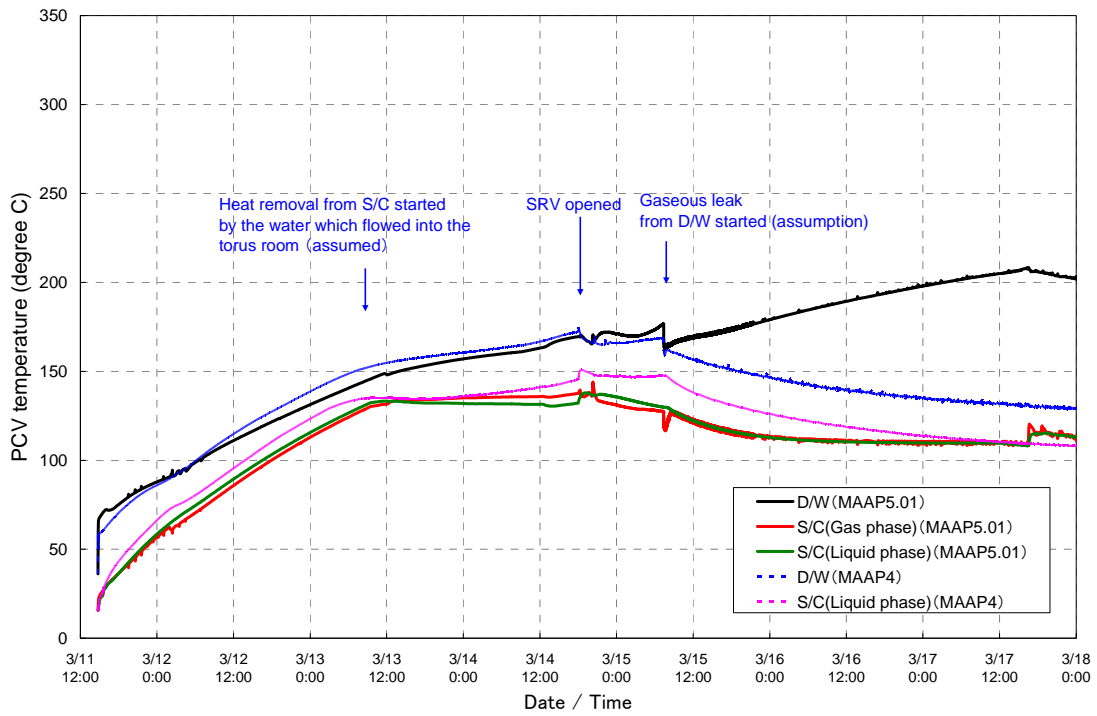
Figure 2-5 PCV temperature changes of Unit-2

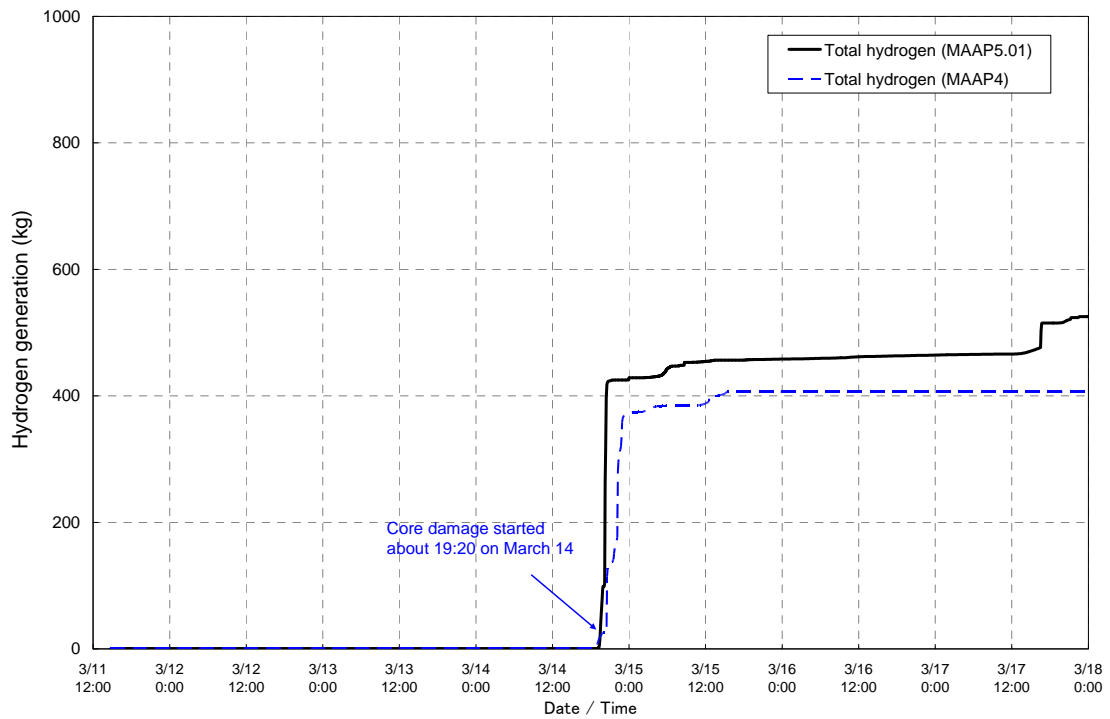
Figure 2-6 Hydrogen gas generation at Unit-2

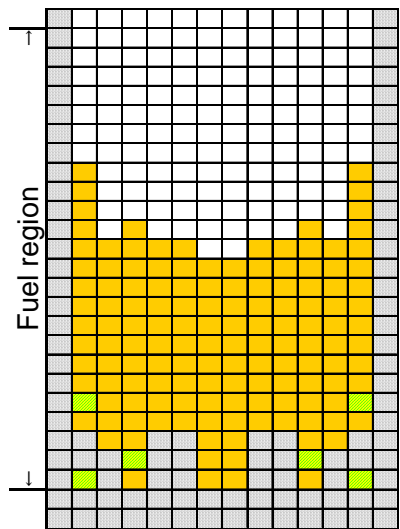
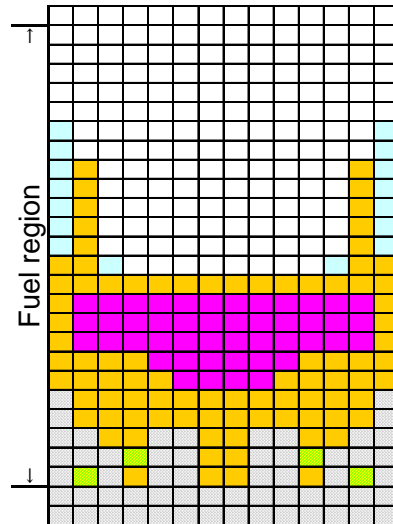
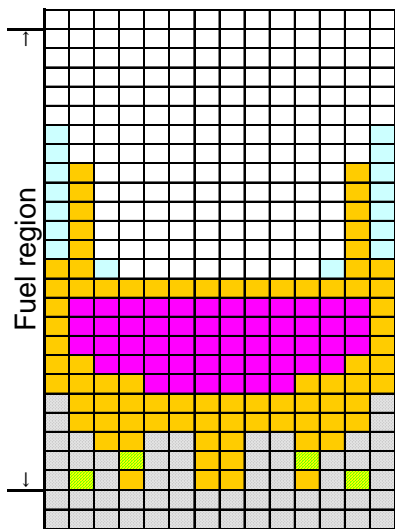
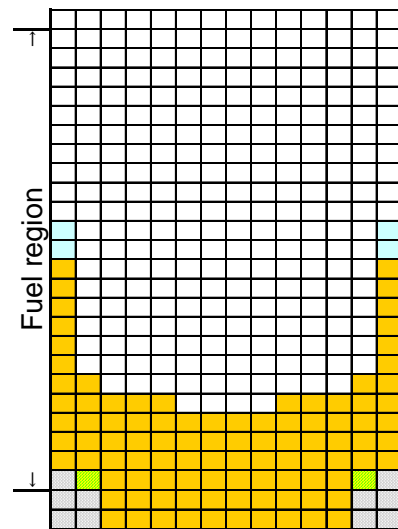
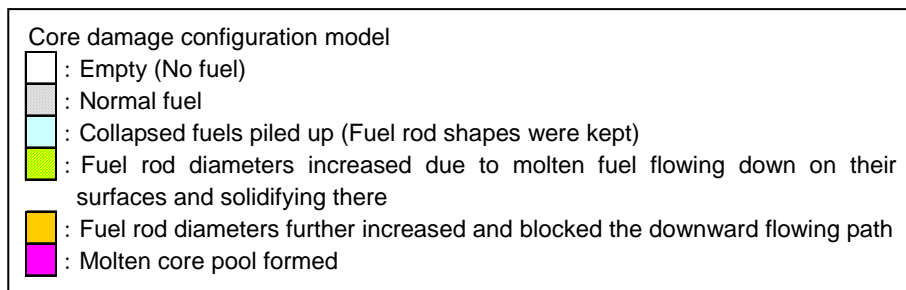
About 80 hours after SCRAM

About 105 hours after SCRAM

About 130 hours after SCRAM

About 155 hours after SCRAM

Figure 2-13 Core status of Unit-2

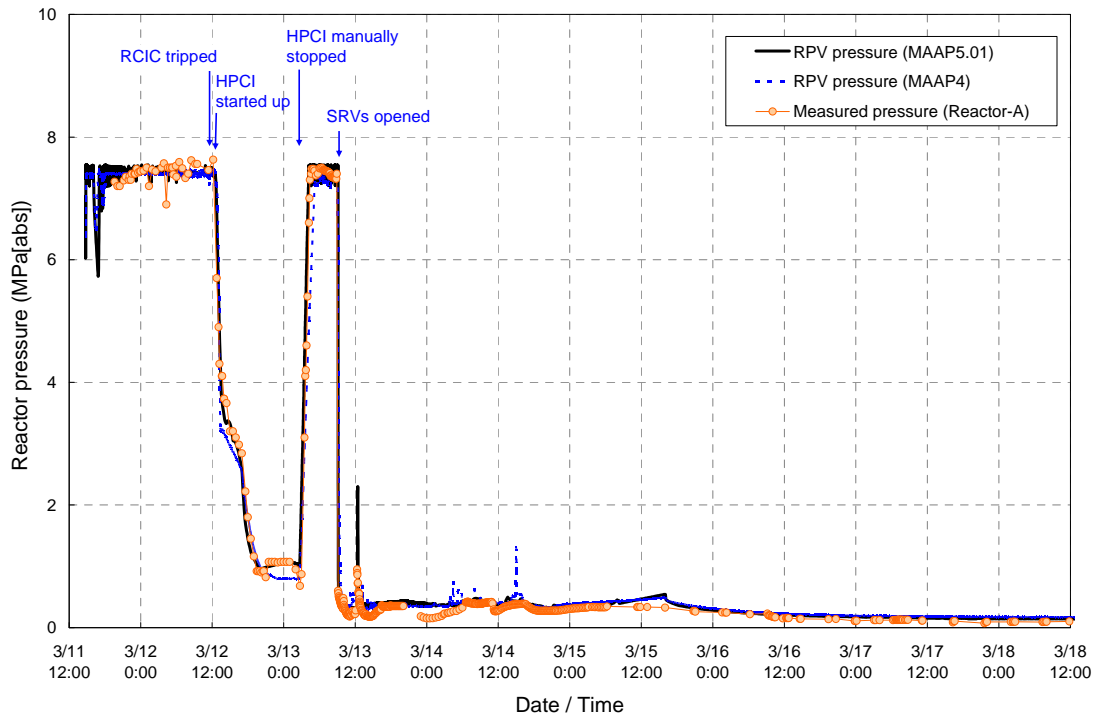
Figure 3-2 RPV pressure changes of Unit-3

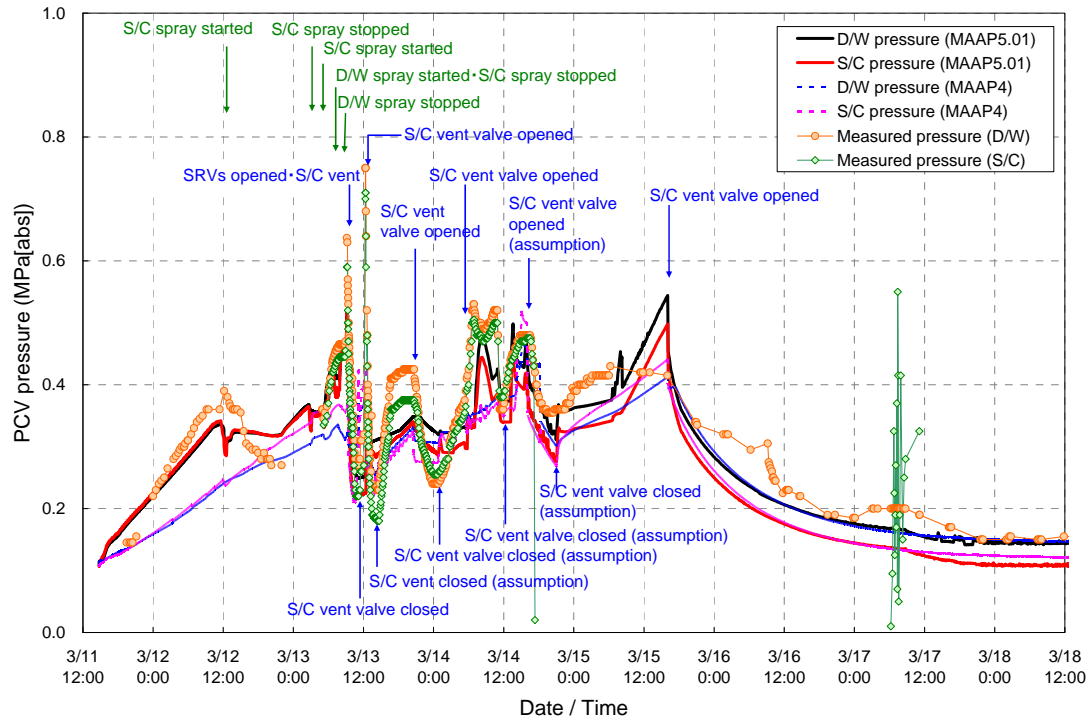
Figure 3-3 PCV pressure changes of Unit-3

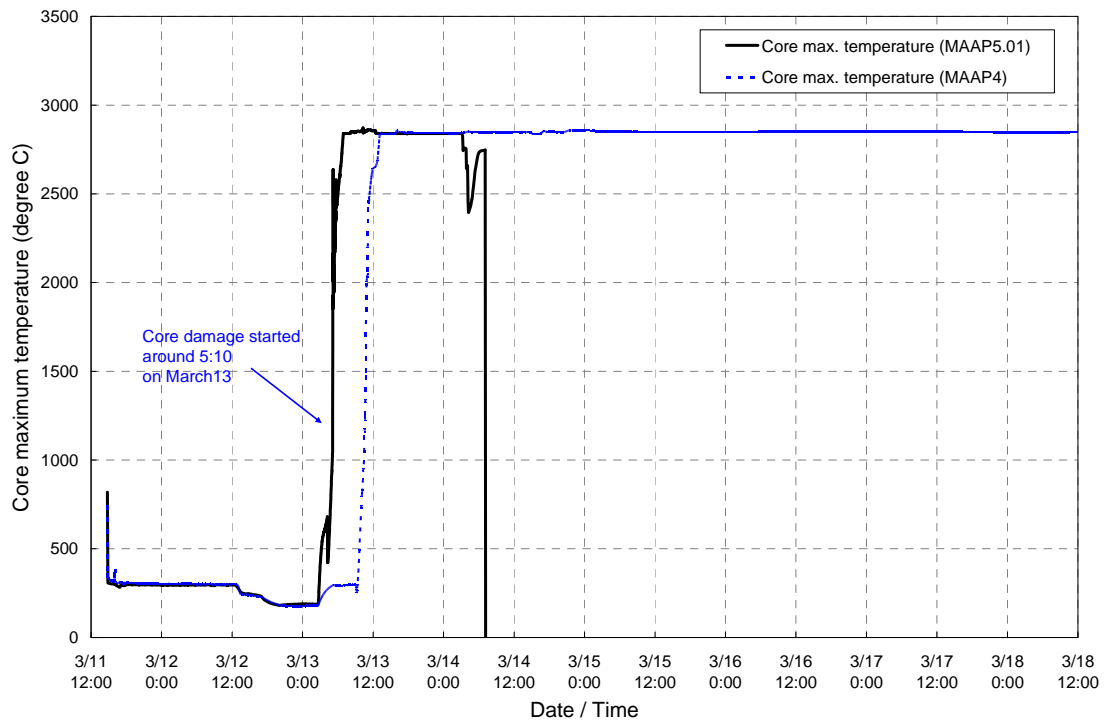
Figure 3-4 Core temperature changes of Unit-3

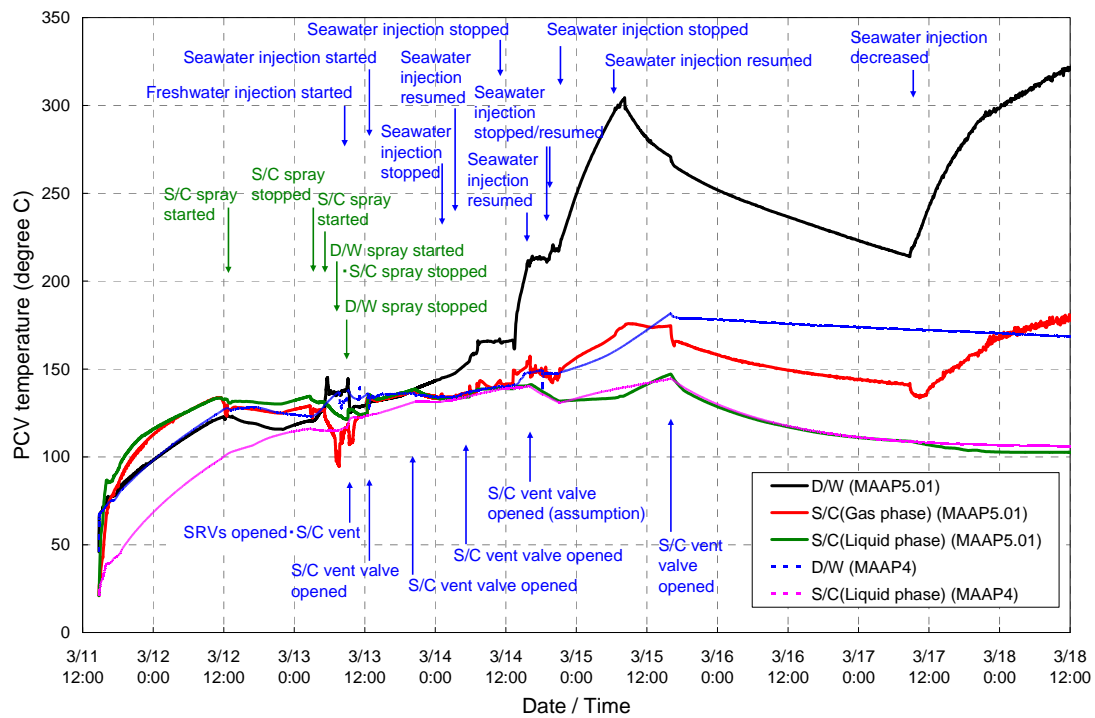
Figure 3-5 PCV temperature changes of Unit-3

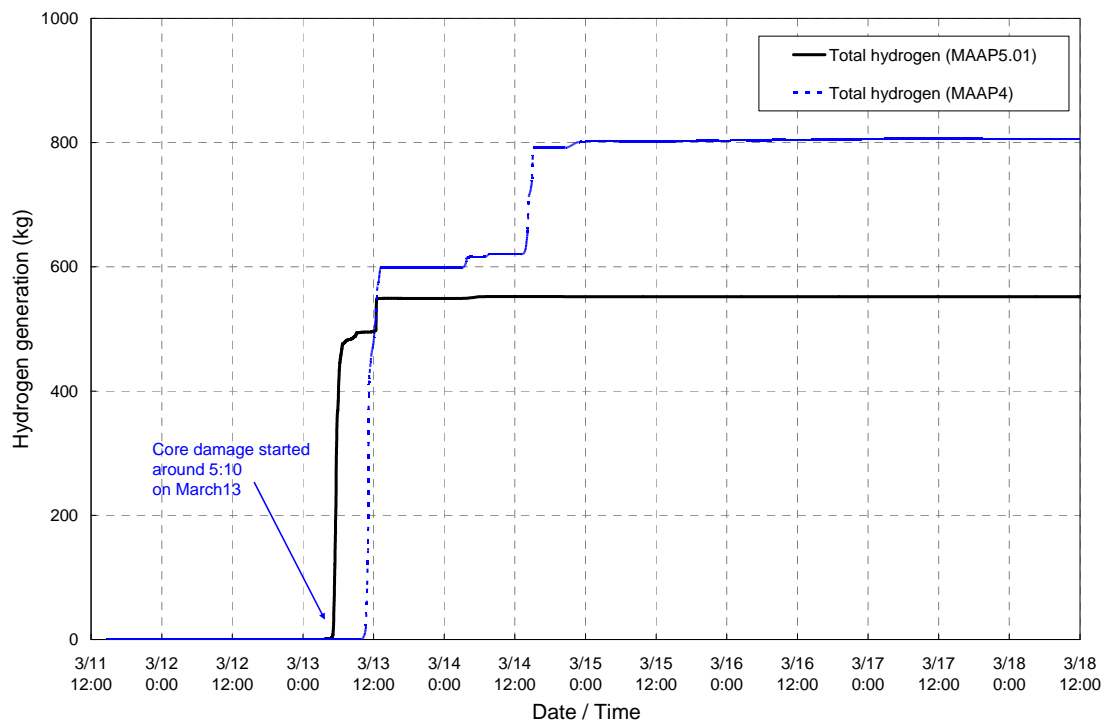
Figure 3-6 Hydrogen gas generation at Unit-3

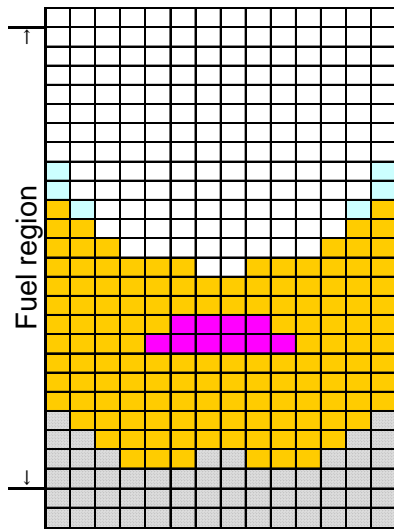
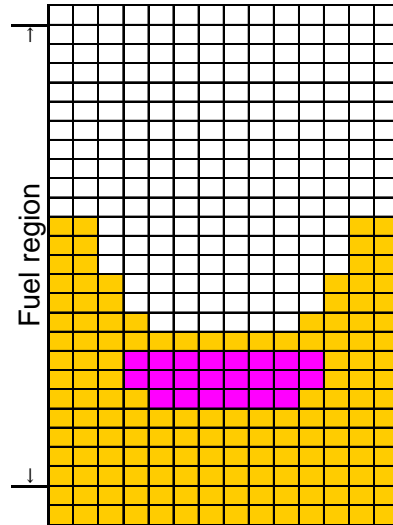
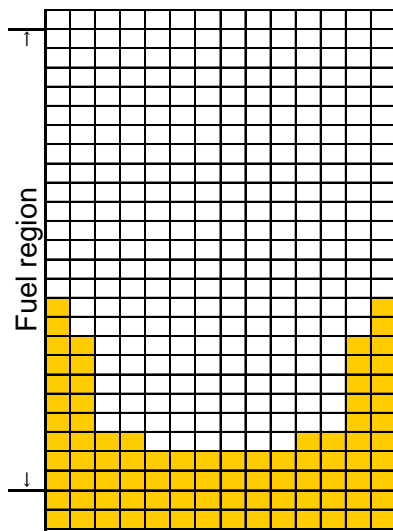
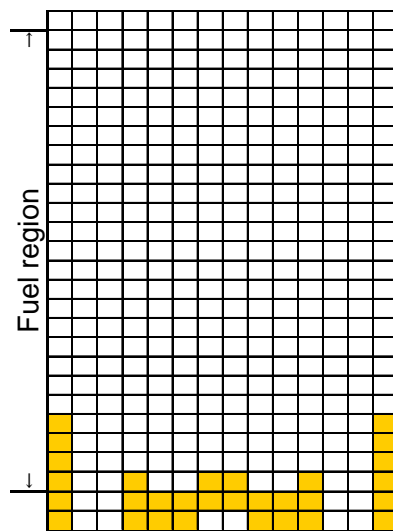
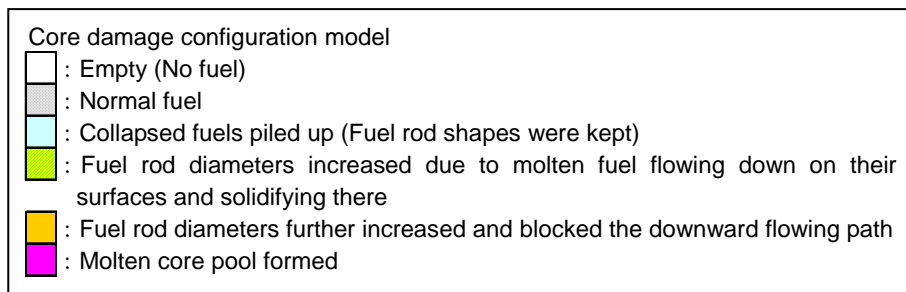
About 42 hours after SCRAM

About 44 hours after SCRAM

About 46 hours after SCRAM

About 64 hours after SCRAM

Figure 3-13 Core status of Unit-3
