## Arrival times of tsunami at the Fukushima Daiichi Nuclear Power Station site

## 1. Overview

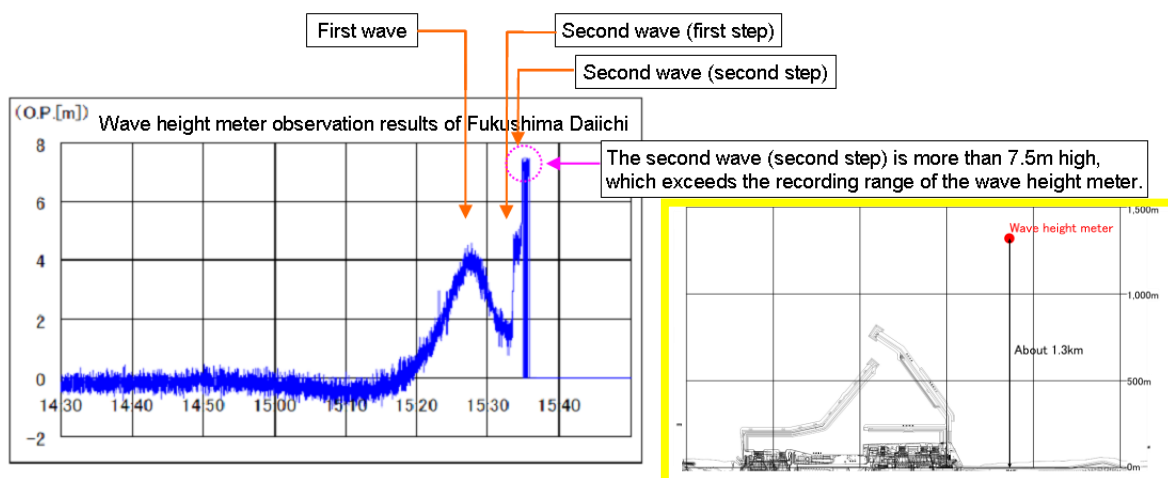
Figure Wave height meter observation results and the positional relation between the Fukushima Daiichi Nuclear Power Station site and the wave height meter

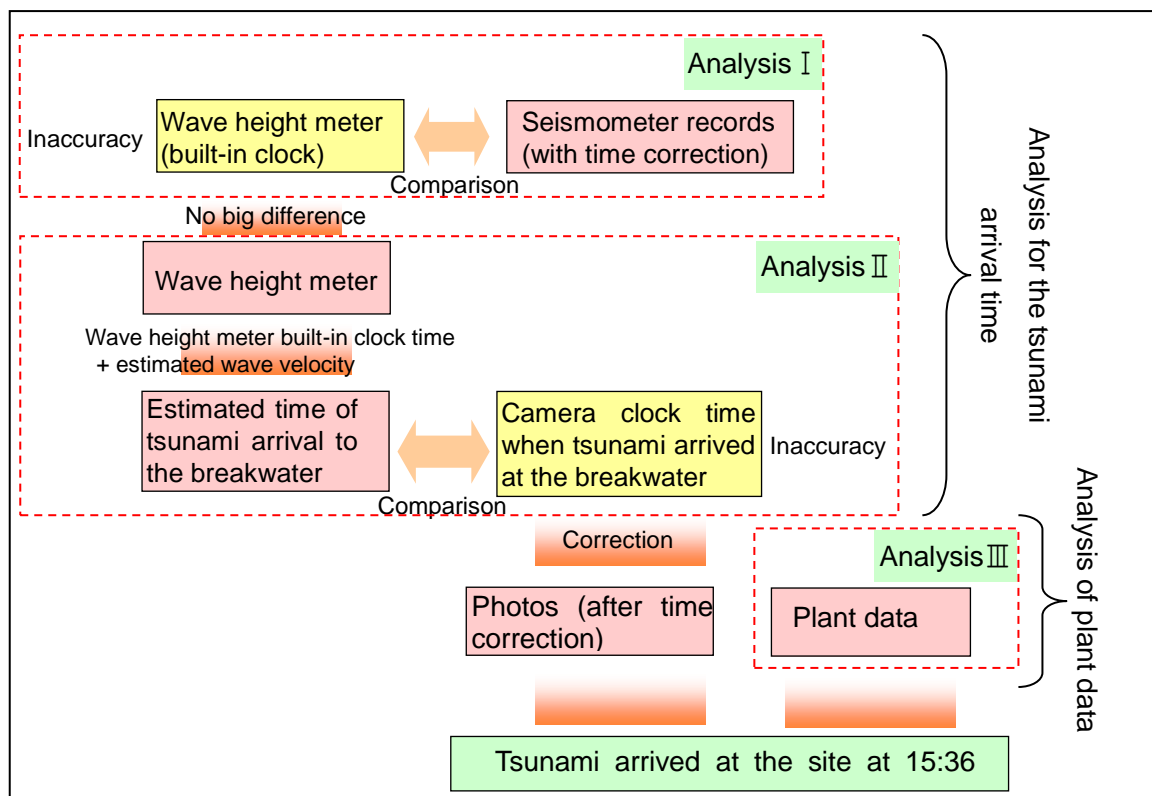
The following approach has been taken to analyze the tsunami arrival timing at the Fukushima Daiichi Nuclear Power Station site. The results of analyses are given in later sections: the results of analyses I and II as “Analysis by the use of wave height meter records and photos” and those of analysis III as “Analysis using plant data.”

In Analysis I, the accuracy of the wave height meter built-in clock was analyzed, which was known to have inaccuracies. Seismometers installed on each unit of the Fukushima Daiichi Nuclear Power Station, which had been calibrated on the each hour, were used as the reference and compared with the water pressure wave time history recorded on the wave height meter for the necessary time calibration.

In Analysis II, the timing of the tsunami wave passing over the wave height meter after its correction by Analysis I and the estimated tsunami wave velocity were used to estimate the tsunami arrival timing when the tsunami reached the southern breakwater flexion.

There is a photo of the tsunami second wave (first peak) arriving at the southern breakwater flexion. The times of the continuous photos recorded have been corrected by comparing the time recorded on the camera and the estimated tsunami arrival time to the southern breakwater flexion obtained above.

In Analysis III, the tsunami arrival time was estimated based on the recorded plant data (times when the seawater pumps, power panels and diesel generators lost their functions).

Figure Approach for the analyses of the tsunami arrival times at the site

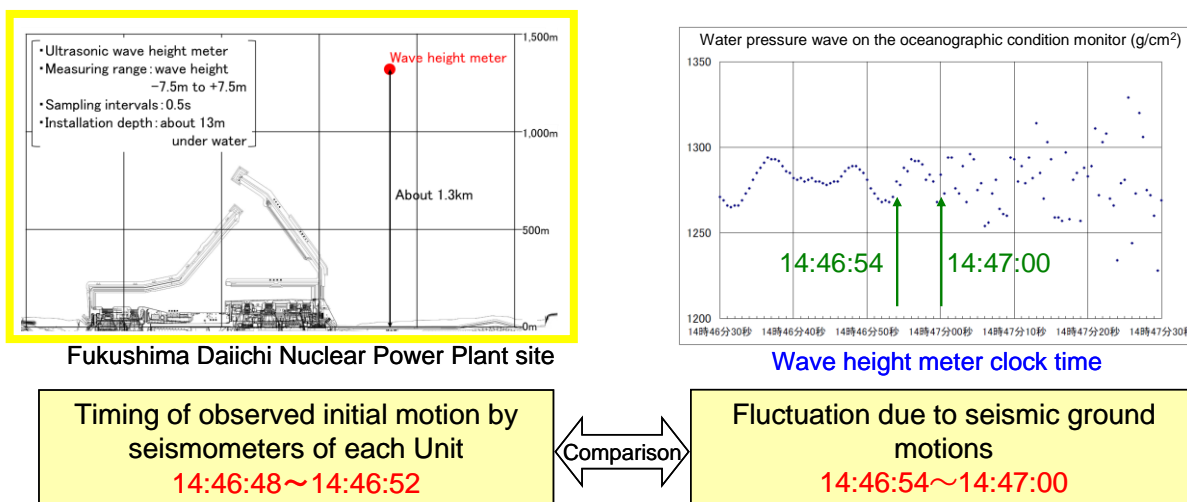
Timing accuracy has been verified by comparing the slight initial motion recorded on the seismometers of each unit and the water pressure wave (responding to the seismic ground motion) recorded on the wave height meter.

Fluctuation noticed in the graph generated by the wave height meter can be considered to be due to the seismic motions, that is, the time when the seismic motion reached the wave height meter can be regarded as around 14:46:54 to 14:47:00 according to the wave height meter built-in clock.

On the other hand, the seismometers installed on each unit (their built-in clocks were calibrated on the hour) recorded that the seismic ground motion started at 14:48:48 to 14:48:52. As the seismic wave propagation speed is regarded as several kilometers per second or more, the time needed for propagation over 1.3 km is almost negligible, which was the distance separating the wave height meter and the seismometers at the power plant.

From deliberations above, the wave height meter built-in clock seemed to be about 4 to 10 s fast, when compared with the median value of the seismometers records of 14:46:50 as the seismic motion starting time. Thus, wave height meter timing would be considered to have no big discrepancy.

Figure Comparison between timing of observed motion by seismometers and fluctuation on wave height meter measurement

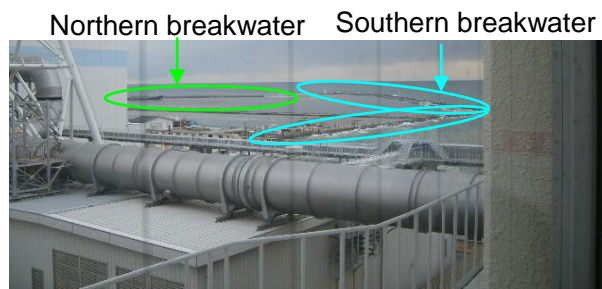
1 (00:00)

The sea level conditions on the southern breakwater shows a gradual sea level drop over the time span of 1 min 26 s from Shot 1 to Shot 4. The sea level clearly declines over the following 3 min 34 s from Shot 4 to Shot 5.

Excluding Shot 1, the sea level in the bay seemed to be declining gradually at least from Shot 2 to Shot 5 (4 min 26 s or longer).

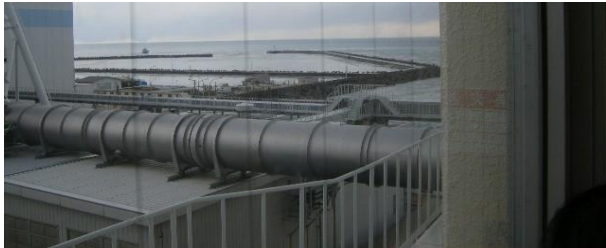
5 (05:00)

When having a look at portions that were not flooded on the land side base of the southern breakwater and the eastern seawall bank, Shot 5 and Shots 6 to 8 have similar conditions of not being flooded. Therefore, it may be understood that the tsunami bore, on the order of several meters in height as seen in Shots 7 and 8, reached that point immediately after the gradual drop of the sea level.

In other words, it can be judged that water drop in Shots 1 to 5 was after the peak of the first wave, and the bore in Shots 7 and 8 was the second wave (first step).

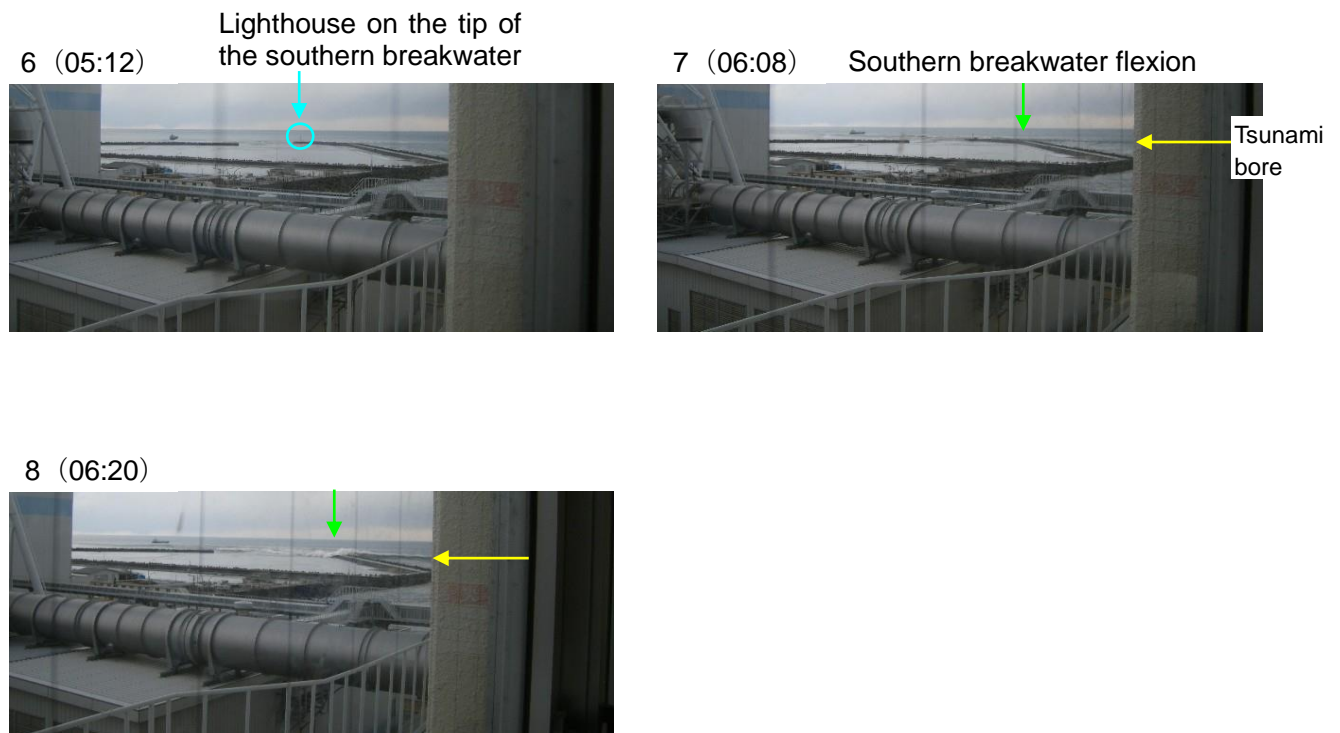
Shot 7 clearly shows the approach of the bore-type tsunami. At this moment the bore had not yet reached the main part of the southern breakwater and the lighthouse on its tip; the bore was clearly outside the bay. Judging from the positions of the bore and a ship in the photo, Shot 7 was taken immediately after the ship had passed the bore.

In Shot 8, the bore reached the southern breakwater and the lighthouse on its tip was behind the tsunami, so that at this moment the bore had reached the flexion of the southern breakwater.

There were four shots, 5 to 8, during 1 min 20 s. Then it was judged that these shots could catch the arrival of second wave (first step) and there was nothing more missing.

As mentioned before, the bore of the second wave (first step) reached the southern breakwater flexion in Shot 8, which allows correction of the time when the shot was taken. The procedure is:

##### (c) Identification of the time Shot 8 was taken

The time when the second wave (first step) reached the wave height meter was about 15:33:30. When the estimated time for propagation is added to this, the time when Shot 8 was taken is estimated to be between 15:34:46 and 15:35:05. On the other hand, the time recorded on the camera built-in clock was 15:41:36.

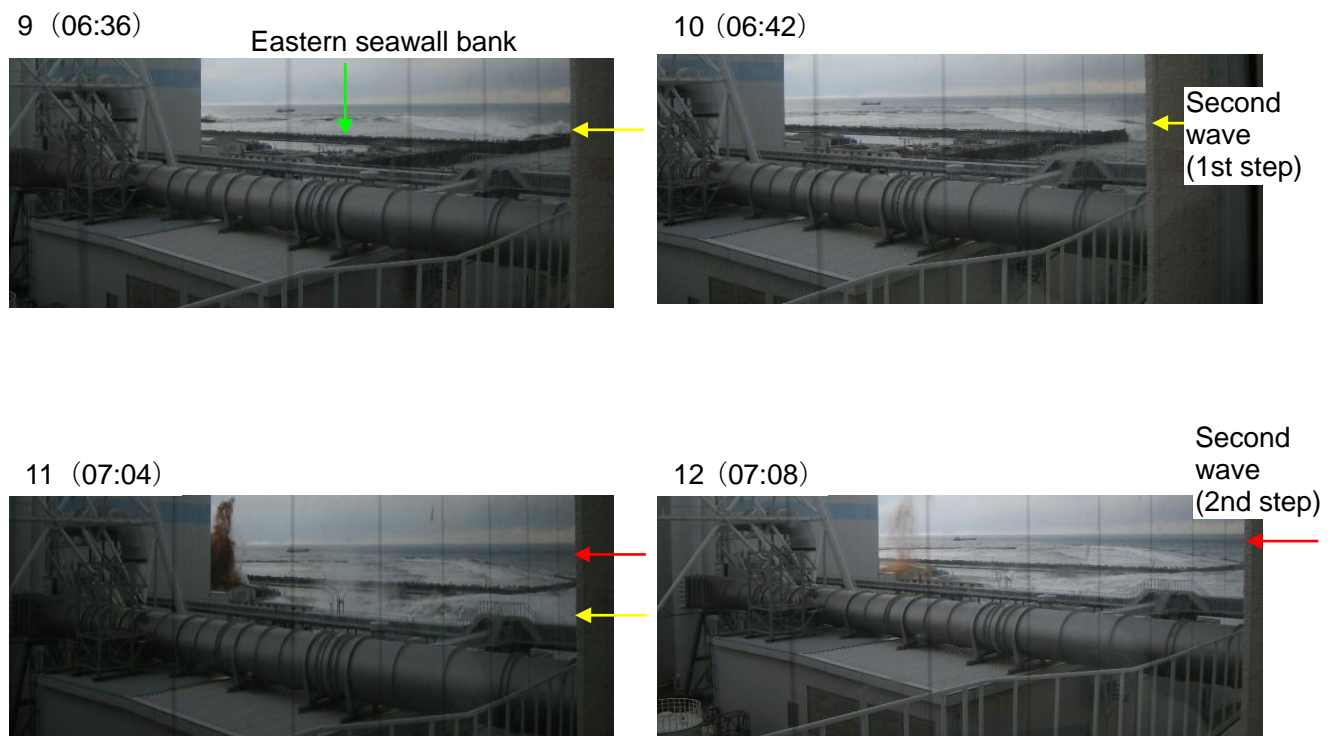
Shots 9 to 12 show tsunami bore running along the southern breakwater, i.e., the tsunami second wave (first step).

In Shot 11 the base area of the southern breakwater is covered by the tsunami water, while the bore cannot be confirmed to have reached the eastern seawall bank. Therefore, the brown water column seen is due to the tsunami which did not come from bay area (from east) but from southeast into the front side of Unit4. But it cannot be judged from this shot only whether it resulted when the tsunami collided with some structures after running up to the 4-m ground level above O.P. (O.P. : Onahama Port construction standard surface, hereafter described as 4-m ground level) or it ran through a water discharge canal and rose from its opening. The location can be considered to be around the border between the 4-m ground level and 10-m ground level, because the column appeared immediately northeast of a hut on the 10-m ground level in front of the Unit-4 building.

In Shots 11 and 12, a wave, probably the second wave (second step), can be seen off the coast. The water column in Shot 11, therefore, can be considered to have risen when the second wave (first step) in the order of several meters in height as observed in Shots 6 to 8 reached the area near the border between the 4-m ground level and 10-m ground level.

The time difference between Shot 8, showing the arrival of the tsunami second wave (first step), and Shot 12 is 48 s, and it can be considered that no phenomenon has been overlooked and consequently the water column was generated due to the second wave (first step).

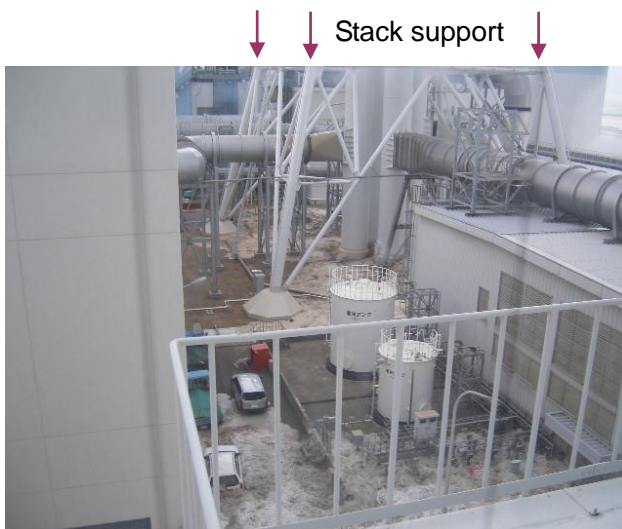
13 (07:24)

Shot 13, 20 s after Shot 11 with the water column, shows inundation to the 10-m ground level.

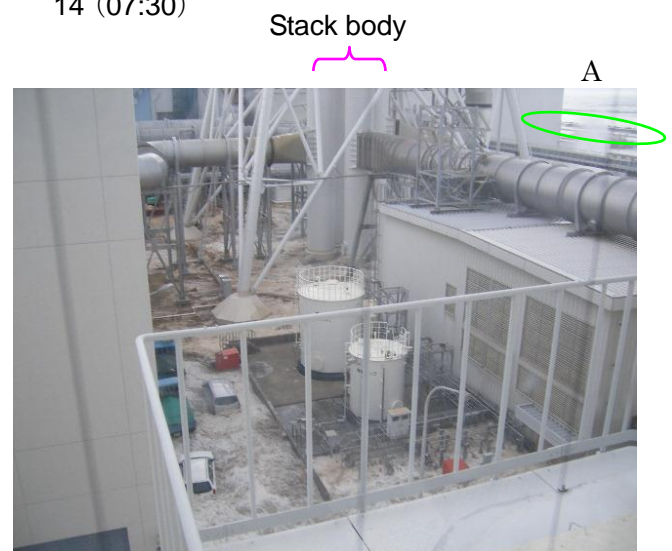
14 (07:30)

On the upper right of Shot 14, 6 s after Shot 13, a structure, probably the eastern seawall bank, can be recognized (A). This timing will be around the time when the second wave (first step) in the order of several meters height as recognized in Shots 7 and 8 reached the 10-m ground level. In Shots 15 and 16, the base of the stack is seen (B), and no big tsunami run-up like those in Shots 17 and 18 is visible. Based on these observations, it can be understood that in Shots 13 to 16 the second wave (second step) in the order of 10 meters high had not reached the 10-m ground level yet and that the run-up to the 10-m ground level recognized in Shots 13 and 14 by the second wave (first step) was a limited scale.

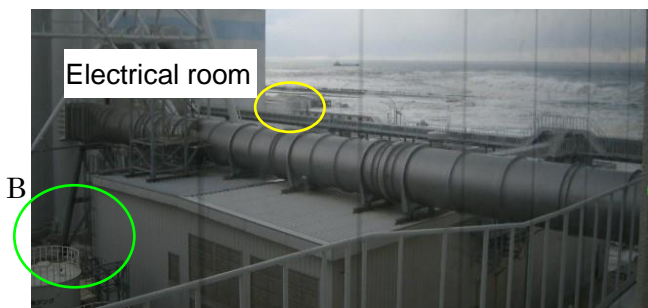
15 (07:42)

In Shot 15, 12 s after Shot 14, tsunami water covers the southern and northern breakwaters. In Shot 16, taken 14 s after Shot 15, the eastern seawall bank is also covered by the tsunami water in addition to the southern and northern breakwaters and big bores are recognized in the bay.

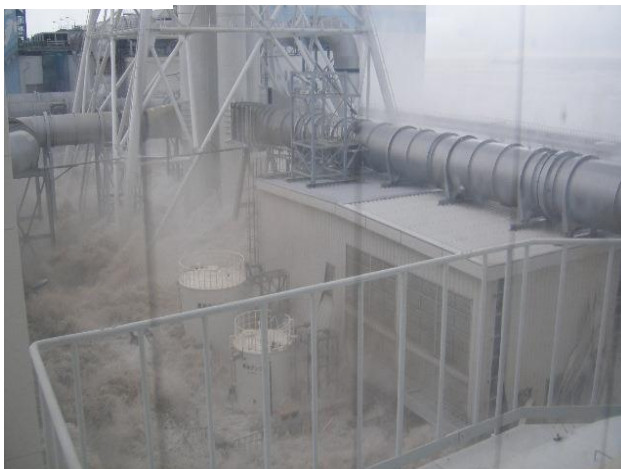
17 (08:10)

In Shot 17, taken 14s after Shot 16, a large amount of seawater flows over the 10-m elevation level and continues in the scenes of Shots 18 and 19. The scene inside the bay is not clear in Shot 17. In Shots 18 and 19, the elevated sea surface can be confirmed, but breakwaters and seawall bank cannot be recognized. This means that, besides the second wave (first step), there was another wave that was big enough to flood completely the breakwaters and seawall bank.

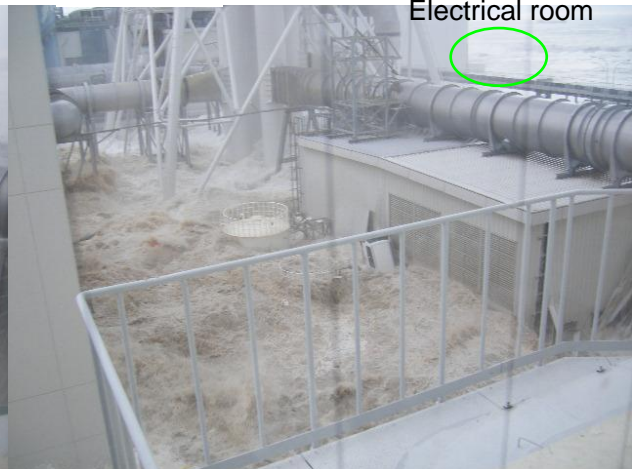
18 (08:20)

Shot 18 was taken 24 s after Shot 16 which shows a massive tsunami rushed into the bay. Further, in Shots 18 and 19, the electrical room on the 10-m ground level is almost completely flooded; which had been seen in Shots 15 and 16. As this electrical room was 5.15 m high, tsunami in Shots 18 and 19 can be regarded as about O.P. +15 m.

From these examinations, it can be concluded that at around the time Shot 18 was taken the second wave (second step) of about O.P. +15 m high had reached the areas near all reactor buildings of the Fukushima Daiichi Nuclear Power Station site.

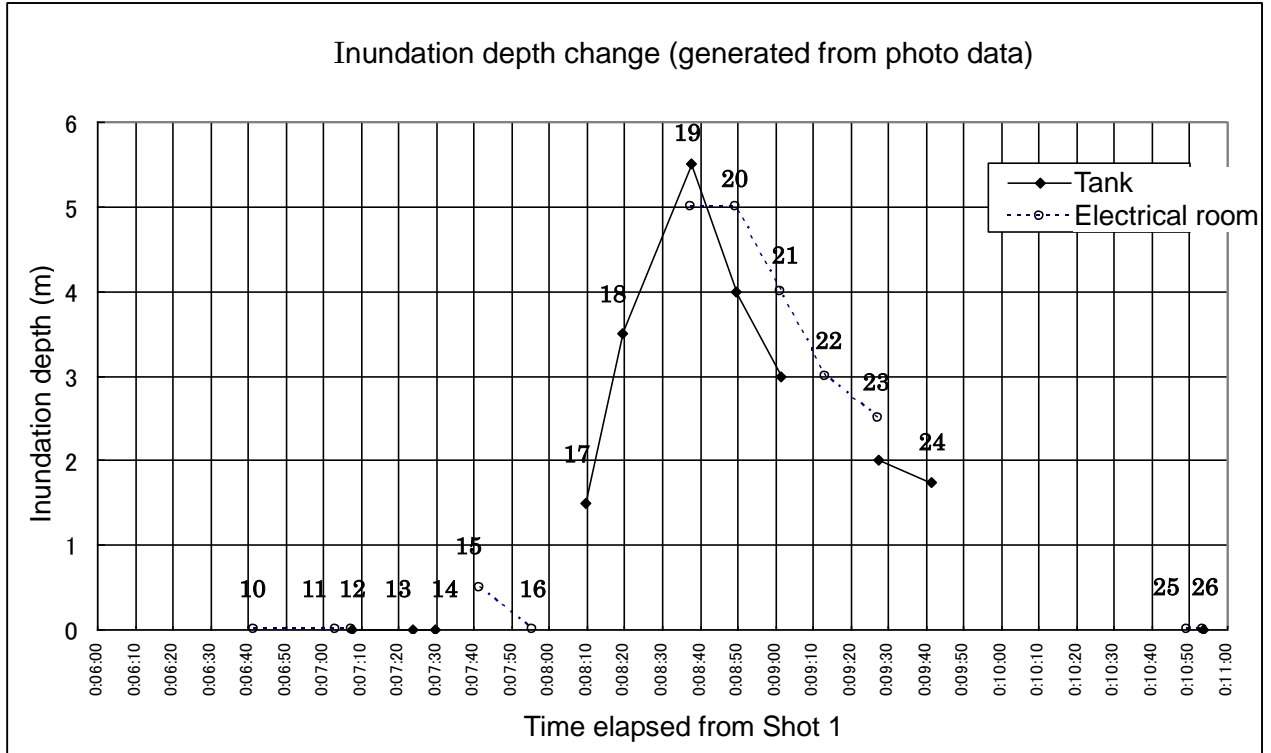
The time history chart of the tsunami level on the wall of a light oil tank and the electrical room in these shots indicates that the run-up of the tsunami in Shots 13 to 16 was a limited scale and the run-up became large scale from just before Shot 17. This observation agrees with the results of the photo analysis.

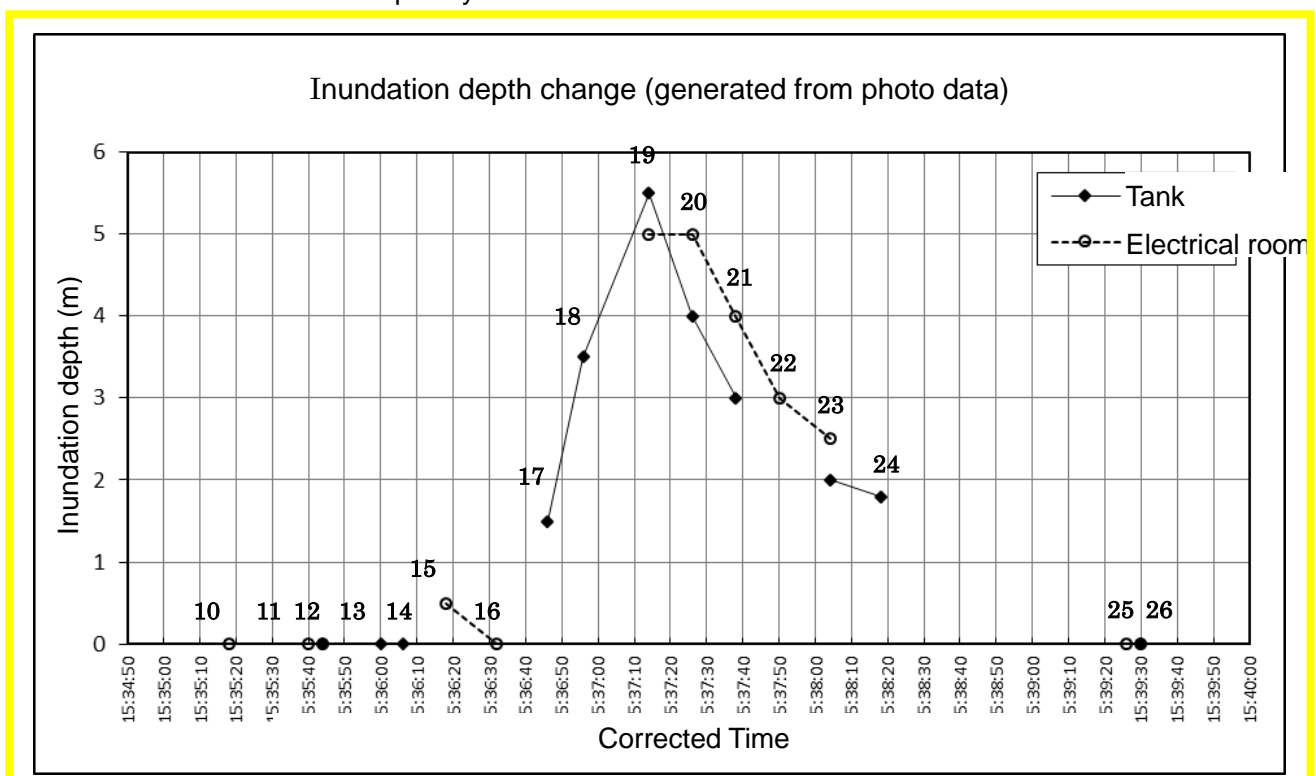
- (f) The following figure shows the inundation situations of the tanks, etc. with the same time correction.
- (g) Run-up of the second wave (first step) to the 10-m ground level remained as a limited one, but it can be understood that the second wave (second step) ran up to the 10-m ground level and almost completely covered the breakwaters and seawall bank.

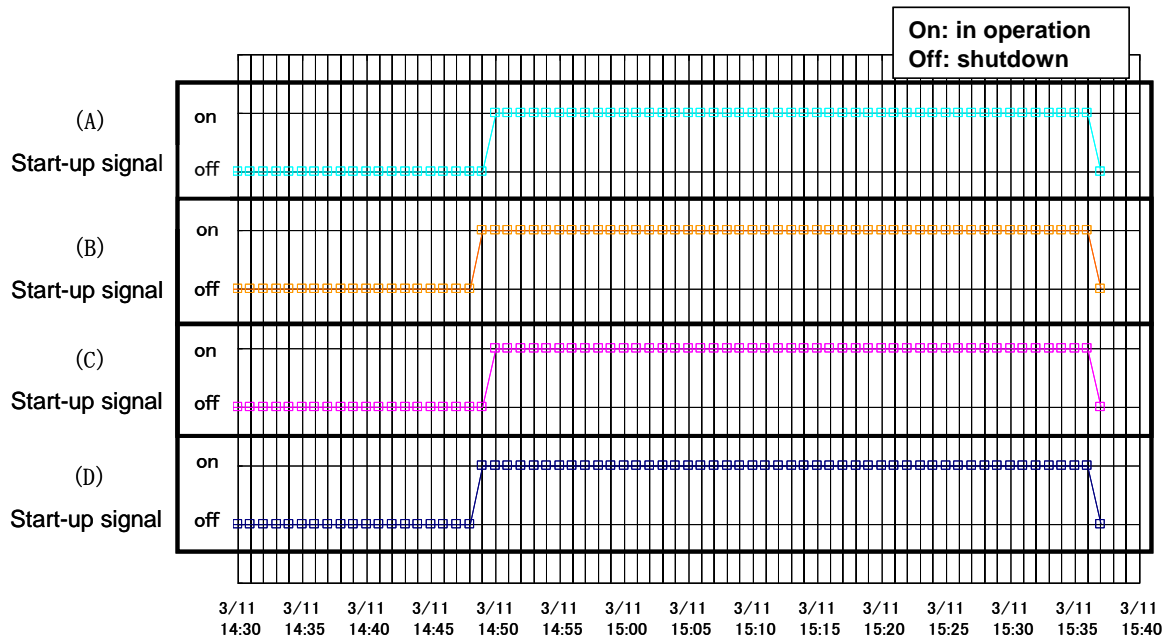
- ✓ Containment cooling sea water system (CCSW) pumps of Unit-1

The CCSW pumps (A) to (D) had anomalies between 15:35:59 and 15:36:59 and lost their functions, according to the one minute cycle data recorded on the transient recorder.

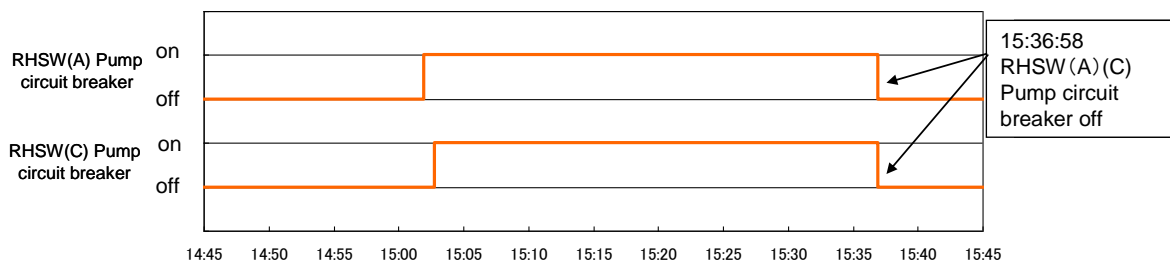
- ✓ Residual heat removal sea water system(RHSW) pumps of Unit-2

The circuit breakers of RHSW pumps (A) and (C) were opened and lost their operating functions at 15:36:58, according to the records in the process computer.

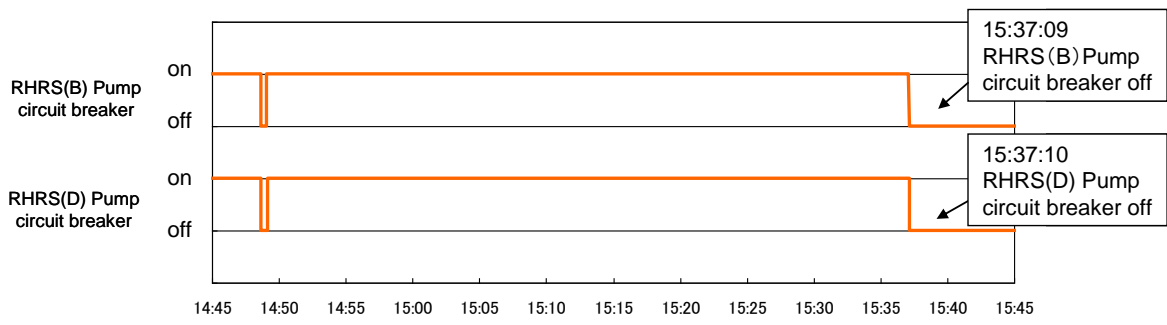
- ✓ Residual heat removal sea water system (RHRS) pumps of Unit-5

The RHRS pumps (B) and (D), which had started operation after the earthquake, had anomalies and lost operating functions at 15:37:09 and 15:37:10 according to the records in the process computer.

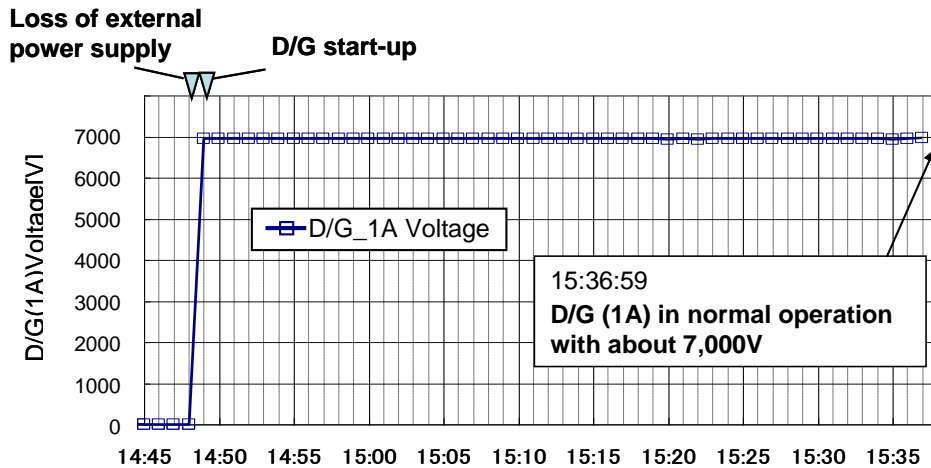
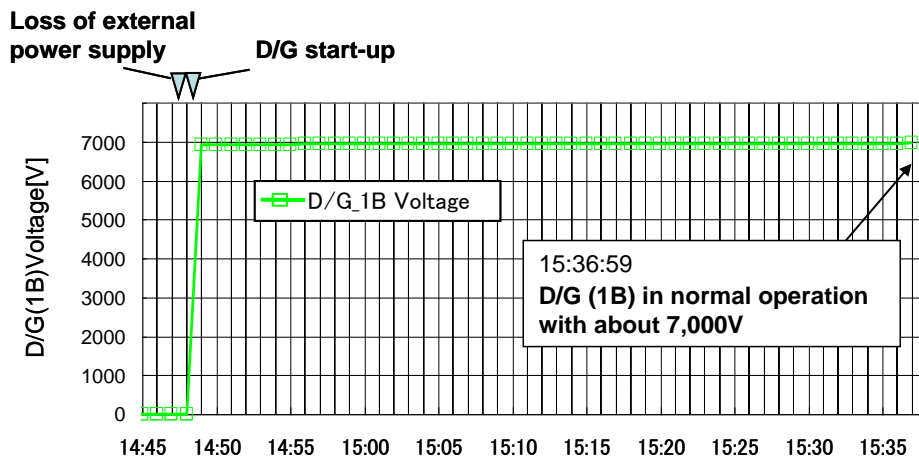
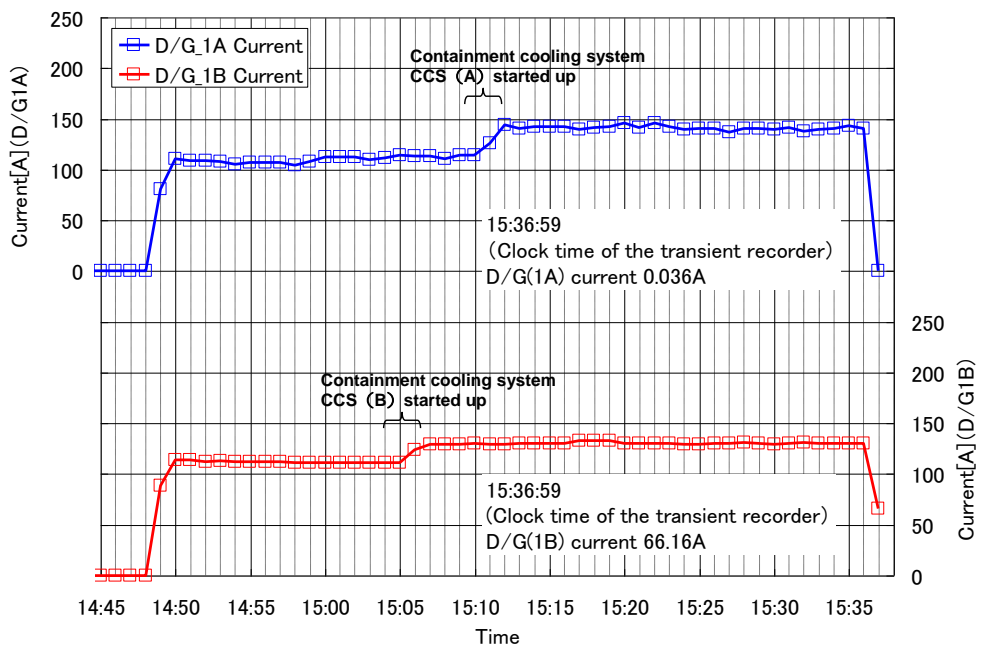
✓ D/Gs (1A) and (1B) of Unit-1

The voltage of the D/Gs (1A) (1B) of Unit-1 had been established until 15:36:59 while the transient recorder was recording data. This confirms their function losses were sometime after 15:36:59.

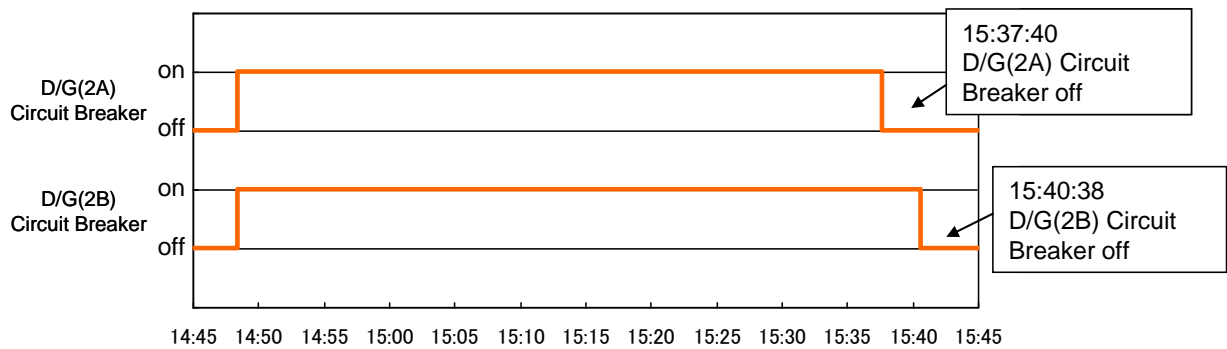
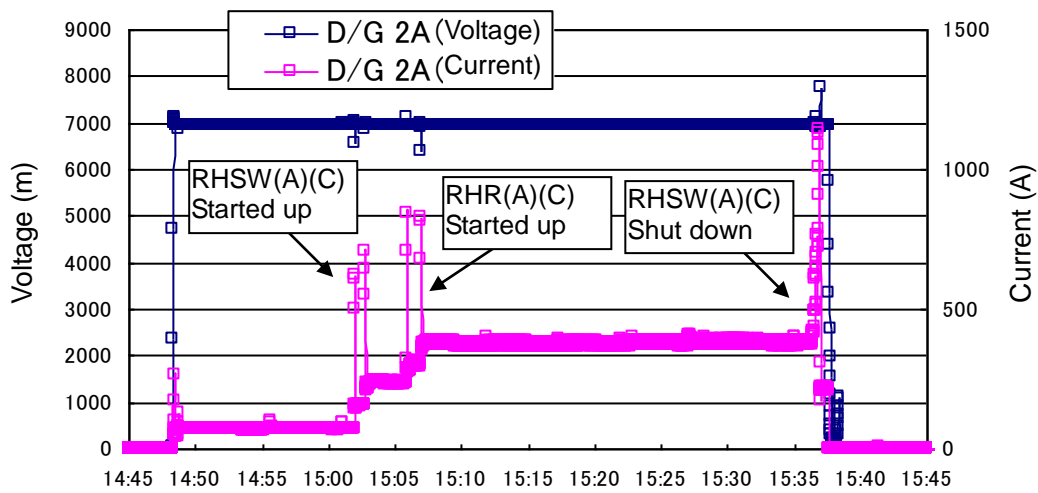
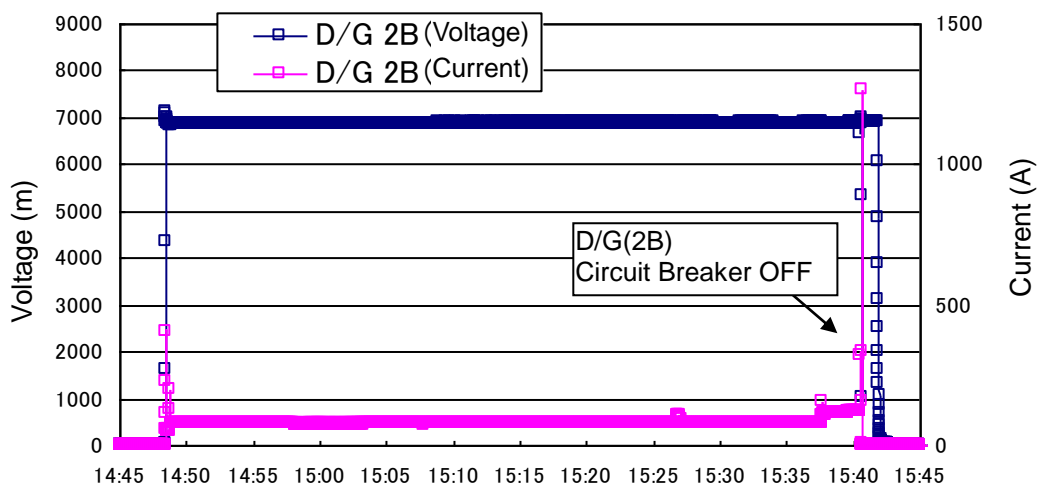
✓ D/Gs (2A) and (2B) of Unit-2

The power receiving circuit breaker of D/G (2A) opened at 15:37:40, according to the data recorded on the process computer.

The D/G (2B) was installed in another building (the common pool building) and its body was not damaged. But its breaker opened at 15:40:38. The function is assumed to have been lost due to the effect of damage to its related facilities or flooding of the emergency power panels to which the D/G (2B) was supplying power.

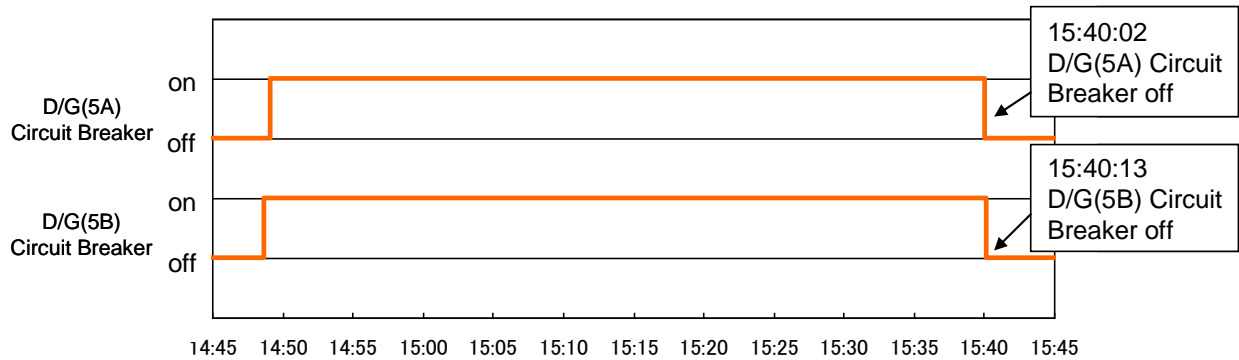
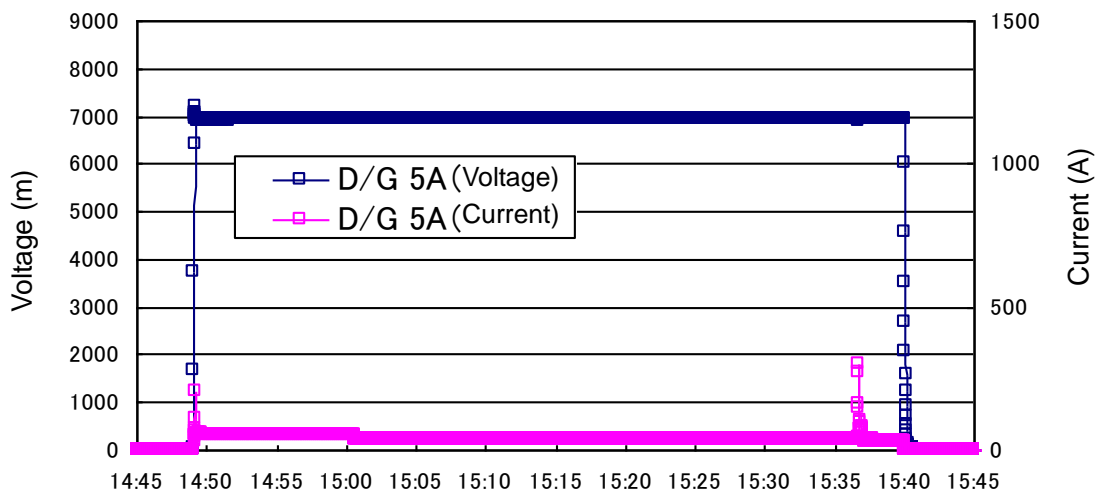
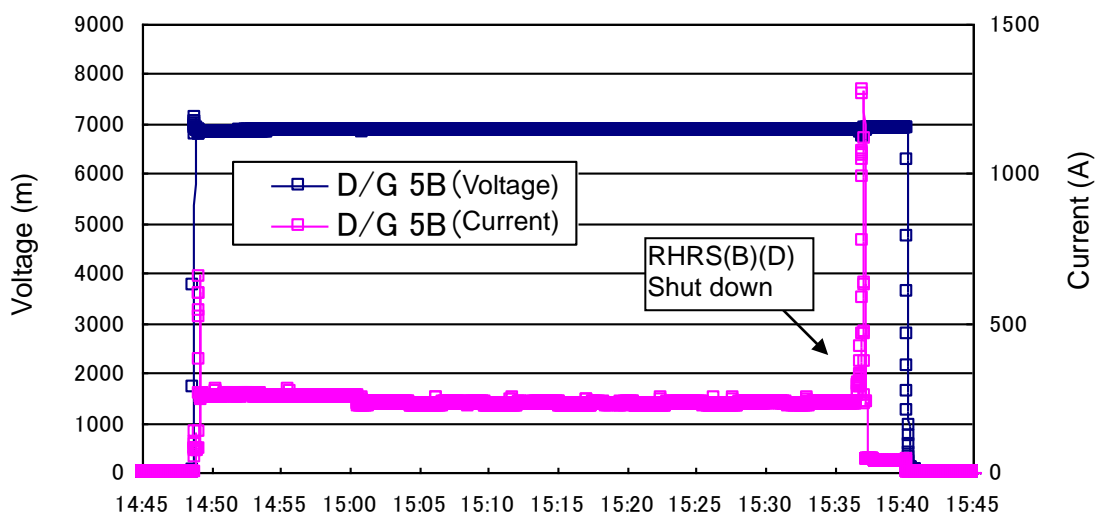
✓ D/Gs (5A) and (5B) of Unit-5

The D/Gs (5A) (5B) had anomalies at around 15:40 and lost their function, according to the data recorded on the process computer.

The bodies of D/Gs (5A) (5B) were confirmed in later investigation to have had no damage by flooding. The function is assumed to have been lost due to damage of their related facilities or flooding of the emergency power panels.

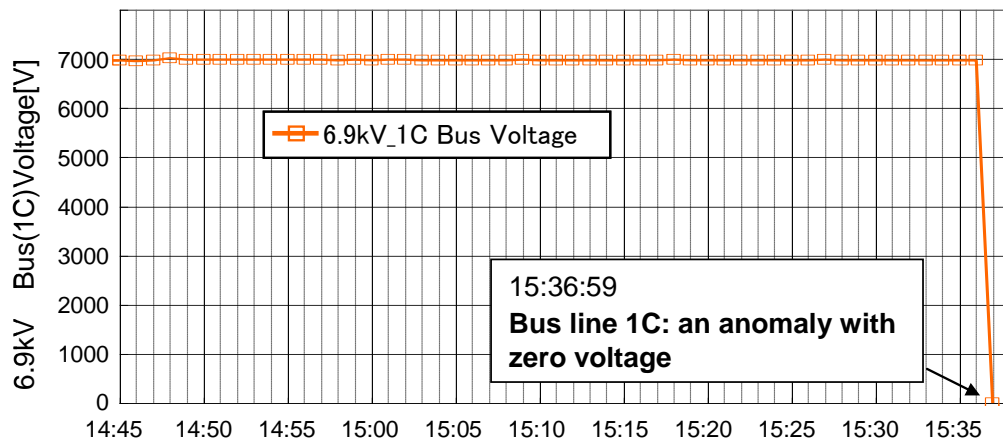
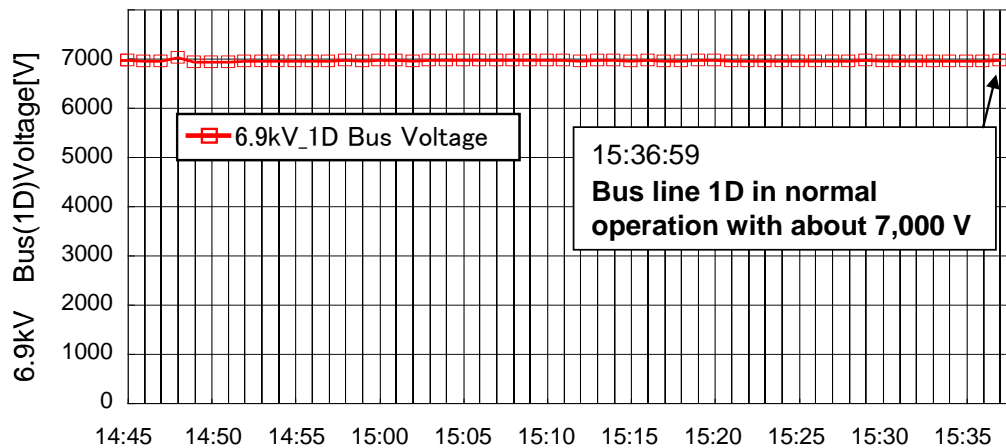
✓ Emergency power panels 1C and 1D of Unit-1

The emergency power panel 1C lost the emergency bus voltage between 15:35:59 and 15:36:59, while the emergency bus voltage of the emergency power panel 1D has been established until 15:36:59, according to the one minute cycle data recorded on the transient recorder. This confirms the function losses of the emergency power panel 1C was sometime after 15:36:59.

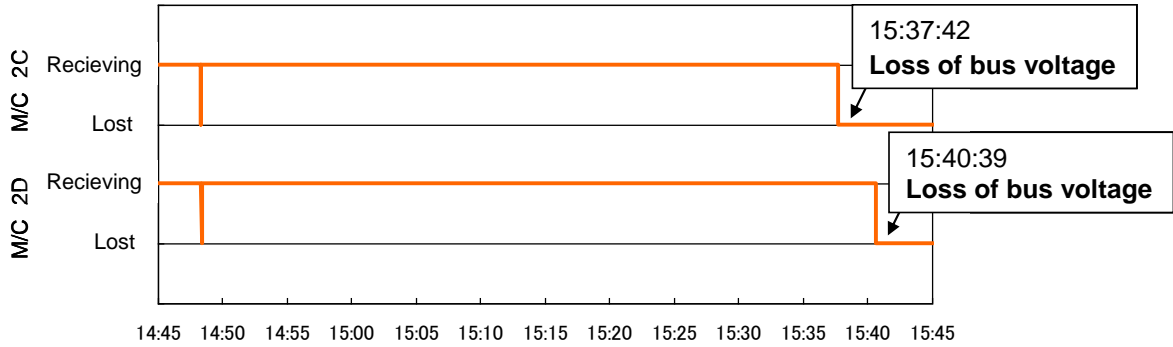
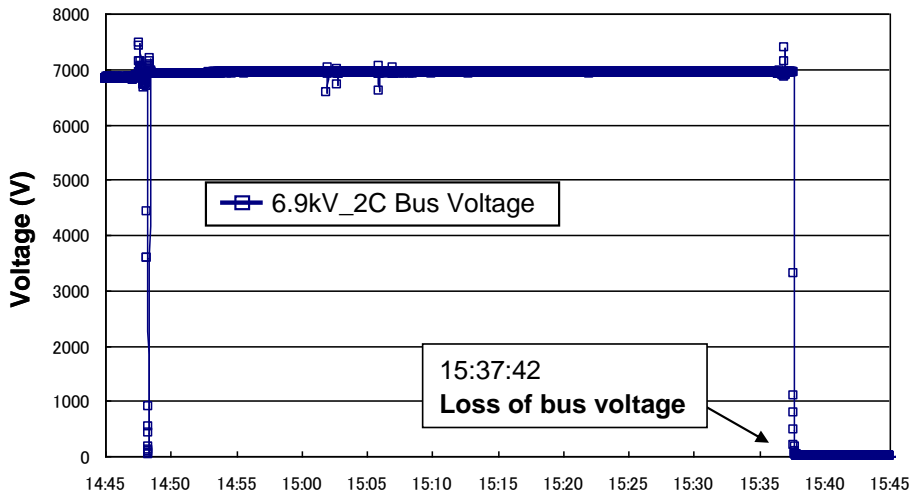
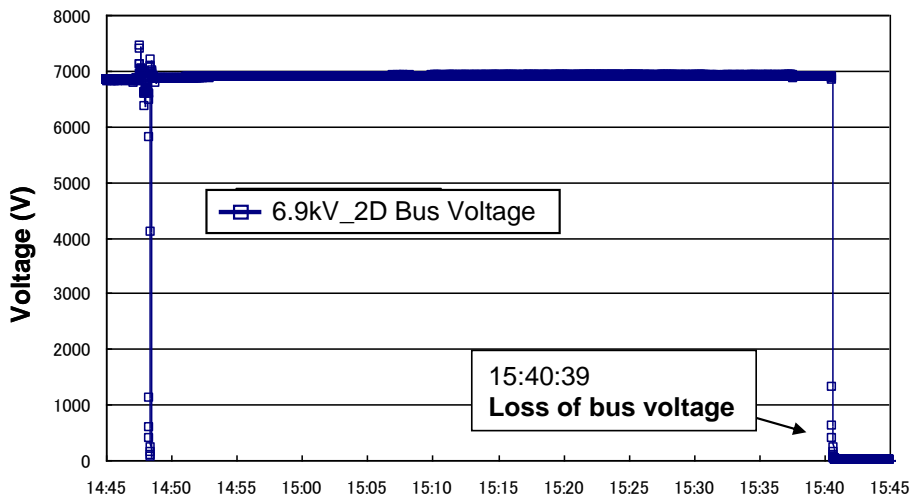
✓ Emergency power panels 2C and 2D of Unit-2

The emergency power panel 2C lost the emergency bus voltage at 15:37:42, while the emergency power panel 2D lost it at 15:40:39, according to the data recorded on the process computer for emergency power panels.

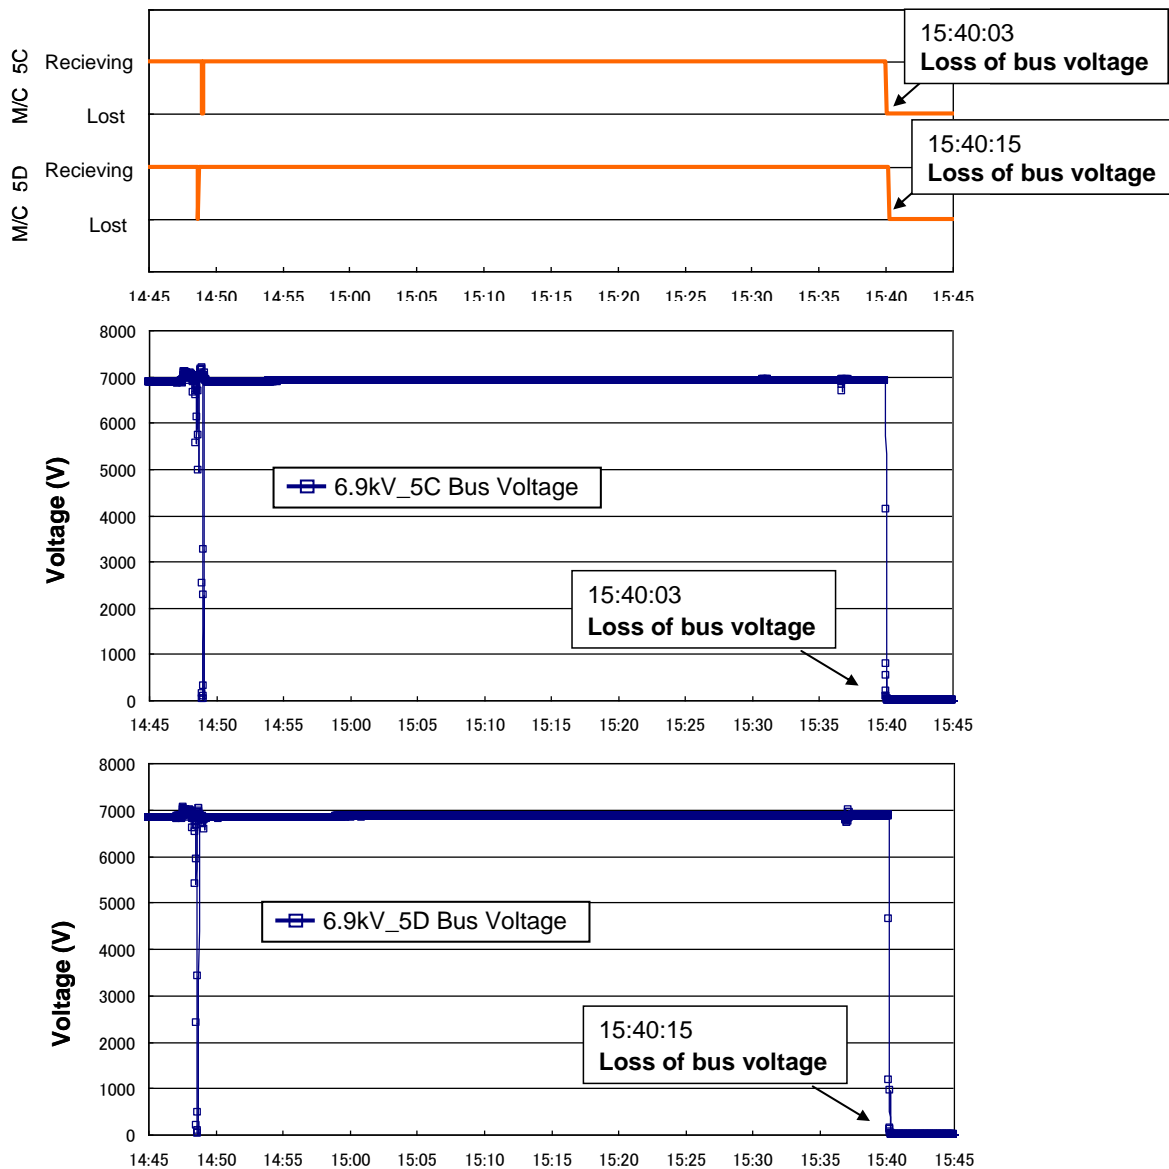
✓ Emergency power panels 5C and 5D of Unit-5

The emergency power panel 5C lost the emergency bus voltage at 15:40:03, while the emergency power panel 5D lost it at 15:40:15, according to the data recorded on the process computer.

The D/Gs showed no anomalies in a post-accident investigation. The loss of function is assumed to have been caused by that of the metal-clad switchgear (M/C) or D/G related facilities, which were flooded.

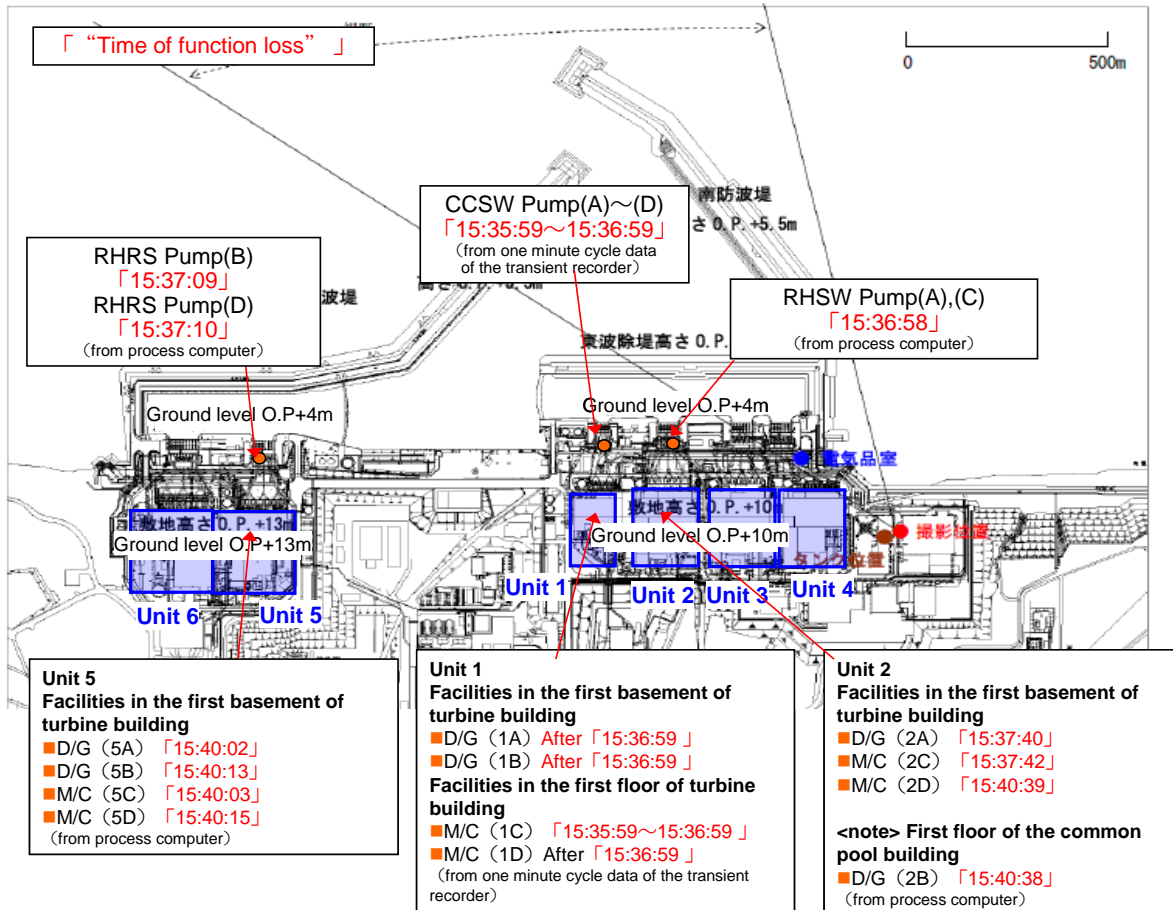
Seawater pumps closest to the sea (installed on the 4-m ground level) lost their function mostly at the 15:36 level, which is thought to be due to the arrival of tsunami second wave at the site.

In other main buildings, the timing of function loss varied depending on the installed locations, but the emergency bus function was lost mostly at around 15:40 caused by tsunami, resulting in the loss of all AC power supplies.

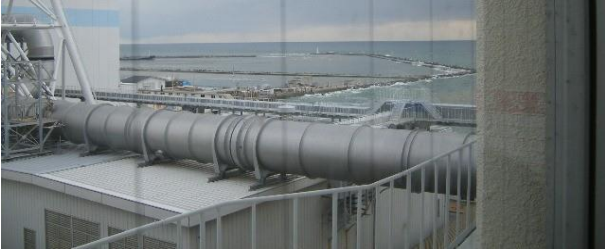
2 (00min.34 sec. later)

about 15:29:10 (corrected time)

15:35:50 (camera built-in clock time)

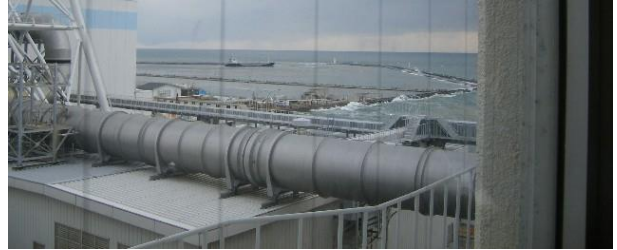
3 (01min.02 sec. later)

about 15:29:38 (corrected time)

15:36:18 (camera built-in clock time)

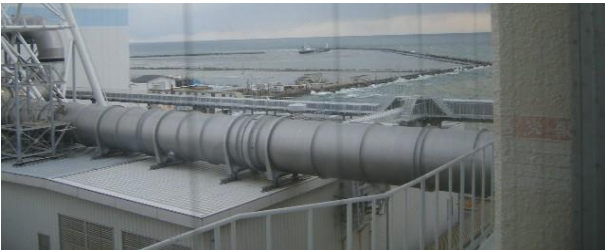
4 (01min.26 sec. later)

about 15:30:02 (corrected time)

15:36:42 (camera built-in clock time)

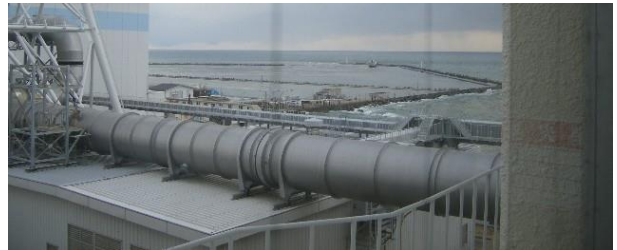
5 (05 min.00 sec. later)

about 15:33:36 (corrected time)

15:40:16 (camera built-in clock time)

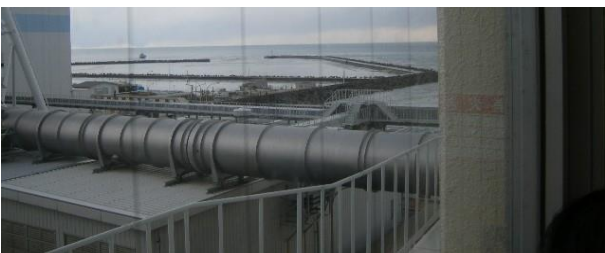
6 (05 min.12 sec. later)

about 15:33:48 (corrected time)

15:40:28 (camera built-in clock time)
