## Arrival times of tsunami at the Fukushima Daiichi Nuclear Power Station site

## 1. Overview

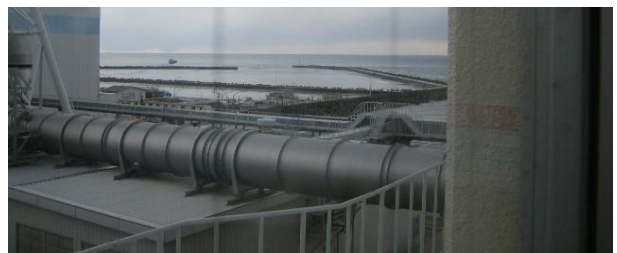
7 (06 min.08 sec. later)

Shot 7 clearly shows the approach of the bore-type tsunami. At this moment the bore had not yet reached the main part of the southern breakwater and the lighthouse on its tip; the bore was clearly outside the bay. Judging from the positions of the bore and a ship in the photo, Shot 7 was taken immediately after the ship had passed the bore.

about 15:34:44 (corrected time)

15:41:24 (camera built-in clock time)

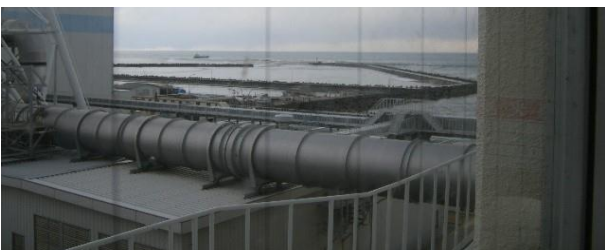
8 (06 min.20 sec. later)

In Shot 8, the bore reached the southern breakwater and the lighthouse on its tip was behind the tsunami, so that at this moment the bore had reached the flexion of the southern breakwater.

about 15:34:56 (corrected time)

15:41:36 (camera built-in clock time)

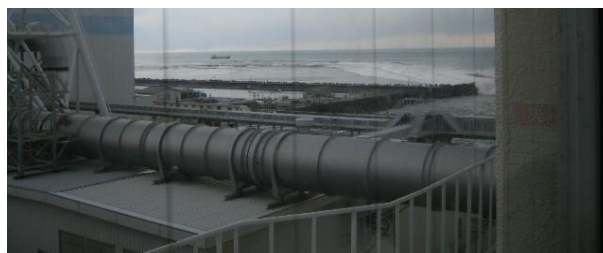
11 (07 min.04 sec. later)  
about 15:35:40 (corrected time)  
15:42:20 (camera built-in clock time)

In Shot 11 the base area of the southern breakwater is covered by the tsunami water, while the bore cannot be confirmed to have reached the eastern seawall bank. Therefore, the brown water column seen is due to the tsunami which did not come from bay area (from east) but from southeast into the front side of Unit4. But it cannot be judged from this shot only whether it resulted when the tsunami collided with some structures after running up to the 4-m ground level above O.P. (O.P. : Onahama Port construction standard surface, hereafter described as 4-m ground level) or it ran through a water discharge canal and rose from its opening. The location can be considered to be around the border between the 4-m ground level and 10-m ground level, because the column appeared immediately northeast of a hut on the 10-m ground level in front of the Unit-4 building.

In Shots 11 and 12, a wave, probably the second wave (second step), can be seen off the coast. The water column in Shot 11, therefore, can be considered to have risen when the second wave (first step) in the order of several meters in height as observed in Shots 6 to 8 reached the area near the border between the 4-m ground level and 10-m ground level.

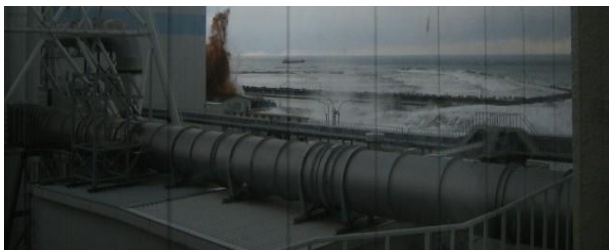
12 (07 min.08 sec. later)  
about 15:35:44 (corrected time)  
15:42:24 (camera built-in clock time)

The time difference between Shot 8, showing the arrival of the tsunami second wave (first step), and Shot 12 is 48 s, and it can be considered that no phenomenon has been overlooked and consequently the water column was generated due to the second wave (first step).

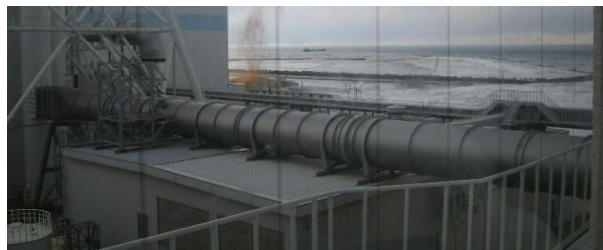
13 (07 min.24 sec. later)  
about 15:36:00 (corrected time)  
15:42:40 (camera built-in clock time)

Shot 13, 20 s after Shot 11 with the water column, shows inundation to the 10-m ground level.

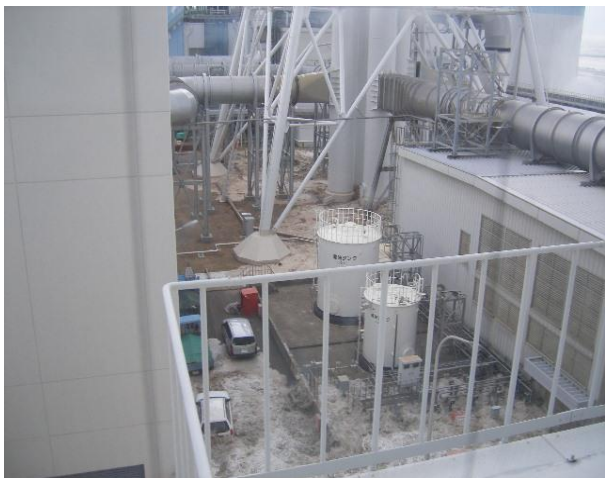
14 (07 min.30 sec. later)  
about 15:36:06 (corrected time)  
15:42:46 (camera built-in clock time)

On the upper right of Shot 14, 6 s after Shot 13, a structure, probably the eastern seawall bank, can be recognized (A). This timing will be around the time when the second wave (first step) in the order of several meters height as recognized in Shots 7 and 8 reached the 10-m ground level. In Shots 15 and 16, the base of the stack is seen (B), and no big tsunami run-up like those in Shots 17 and 18 is visible. Based on these observations, it can be understood that in Shots 13 to 16 the second wave (second step) in the order of 10 meters high had not reached the 10-m ground level yet and that the run-up to the 10-m ground level recognized in Shots 13 and 14 by the second wave (first step) was a limited scale.

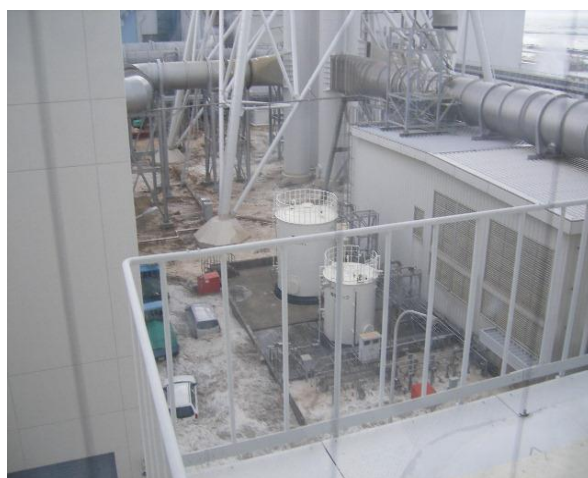
15 (07 min.42 sec. later)  
about 15:36:18 (corrected time)  
15:42:58 (camera built-in clock time)

In Shot 15, 12 s after Shot 14, tsunami water covers the southern and northern breakwaters. In Shot 16, taken 14 s after Shot 15, the eastern seawall bank is also covered by the tsunami water in addition to the southern and northern breakwaters and big bores are recognized in the bay.

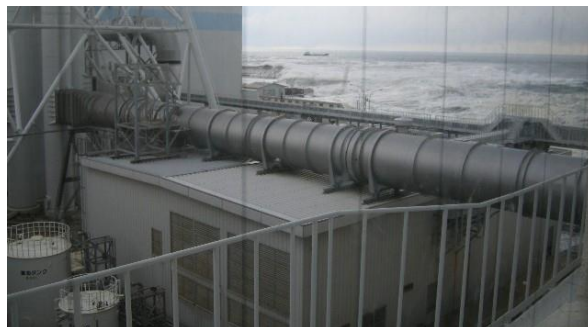
17 (08 min.10 sec. later)

In Shot 17, taken 14s after Shot 16, a large amount of seawater flows over the 10-m elevation level and continues in the scenes of Shots 18 and 19. The scene inside the bay is not clear in Shot 17. In Shots 18 and 19, the elevated sea surface can be confirmed, but breakwaters and seawall bank cannot be recognized. This means that, besides the second wave (first step), there was another wave that was big enough to flood completely the breakwaters and seawall bank.

about 15:36:46 (corrected time)

15:43:26 (camera built-in clock time)

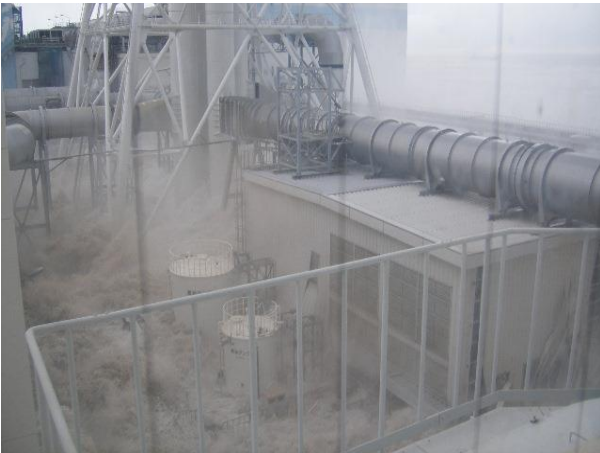
18 (08 min.20 sec. later)

about 15:36:56 (corrected time)

15:43:36 (camera built-in clock time)

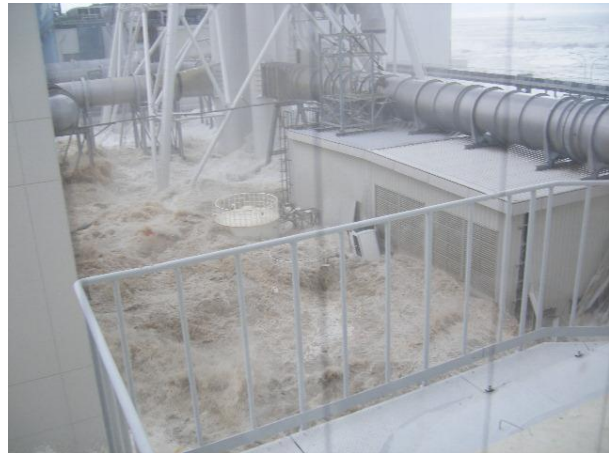
19 (08 min.38 sec. later)

about 15:37:14 (corrected time)

15:43:54 (camera built-in clock time)

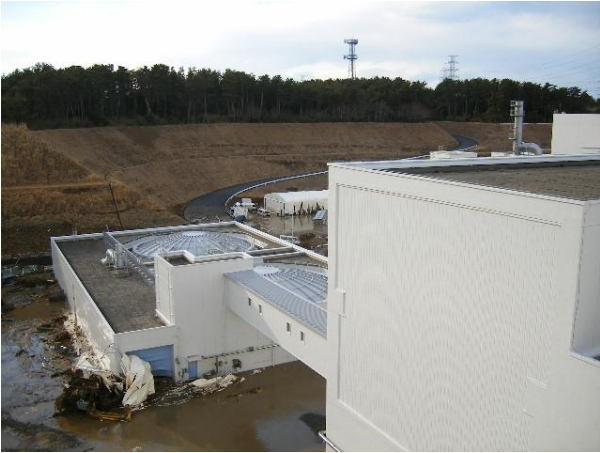
44 (25 min.48 sec. later)

about 15:54:24 (corrected time)

16:01:04 (camera built-in clock time)

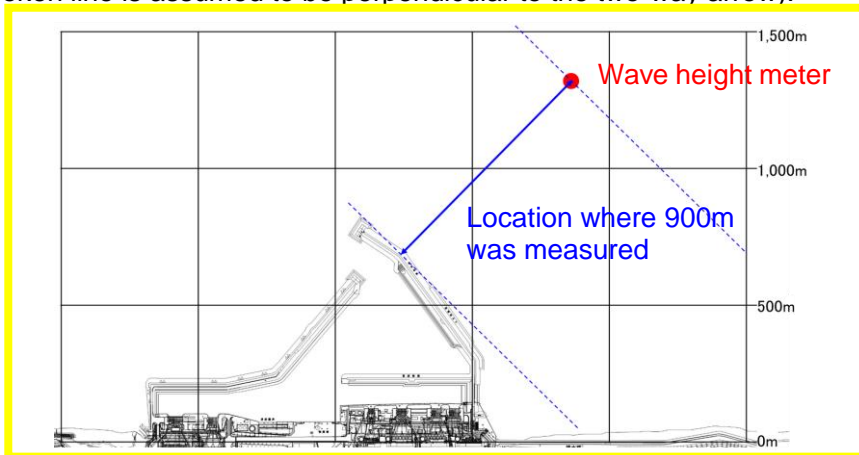
In this current examination, the distance was set as 900 m from the wave height meter to the southern breakwater flexion.

The positional relation for setting 900 m is seen below, which means that the tsunami wave-front shown by the broken line is assumed to be perpendicular to the two-way arrow).

From this consideration, the distance of 900 m is considered to be longer than the real propagation distance of the tsunami, and, therefore, leads to estimation of a longer propagation time.

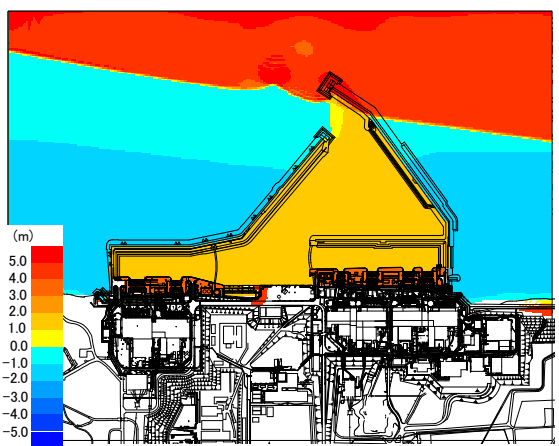
The wave-front obtained by a simulation for tsunami reproduction has the angles shown in the figure below.

In the simulation, wave forms and the arrival timing cannot be precisely reproduced, but the direction of the simulated wave-front can be considered to be close to the real one, because the wave-front is controlled by the seabed topography.
