Progress with the Unit 3 Reactor Building Internal Investigation

May 30, 2024

TEPCO

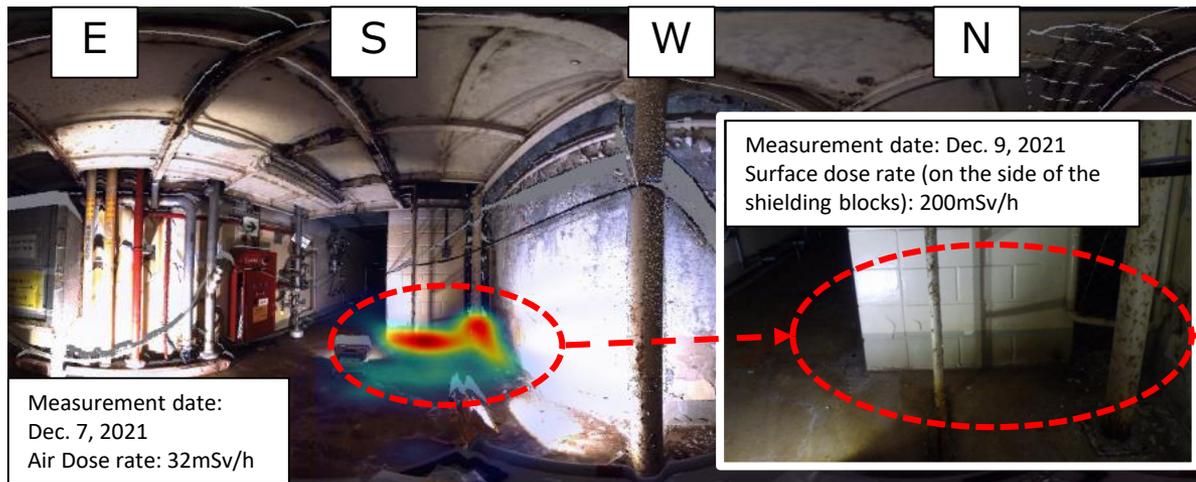
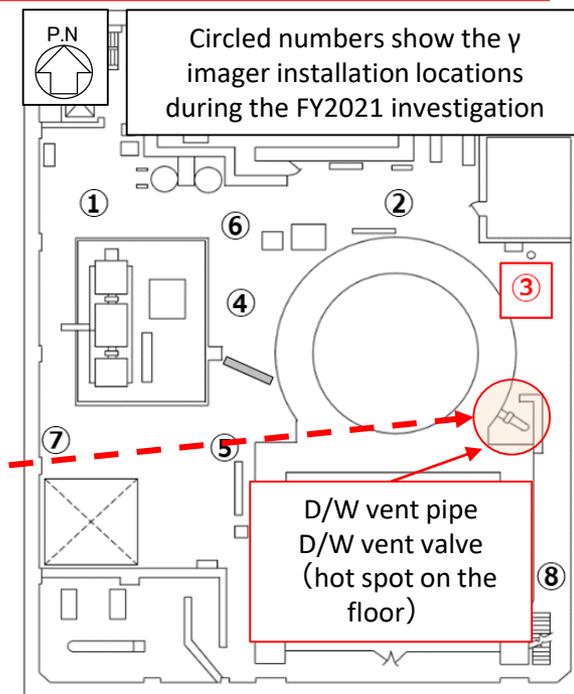
Result of γ imager measurements for location ③ on the 3rd floor of the Unit 1 R/B

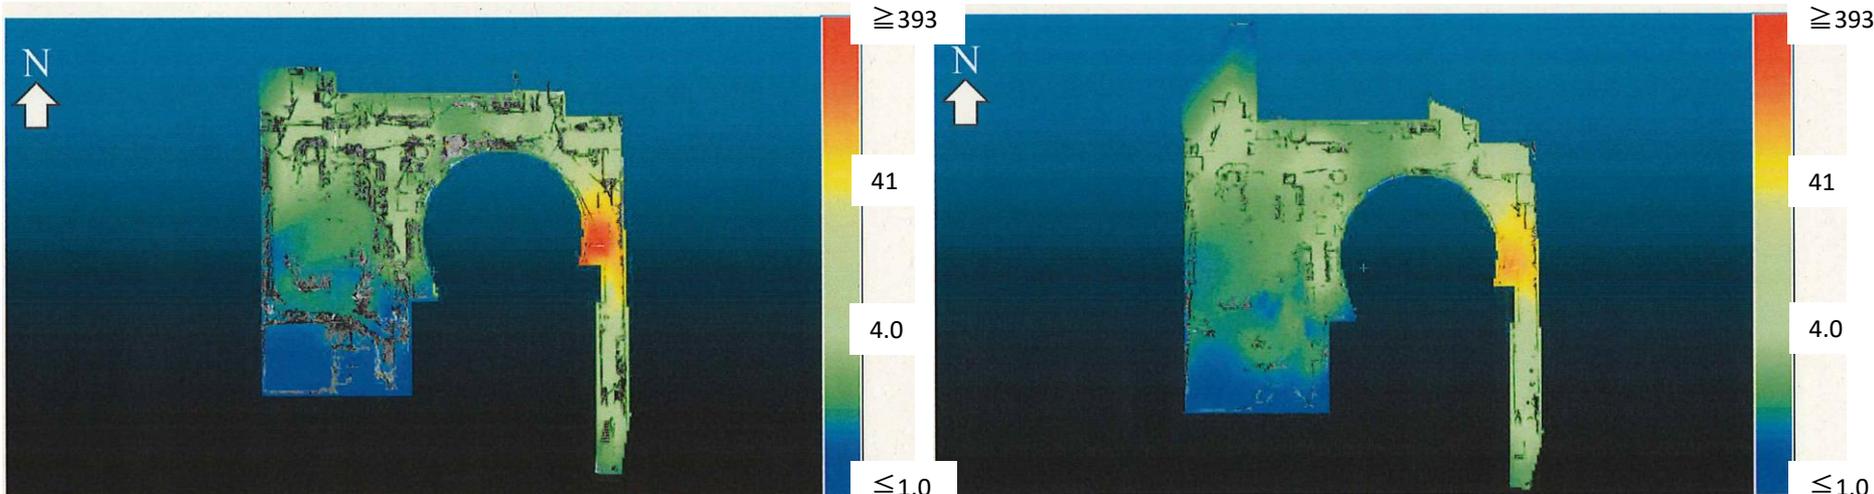
Unit 1 R/B 3rd floor: Dose redistribution 0.20m above the floor [mSv/h]

Unit 1 R/B 3rd floor: Dose rate distribution 1.5m above the floor [mSv/h] 8
