- On February 3, 2025, a contractor worker discovered a fire breaking out in the dust collection equipment in the periodic inspection equipment storage warehouse B (site of horizontal tank dismantling), and the fire breaking was declared a “fire” by the Futaba Fire Department. (*Since the horizontal tank being dismantled was unused so there is no contamination, there are no injuries.)

Incident overview I

[Reference] Assumed mechanism of duct scorching (primary incident) **TEPCO**

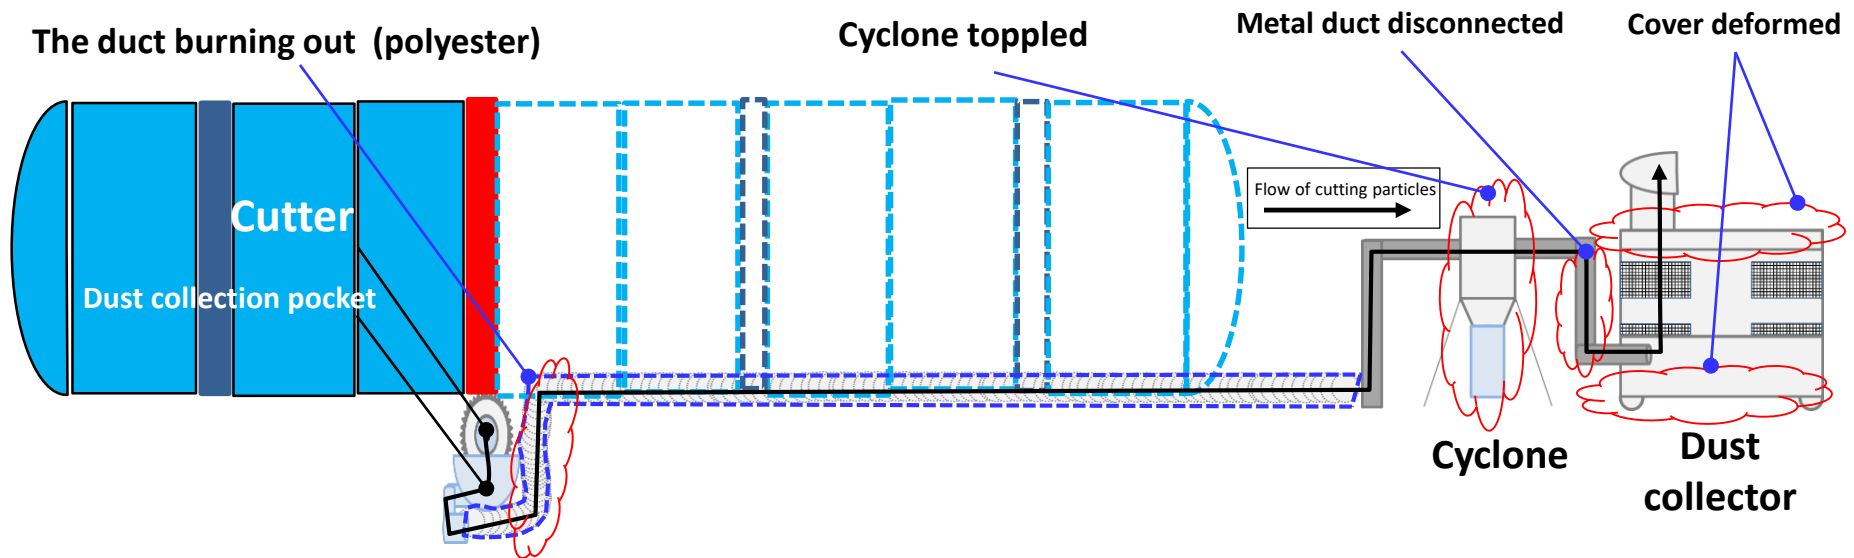
- Hot cutting scraps are generated when the cutter is used to cut the horizontal tank, so a cyclone trap the large particles and the filter inside the dust collector trap the fine particles, while also cooling by the intake air of the dust collector, etc.
- Around 2:00 PM on February 3, 2025, a fire broke out during cutting of the horizontal tank (unused) and the polyester duct connected to the dust collection pocket and cyclone was fire damage.
- The cover of dust collector deformed and the cyclone toppled. The metal duct also became disconnected.

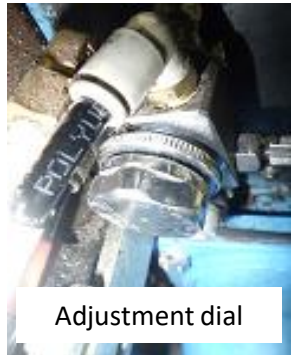
【Around the area of the tank being cut】

The cutting oil adjustment dial was unintentionally changed dulling preparation work on the day (①) causing many clumps of scraps of metals were generated and accumulated inside the dust collection pocket and duct (②). Decreased the airflow and cooling function of the duct and dust collection pockets caused high temperature scraps of metals to not cool sufficiently leading to become a fire source and burning out of the duct (③).
