Fukushima Daiichi Nuclear Power Station  
Investigation Results for the inside of the Unit 3 Personal Access Lock  
and Past Investigation Results for each penetration

November 30, 2025

Tokyo Electric Power Company Holdings, Inc.

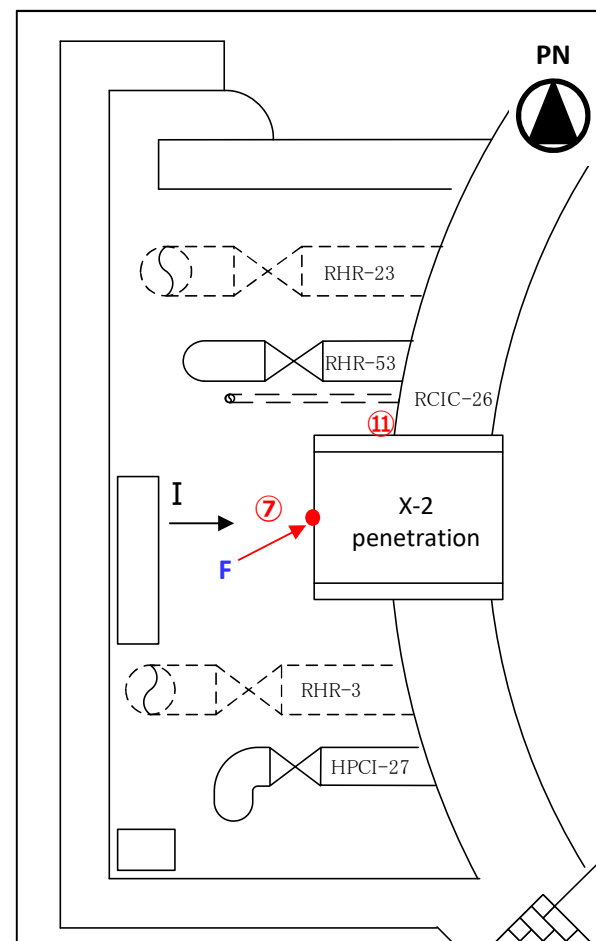
**Arrow I** (Front of X-2 penetration (Near No.⑦) )

- No adhesion of molten material was found on the surface of the X-2 penetration flange like that found in the front chamber of the Unit 2 X-6 penetration, and no signs of leakage or deformations were confirmed.

Approx. 0.5m from the X-2 penetration

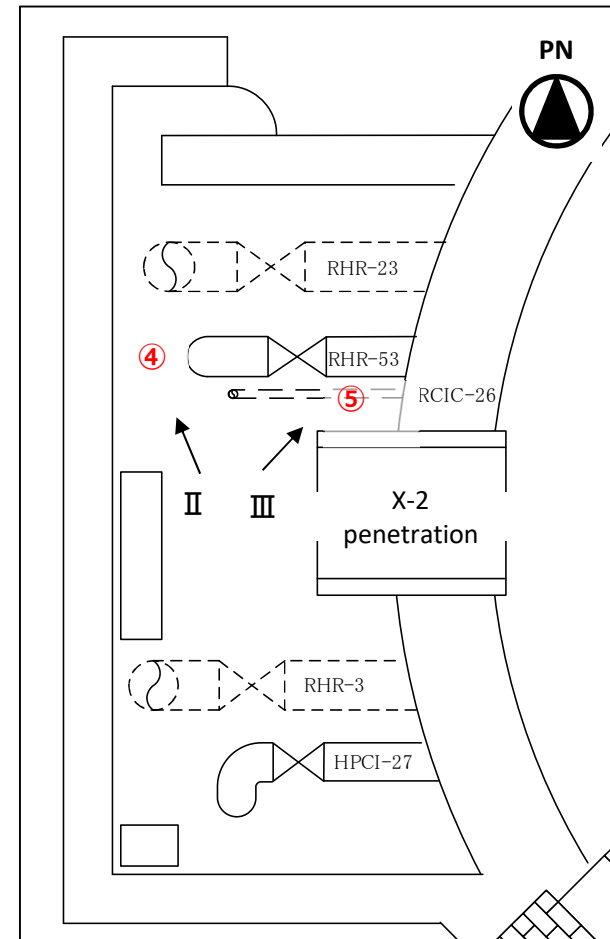
- Some corrosion was found inside the P/A room, but no deformities were confirmed.

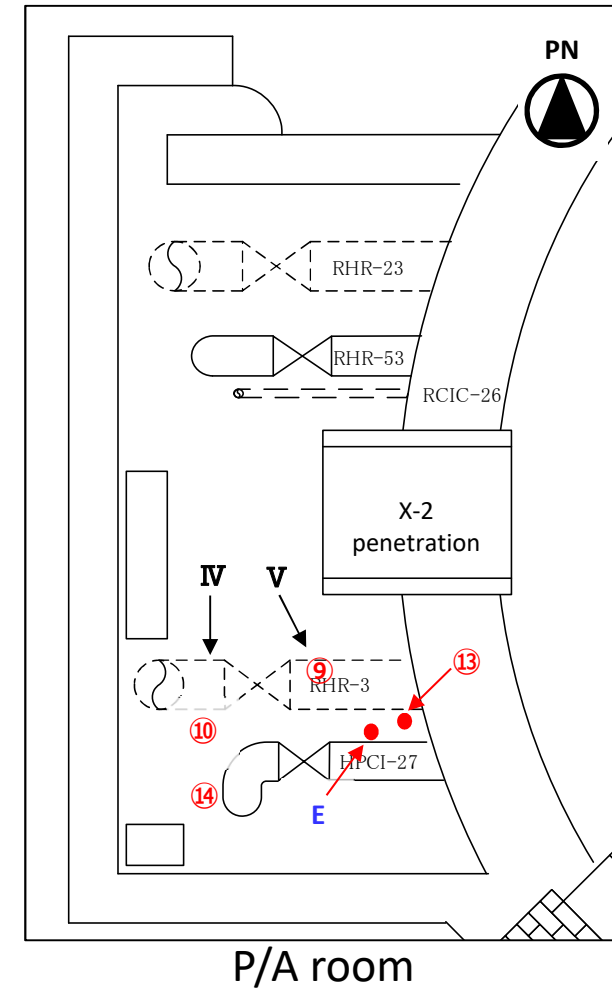
**Arrow V** (Near No.⑨)

- A strong hotspot of max 1,120mSv/h was confirmed near the floor on the south side of the X-2 penetration.

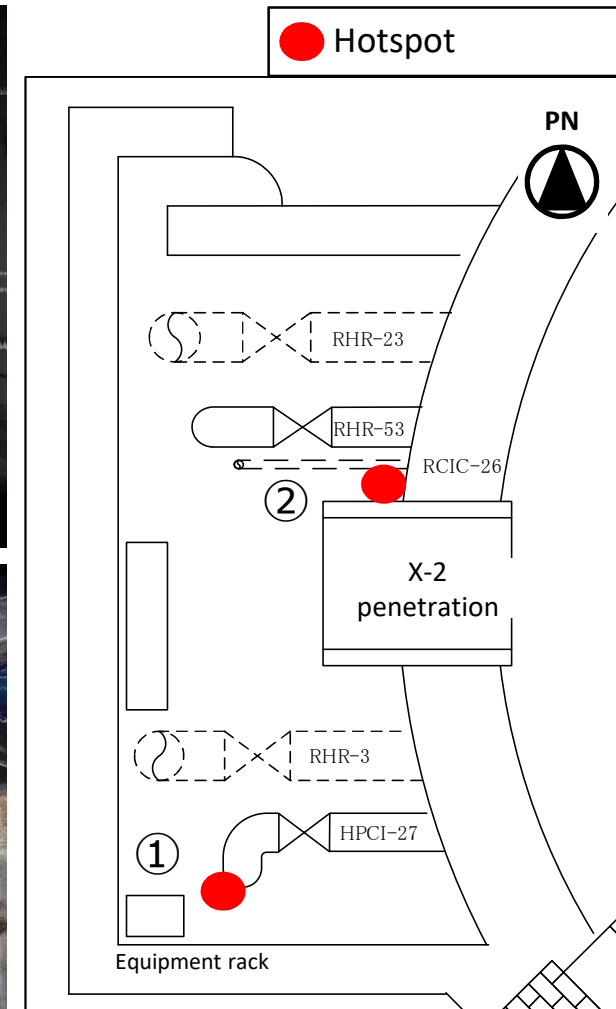
- Dose measurement results show hot spots to exist in the same locations where high doses were measured.
- Hotspots were mainly found on the floor.

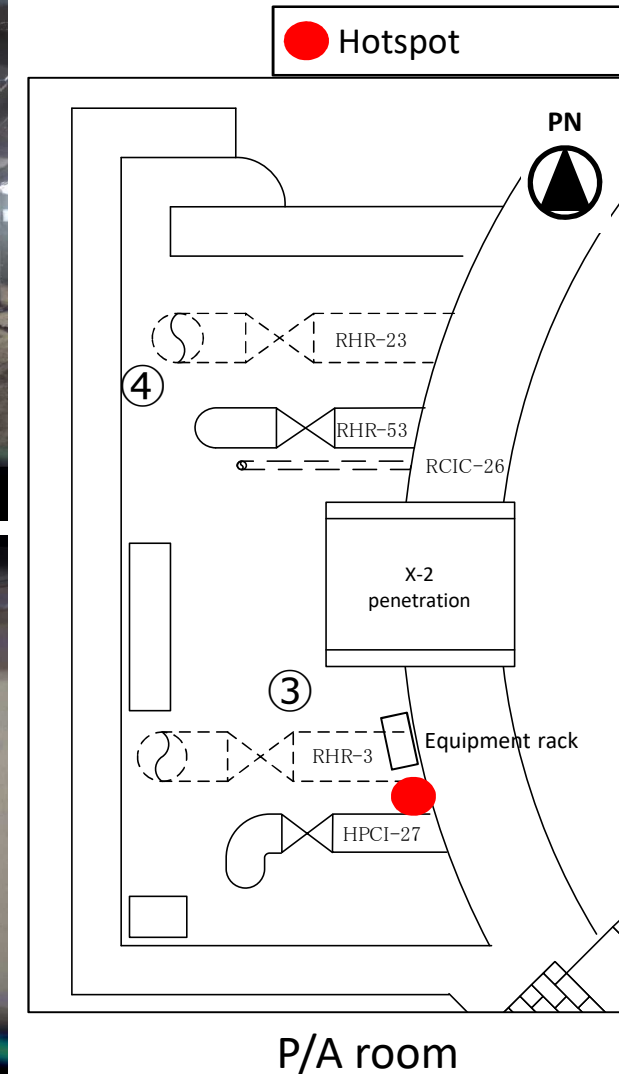
- Dose measurement results show hotspots to exist in the same locations where high doses were measured.
- G/I measurement ④ hotspot is assumed to contribute greatly to the doses from the back of the P/A room.

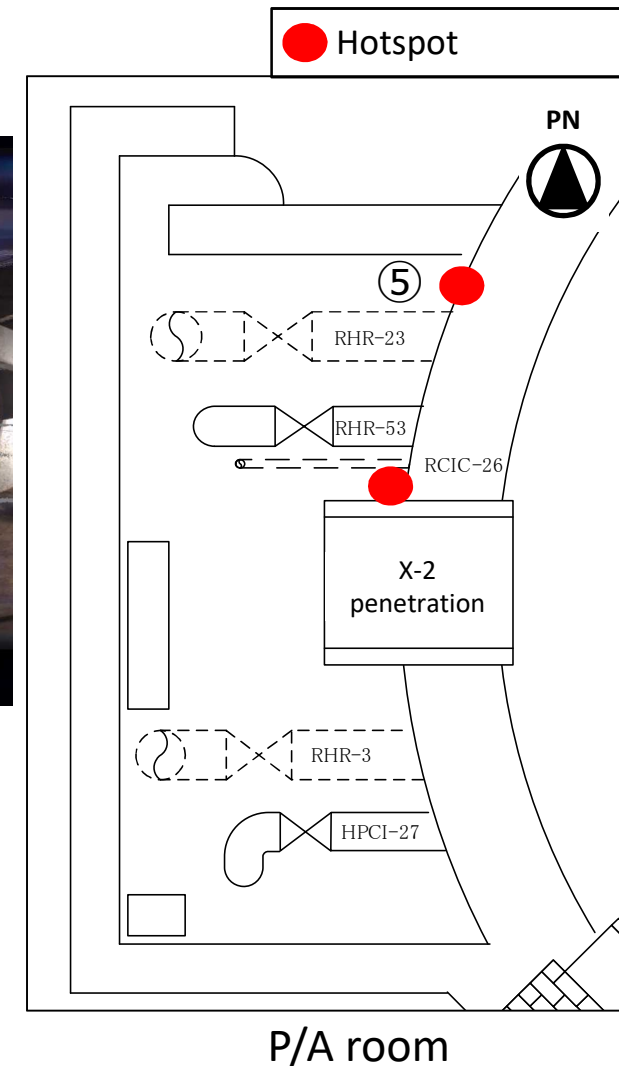
- G/I measurement ⑤ hotspot was found in the direction of the upper penetration (X-13A) and the RHR-53 piping.
- The hotspot in the direction of the RHR-53 piping is assumed to be a contribution from the hotspot found on the north side of the X-2 penetration behind the piping.

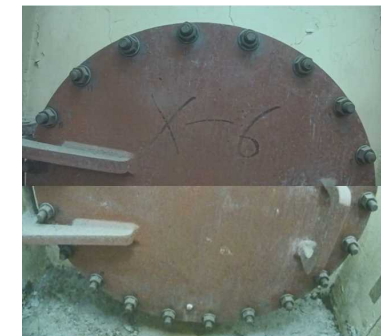
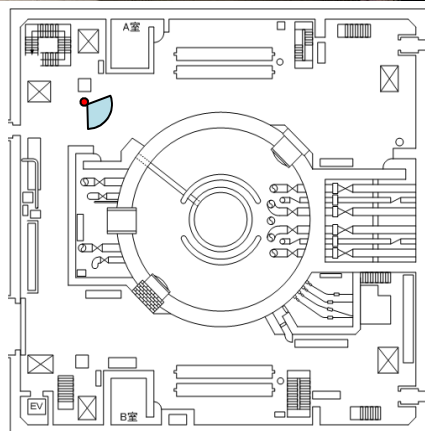
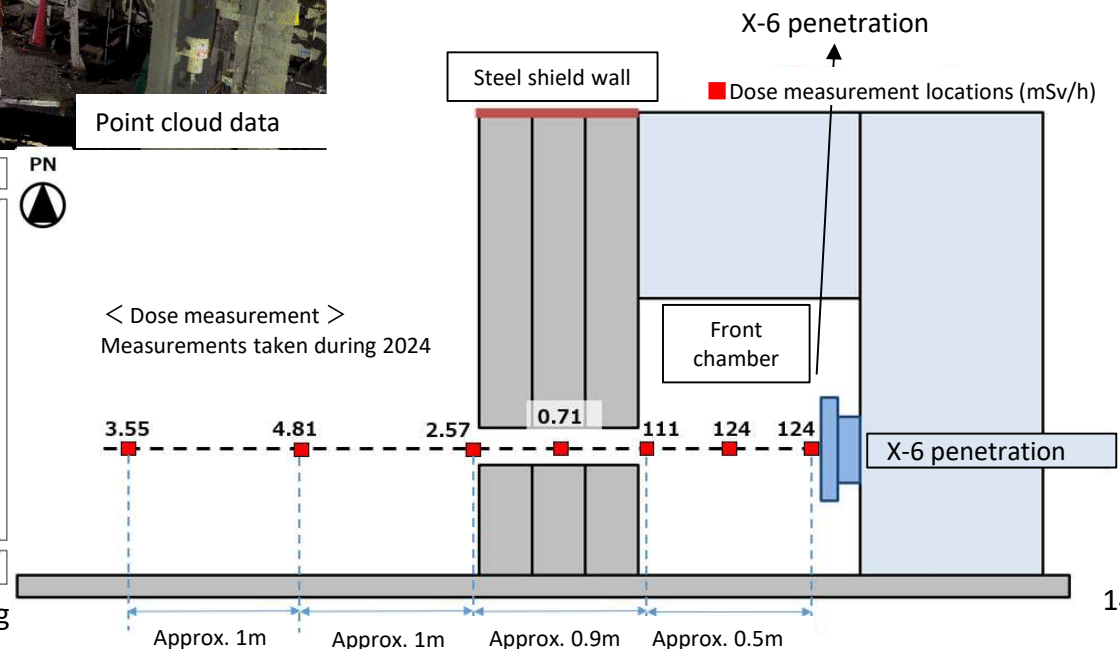
- 124mSv/h was measured near the surface of the Unit 3 X-6 penetration flange, but surface dose is low compared to the investigation results from the Unit 2 X-6 penetration flange surface taken in 2015. Furthermore, molten deposits found on the floor of Unit 2 were not found in Unit 3.
- Steel (concrete block filled) shielding walls have been installed around the X-6 penetration front chamber. Dose investigations and dose reduction measures inside the penetration will be deliberated after removing the shield walls.

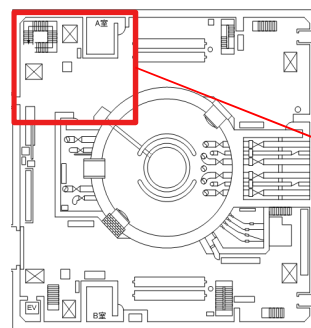
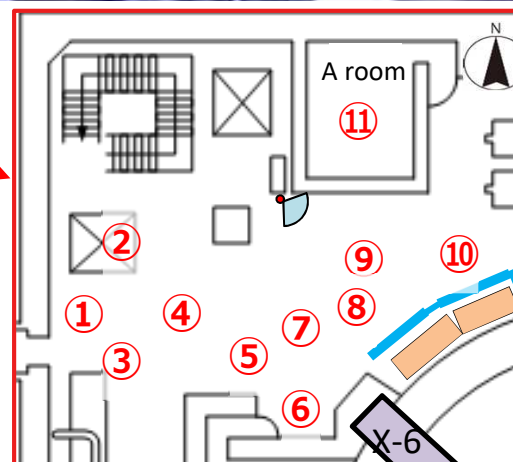
- The HCU (north side) is greatly affected by doses from the jet pump instrument rack, and it is not clear whether there are any other radiation sources.
- The HCU and jet pump instrument rack, which are the main radiation sources, have been shielded, and the air dose rate around the X-6 penetration is between 3~5mSv/h, thereby prohibiting workers from remaining in the area for a long period of time.

- Dose reduction measures for the jet pump instrument rack closest to the X-6 penetration are being deliberated.
- Due to the difficulty of work implementation, it is expected that much time will be needed to reduce doses in the HCU.

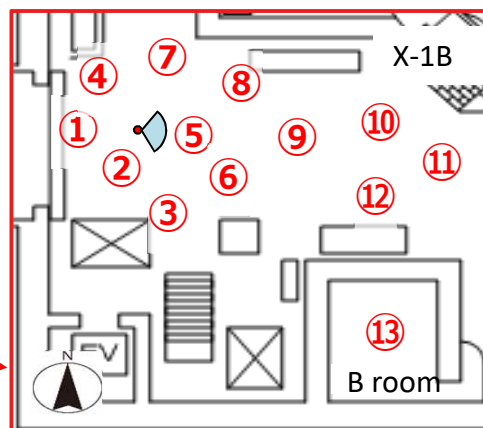
- The dose contributions from the HCU (south side) and parts of the floor are substantial, and it is not clear whether there are any other radiation sources.
- The HCU, which is the main radiation sources, has been shielded, and the air dose rate around the X-1B penetration is between 5~8mSv/h, thereby prohibiting workers from remaining in the area for a long period of time.

- Since floor surface contamination is concentrated around the places where existing panels are installed and the edges of the walls, we are deliberating the removal of the existing panels.
- Due to the difficulty of work implementation, it is expected that much time will be needed to reduce doses in the HCU.

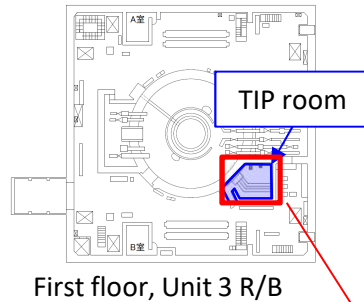
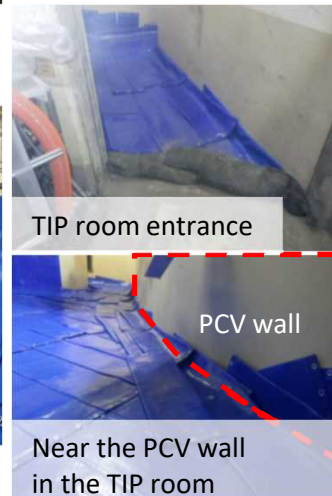
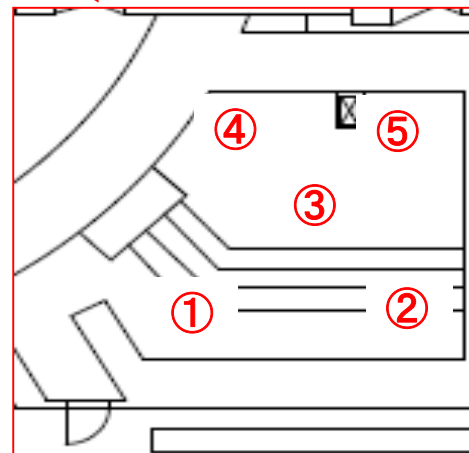
- ① Equipment and sludge removal
- ② Wall decontamination through water spraying
- ③ Pressure wash stripping decontamination of floor surfaces
- ④ Decontamination through mechanical stripping (floor surfaces)
- ⑤ Shield installation

⇒ Average dose of 1.2mSv/h has been achieved

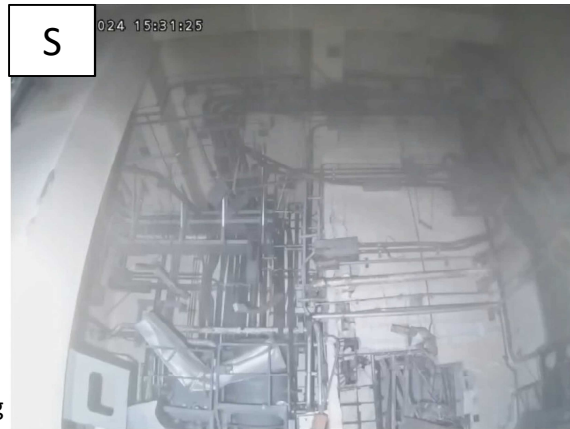
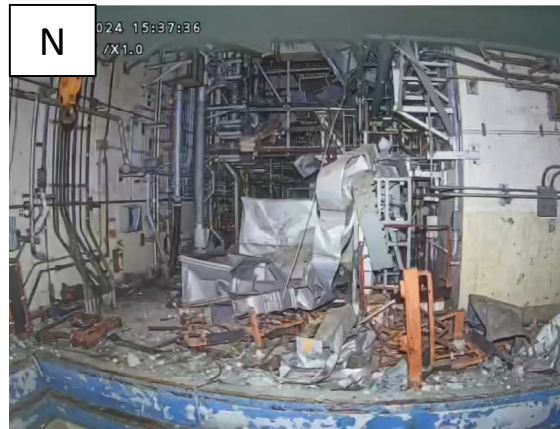
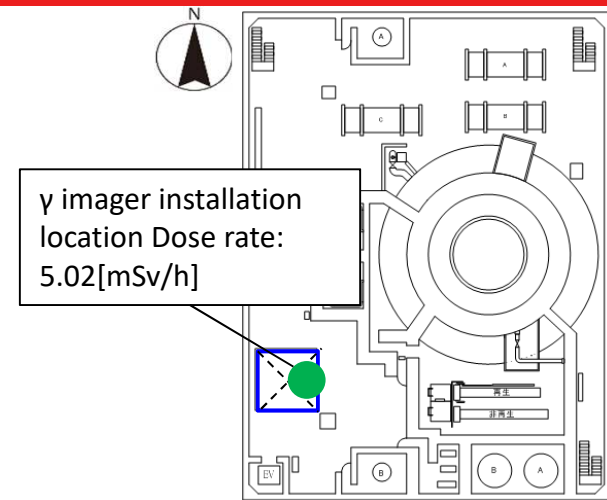
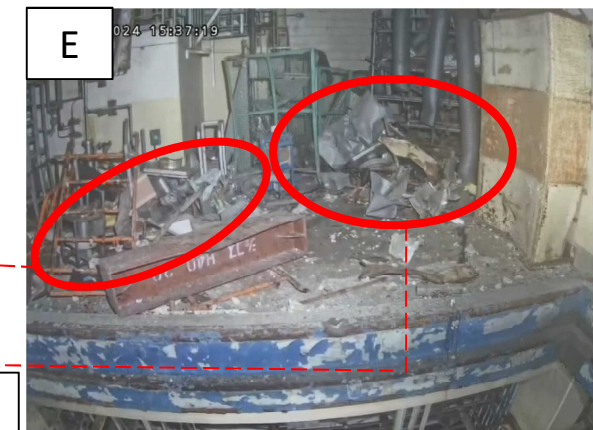
- $\gamma$  ray distribution by  $\gamma$  imager measurement.
- On the 2nd floor, it was confirmed that the hot spot was around the rubble near the floor.

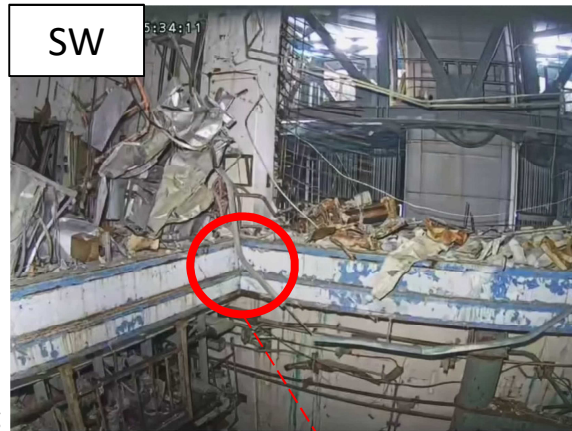
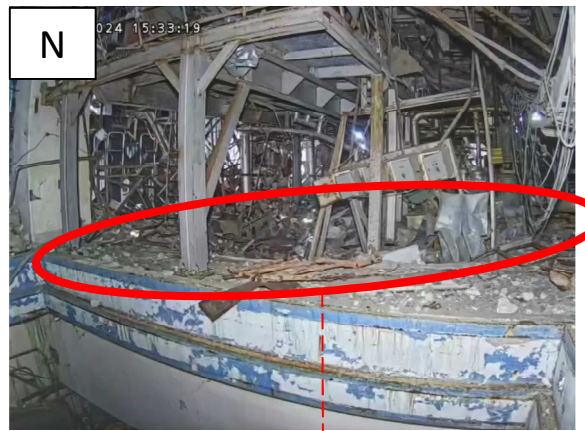
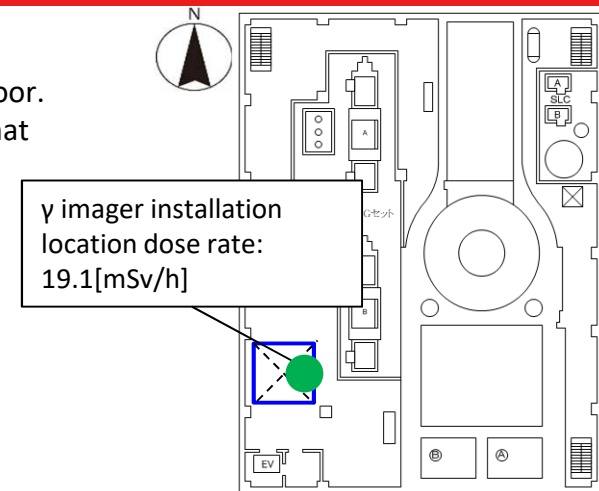
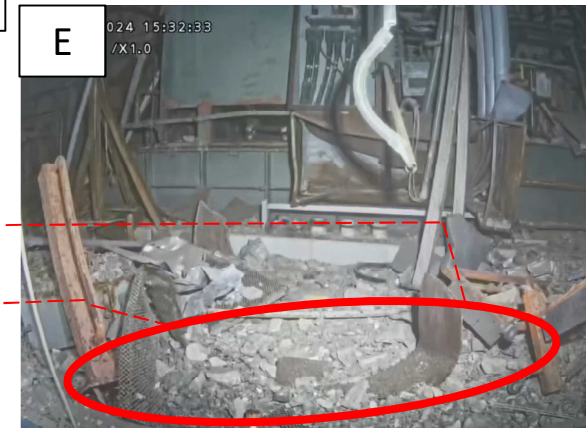
Unit 3 R/B 4th floor

- Gamma ray distribution by gamma imager measurement
- On the 4th floor, it was confirmed that the hot spot was around the rubble near the floor.
- Since the intensity of the hot spot on the 3rd floor are relatively weak, it is assumed that dose rates on the 4th floor are higher
