Investigation Results inside the Unit 3's PCV at Fukushima Daiichi Nuclear Power Station (Prompt report as of October 22) Tokyo Electric Power Company

Investigation Results by the Pan-tilt Camera of Sampling Device

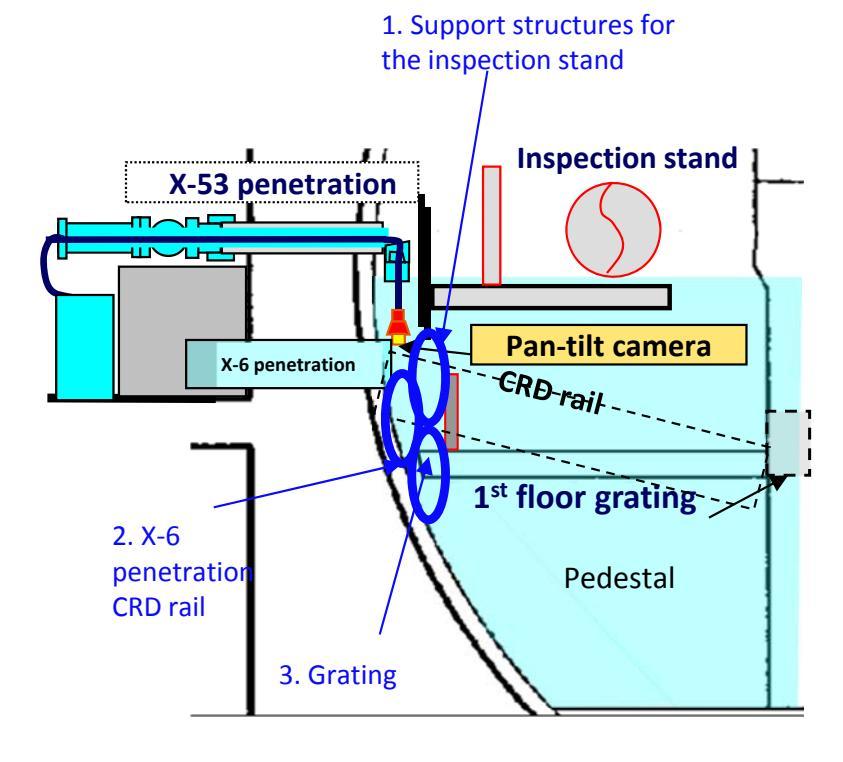
1. Support structures for the inspection stand

- No damage of the structures inside the PCV (electricity wire pipe, support structures, X-6 penetration, CRD rail) and the PCV's inner wall was found within the investigation range.
- Sediments were found on the CRD rail and 1st floor grating.
