Progress of Landside Impermeable Wall freezing: Phase 2 of the first stage

December 22, 2016

Tokyo Electric Power Company Holdings, Inc.

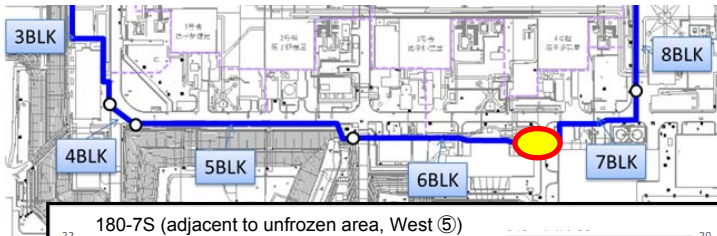
(Freezing began on December 3 West⑤)

- 【180-7S】: Auxiliary construction is under way. Soil temperatures are decreasing relatively steadily.
- 【170-7S】: Auxiliary construction is under way. Soil temperatures are decreasing relatively steadily.
- 【160-7S】: Auxiliary construction is under way. Soil temperature decrease is being monitored.
- 【150-7S】: Auxiliary construction is yet to be applied. Soil temperatures are decreasing relatively steadily.

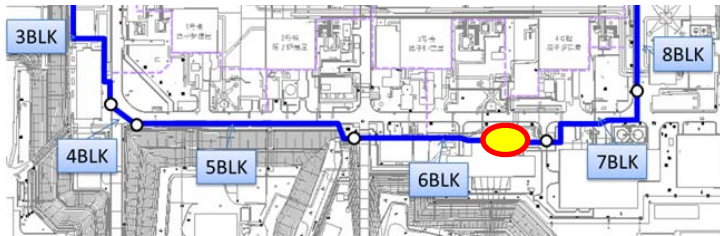
3-5 Auxiliary construction to further freezing the mountainside, soil temperature decrease (6BLK)

【10-6S】: Soil temperatures went below 0 °C.

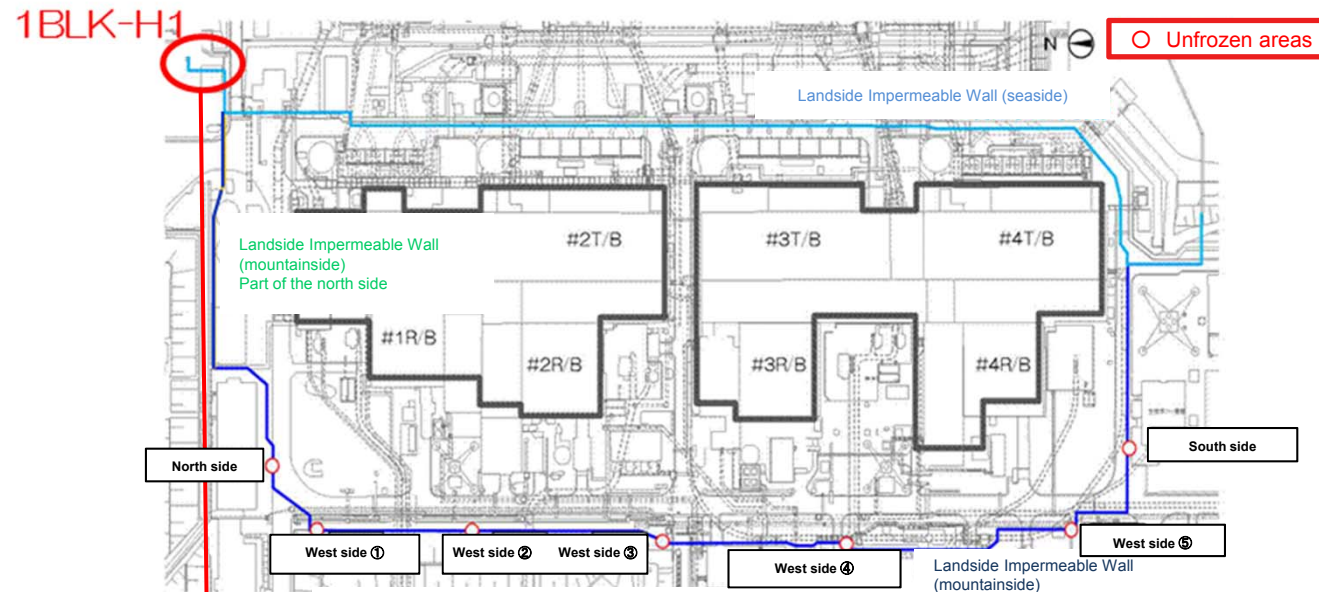
5-1 Coolant leakage at 1BLK (1)

Map of Fukushima Daiichi Nuclear Power Station
Location of the leak

On December 19, 2016, a coolant leak was found around 1BLK-H1, one of the coolant header return pipes for the landside impermeable wall.

- Source of the leakage will be identified by removing insulators surrounding the pipe.
⇒ On Tuesday, December 20, source of the leakage was found at one of the header pipe joints.
- Repair will be carried out after removing coolant from the header pipe, dismantling the joint, and identifying the cause of the leak.

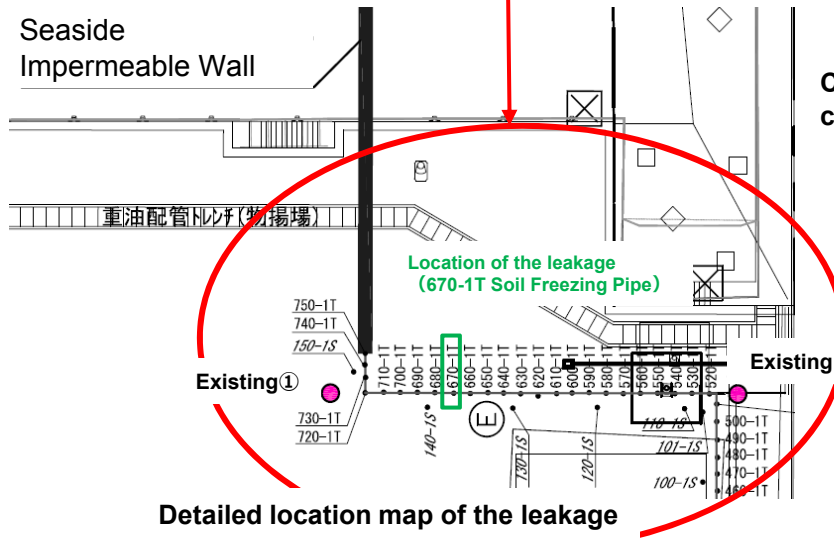
Detailed location map of the leakage

(Current situation)
Coolant supply has been suspended for 28 soil freezing pipes
connected to the header pipe.
(The supply continues for the other soil freezing pipes.)
