Progress Status and Future Challenges of Mid-and-long-Term Roadmap toward the Decommissioning of Units 1-4 of the TEPCO's Fukushima Daiichi Nuclear Power Station (Outline)

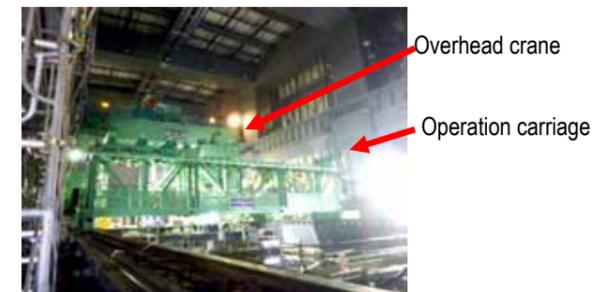
Figure 5: Installation status of fuel removal cover of Unit 4

- The cover installation for fuel removal is ongoing (to be completed around October). Work on lifting the overhead crane (June 7-14), lifting the Fuel Handling Machine (July 10-13), and installing the outside walls of the fuel removal covers and exterior roof panels (April 1 - July 20) was completed. At present, assembly and installation work is ongoing (see Figure 5).
- Toward debris removal inside the spent fuel pool, which will be conducted before removing spent fuel, an investigation was conducted regarding the inside of RPV and the spent fuel pool (August 5-9). Reflecting the results of this investigation, the final step such as debris removal inside the pool is being conducted toward the start of fuel removal in November (from August 27).

Inside the cover for fuel removal

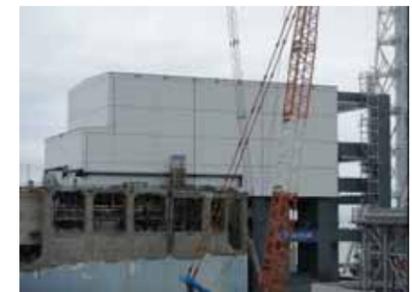
Cover for fuel removal
