Main decommissioning works and steps

All fuel had been removed from Unit 4 SFP by December 22, 2014. Work continues toward fuel removal and debris (Note 1) retrieval from Unit 1-3.

Summary of TEPCO data as of February 27, 2019

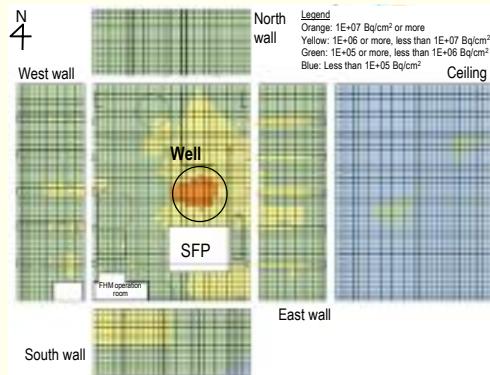
From the analysis, based on the investigative results, the "contamination density distribution" of the entire operating floor was obtained, based on which the airborne radiation dose rate inside the operating floor could be evaluated.

Contamination density distribution obtained in this investigation

Toward fuel removal, shielding design, measures to prevent radioactive material scattering, etc. will be examined using the "contamination density distribution."
