Main decommissioning work and steps

Fuel removal from the spent fuel pool was completed in December 2014 at Unit 4 and started from April 15, 2019 at Unit 3. Dust concentration in the surrounding environment is being monitored and work is being implemented with safety first. Work continues sequentially toward the start of fuel removal from Units 1 and 2 and debris (Note 1) retrieval from Units 1-3.

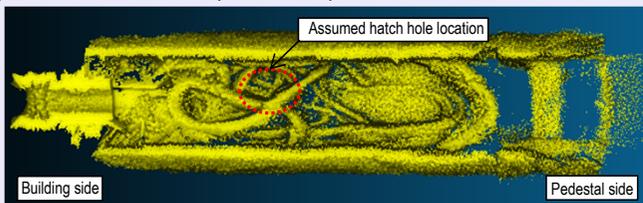
As a preparatory stage for the PCV internal investigation and the trial retrieval, a 3D scan investigation inside the penetration (X-6 penetration) was conducted on October 30, whereby information about the deposit distribution and others was obtained.

<3D scan image of deposit seen from above the X-6 penetration>

Alongside the results of the deposit contact investigation on October 28 and using information on deposit distribution obtained in this investigation, procedures to remove deposits in the penetration will be examined.

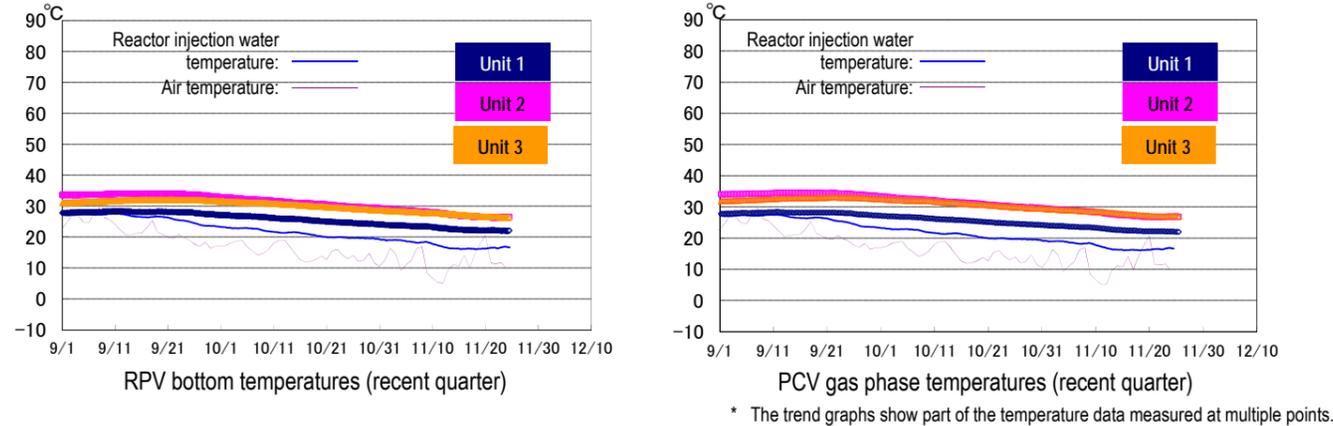
Through continuous reactor cooling by water injection, the temperatures of the Reactor Pressure Vessel (RPV) bottom and the Primary Containment Vessel (PCV) gas phase were maintained within the range of approx. 20 to 30°C for the past month, though it varied depending on the unit and location of the thermometer.

◆ The temperatures of the Reactor Pressure Vessel (RPV) and Primary Containment Vessel (PCV) of Units 1-3 have been maintained within the range of approx. 20-30°C¹ over the past month. There was no significant change in the concentration of radioactive materials newly released from Reactor Buildings into the air². It was concluded that the comprehensive cold shutdown condition had been maintained.

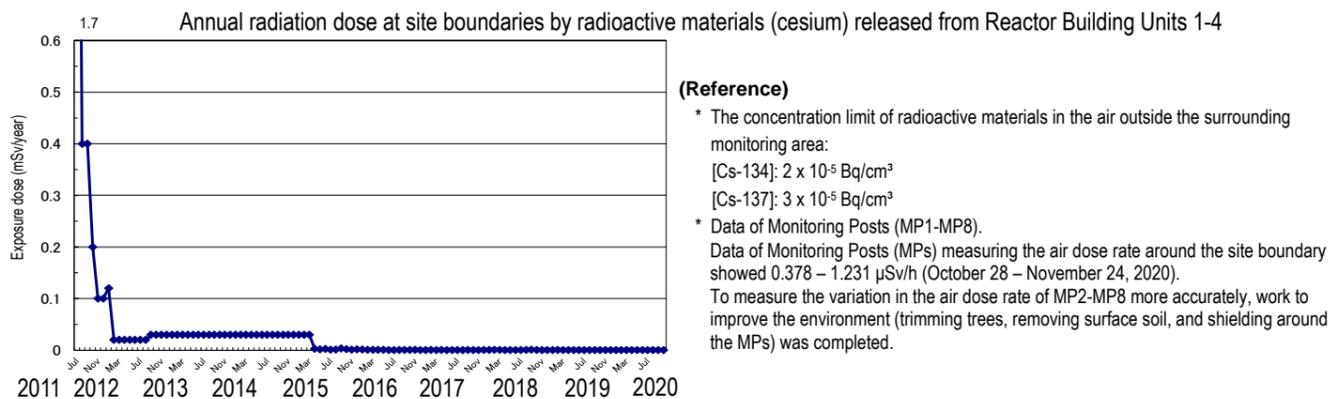
As of October 2020, the concentration of the radioactive materials newly released from Reactor Building Units 1-4 into the air and measured at the site boundary was evaluated at approx. 3.4×10^{-12} Bq/cm³ and 2.9×10^{-12} Bq/cm³ for Cs-134 and Cs-137 respectively, while the radiation exposure dose due to the release of radioactive materials there was less than 0.00007 mSv/year.

Note 1: Different formulas and coefficients were used to evaluate the radiation dose in the facility operation plan and monthly report. The evaluation methods were integrated in September 2012. As the fuel removal from the spent fuel pool (SFP) commenced for Unit 4, the radiation exposure dose from Unit 4 was added to the items subject to evaluation since November 2013. The evaluation has been changed to a method considering the values of continuous dust monitors since FY2015, with data to be evaluated monthly and announced the following month.

Note 2: Radiation dose was calculated using the evaluation values of release amount from Units 1-4 and Units 5 and 6. The radiation dose of Unit 5 and 6 was evaluated based on expected release amount during operation until September 2019 but the evaluation method was reviewed and changed to calculate based on the actual measurement results of Units 5 and 6 from October.

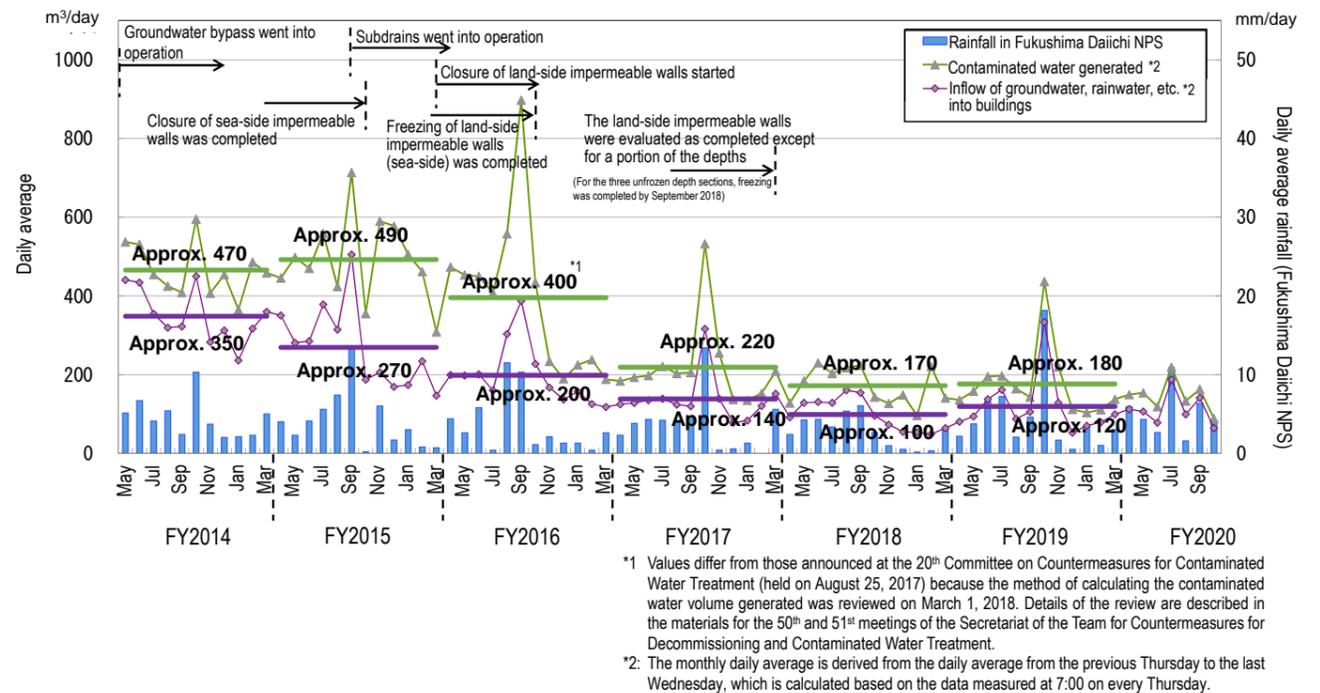
Figure 1: Changes in contaminated water generated and inflow of groundwater, rainwater, into buildings

- Multi-layered measures, including pumping up by subdrains and land-side impermeable walls, which were implemented to control the continued generation of contaminated water, suppressed the groundwater inflow into buildings.
- After "redirecting" measures (groundwater bypass, subdrains, land-side impermeable walls and others) were steadily implemented, the amount generated declined from approx. 470 m³/day (the FY2014 average) when the measures were first launched to approx. 180 m³/day (the FY2019 average).
- Measures will continue to further reduce the volume of contaminated water generated.

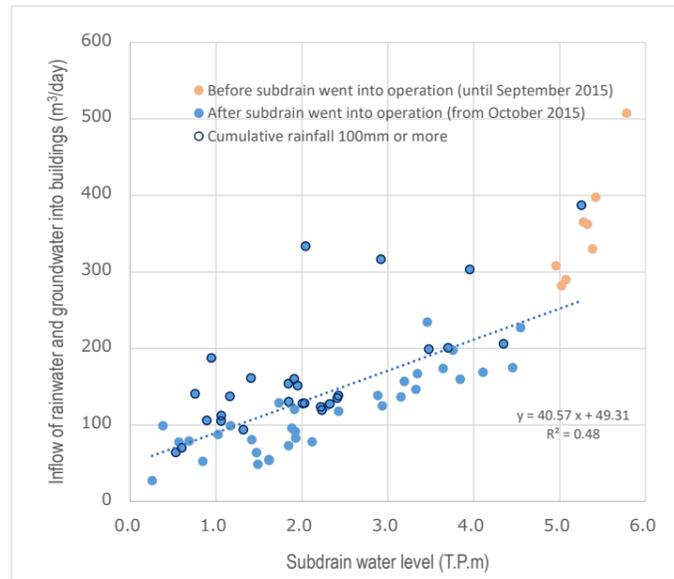
Figure 2: Correlation between inflow such as groundwater and rainwater into buildings and the water level of Units 1-4 subdrains

- To maintain the groundwater level, work to install additional subdrain pits and recover those existing is underway. The additional pits are scheduled to start operation sequentially, from pits for which work is completed (12 of 14 new subdrain pits went into operation). To recover existing pits, work for all three pits scheduled was completed and all went into operation from December 26, 2018. Work to recover another pit (No. 49) started from November 2019 and it went into operation from October 9, 2020.
- To eliminate the need to suspend water pumping while cleaning the subdrain transfer pipe, the pipe will be duplicated. Installation of the pipe and ancillary facilities was completed.
- Since the subdrains went into operation, the inflow to buildings tended to decline to under 150 m³/day when the subdrain water level declined below T.P. 3.0 m but increased during rainfall.

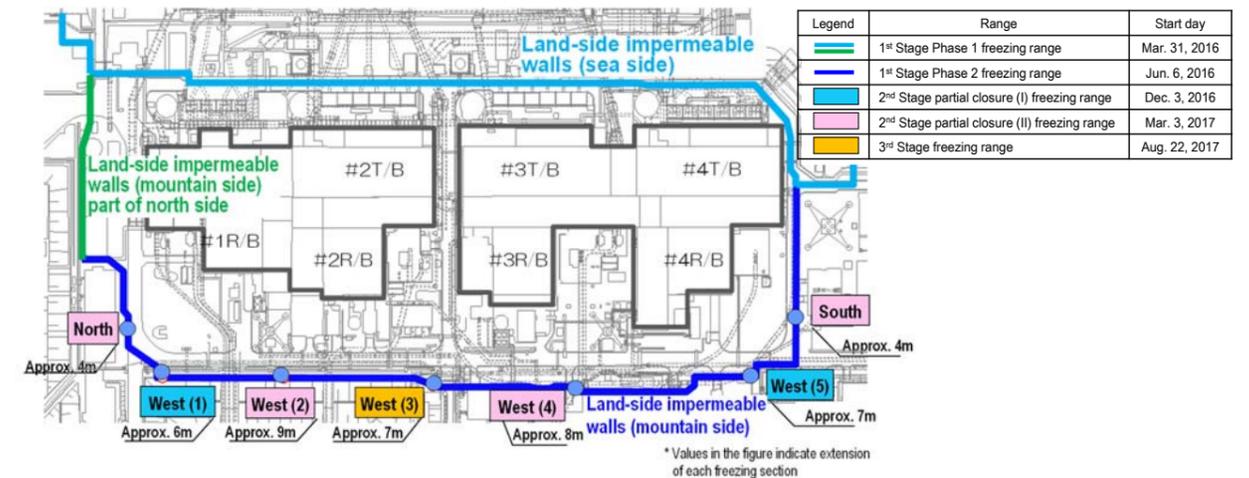
Figure 3: Closure parts of the land-side impermeable walls (on the mountain side)

- In March 2018, construction of the land-side impermeable walls was completed, except for a portion of the depth, based on a monitoring result showing that the underground temperature had declined below 0°C in almost all areas, while on the mountain side, the difference in internal and external water levels increased to approx. 4-5 m. The 21st Committee on Countermeasures for Contaminated-Water Treatment, held on March 7, 2018, evaluated that alongside the function of subdrains and other measures, a water-level management system to stably control groundwater and redirect groundwater from the buildings had been established and allowed the amount of contaminated water generated to be reduced significantly.

- A supplementary method was implemented for the unfrozen depth and it was confirmed that the temperature of this portion had declined below 0°C by September 2018. From February 2019, a maintenance operation started throughout all sections.
- The groundwater level in the area inside the land-side impermeable walls has been declining every year. On the mountain side, the difference between the inside and outside was maintained, despite varying during rainfall. The water level of the groundwater drain observation well has been maintained at approx. T.P.+1.5 m, sufficiently below the ground surface (T.P. 2.5 m).

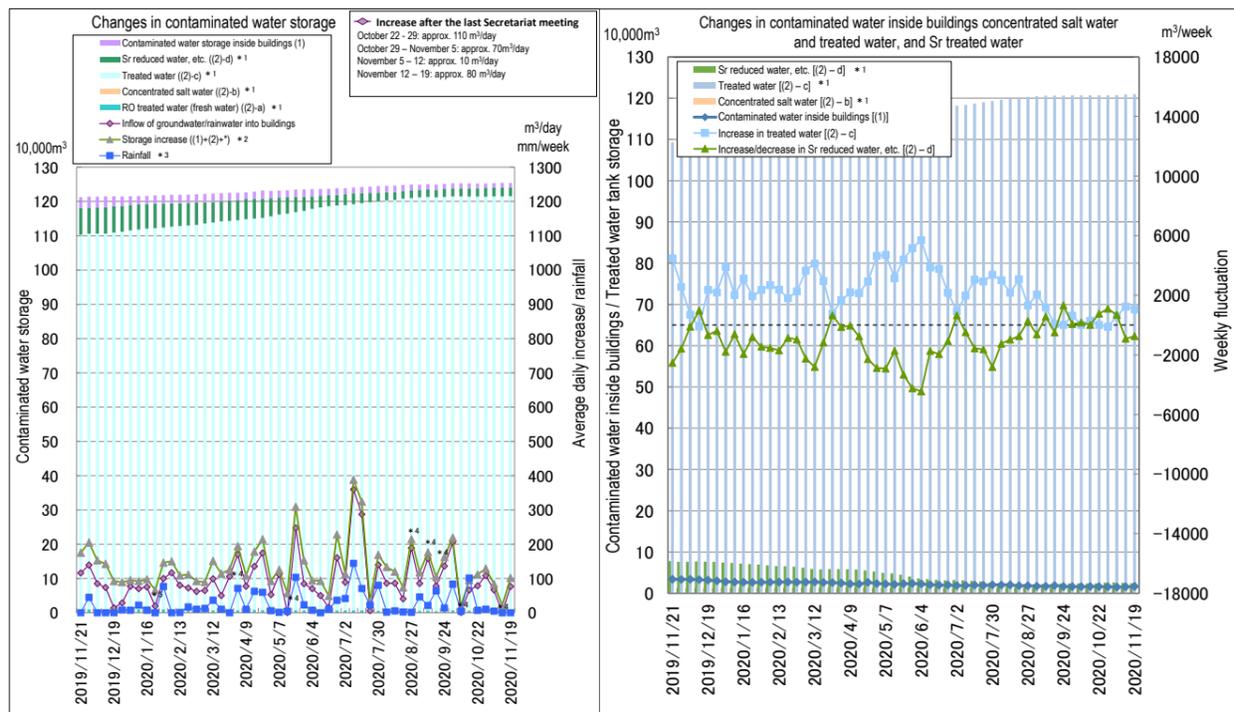
Figure 4: Status of contaminated water storage

*1: Water amount for which the water-level gauge indicates 0% or more
 *2: To detect storage increases more accurately, the calculation method was reviewed as follows from February 9, 2017: (The revised method was applied from March 1, 2018)
 [(Inflow of groundwater/rainwater into buildings) + (other transfer) + (chemical injection into ALPS)]
 *3: Changed from December 13, 2018 from rainfall in Namie to that within the site.
 *4: Considered attributable to the increased inflow of groundwater, rainwater, and others to buildings due to the decline in the level of contaminated water in buildings. (March 18, May 7-14, June 11-18, July 16-23, August 20-27, September 3-10 and 17-24, and October 1-8, 2020)
 *5: From the period January 16-23, 2019, amid a decline in the water level in Unit 4 R/B, system water in S/C flowing into R/B contaminated water is reflected in the inflow of groundwater and rainwater in addition to the transferred amount generated in decommissioning work.

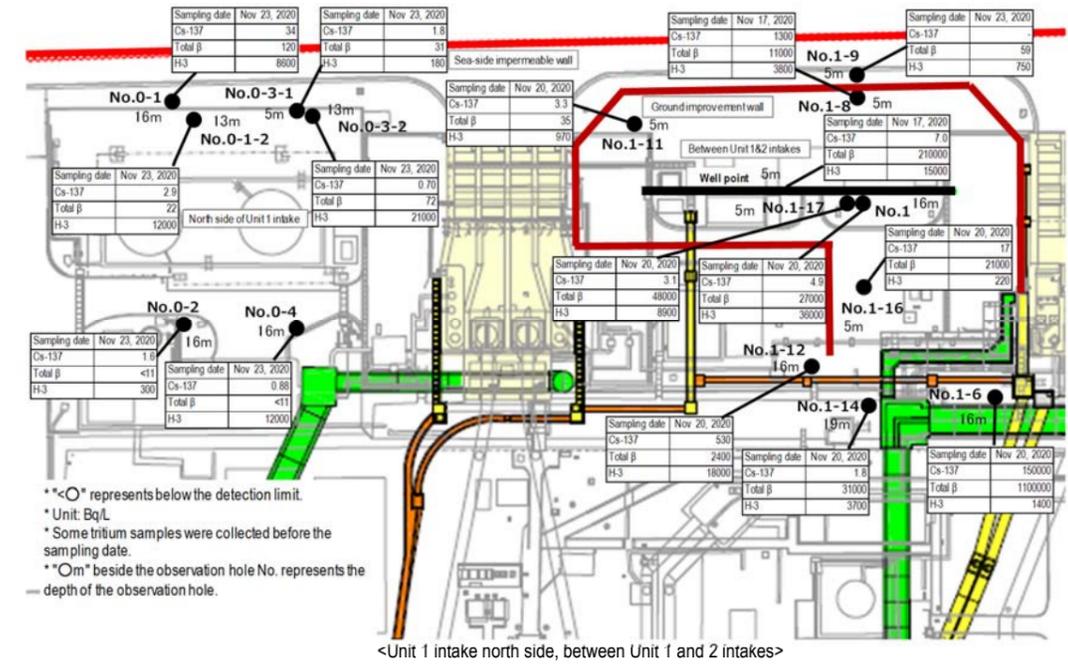
Figure 5: Groundwater concentration on the Turbine Building east side

- In the area between the Unit 1 and 2 intakes, the H-3 concentration has remained below the legal discharge limit of 60,000 Bq/L at all observation holes. It increased temporarily at No. 1-14 but remained constant or been declining at many observation holes overall. The concentration of total β radioactive materials has remained constant or been declining at many observation holes overall except for No.1-6, at which an increase has been observed.

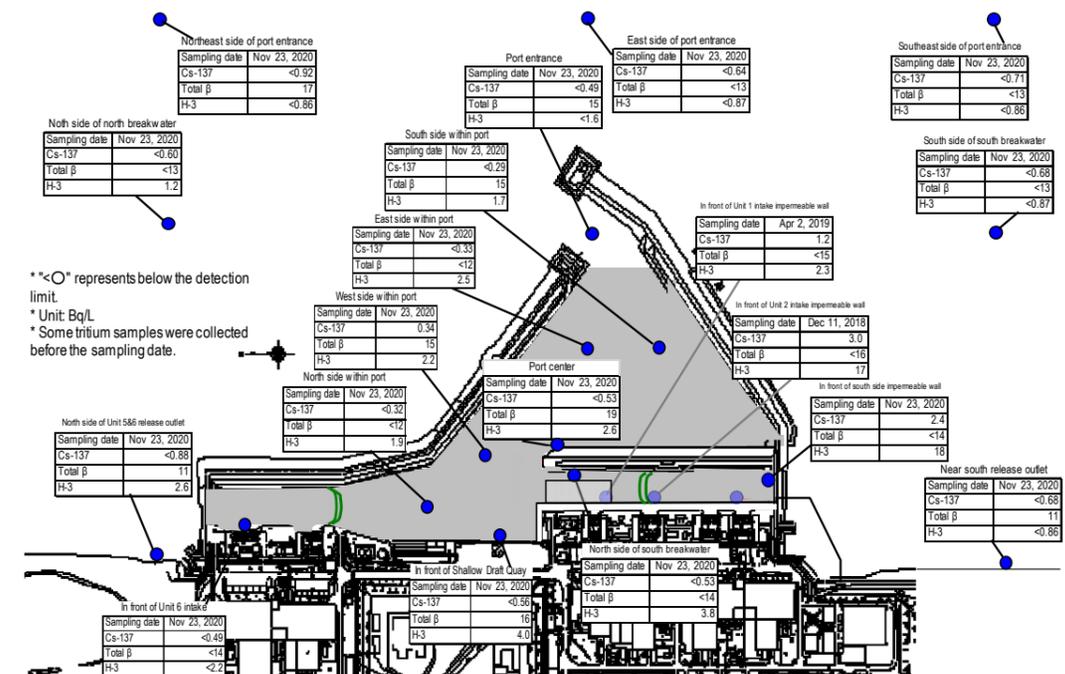
Figure 6: Seawater concentration around the port

- The concentration of radioactive materials in drainage channels has remained constant, despite increasing during rainfall.
- In the Units 1-4 open channel area of seawater intake for Units 1 to 4, the concentration of radionuclides in seawater has remained below the legal discharge limit, despite increases in Cs-137 and Sr-90 noted during rainfall. They have also been declining following the completed installation and the connection of steel pipe sheet piles for the sea-side impermeable walls. The concentration of Cs-137 has remained slightly higher in front of the south side impermeable walls and slightly lower on the north side of the east breakwater since March 20, 2019, when the silt fence was transferred to the center of the open channel due to mega float-related construction.

- In the port area, the concentration of radionuclides in seawater has remained below the legal discharge limit, despite increases in Cs-137 and Sr-90 observed during rainfall. They have remained below the level of those in the Units 1-4 intake open channel area and been declining following the completed installation and connection of steel pipe sheet piles for the sea-side impermeable walls.

- In the area outside the port, regarding the concentration of radioactive materials in seawater, those of Cs-137 and Sr-90 declined and remained low after steel pipe sheet piles for the sea-side impermeable walls were installed and connected.

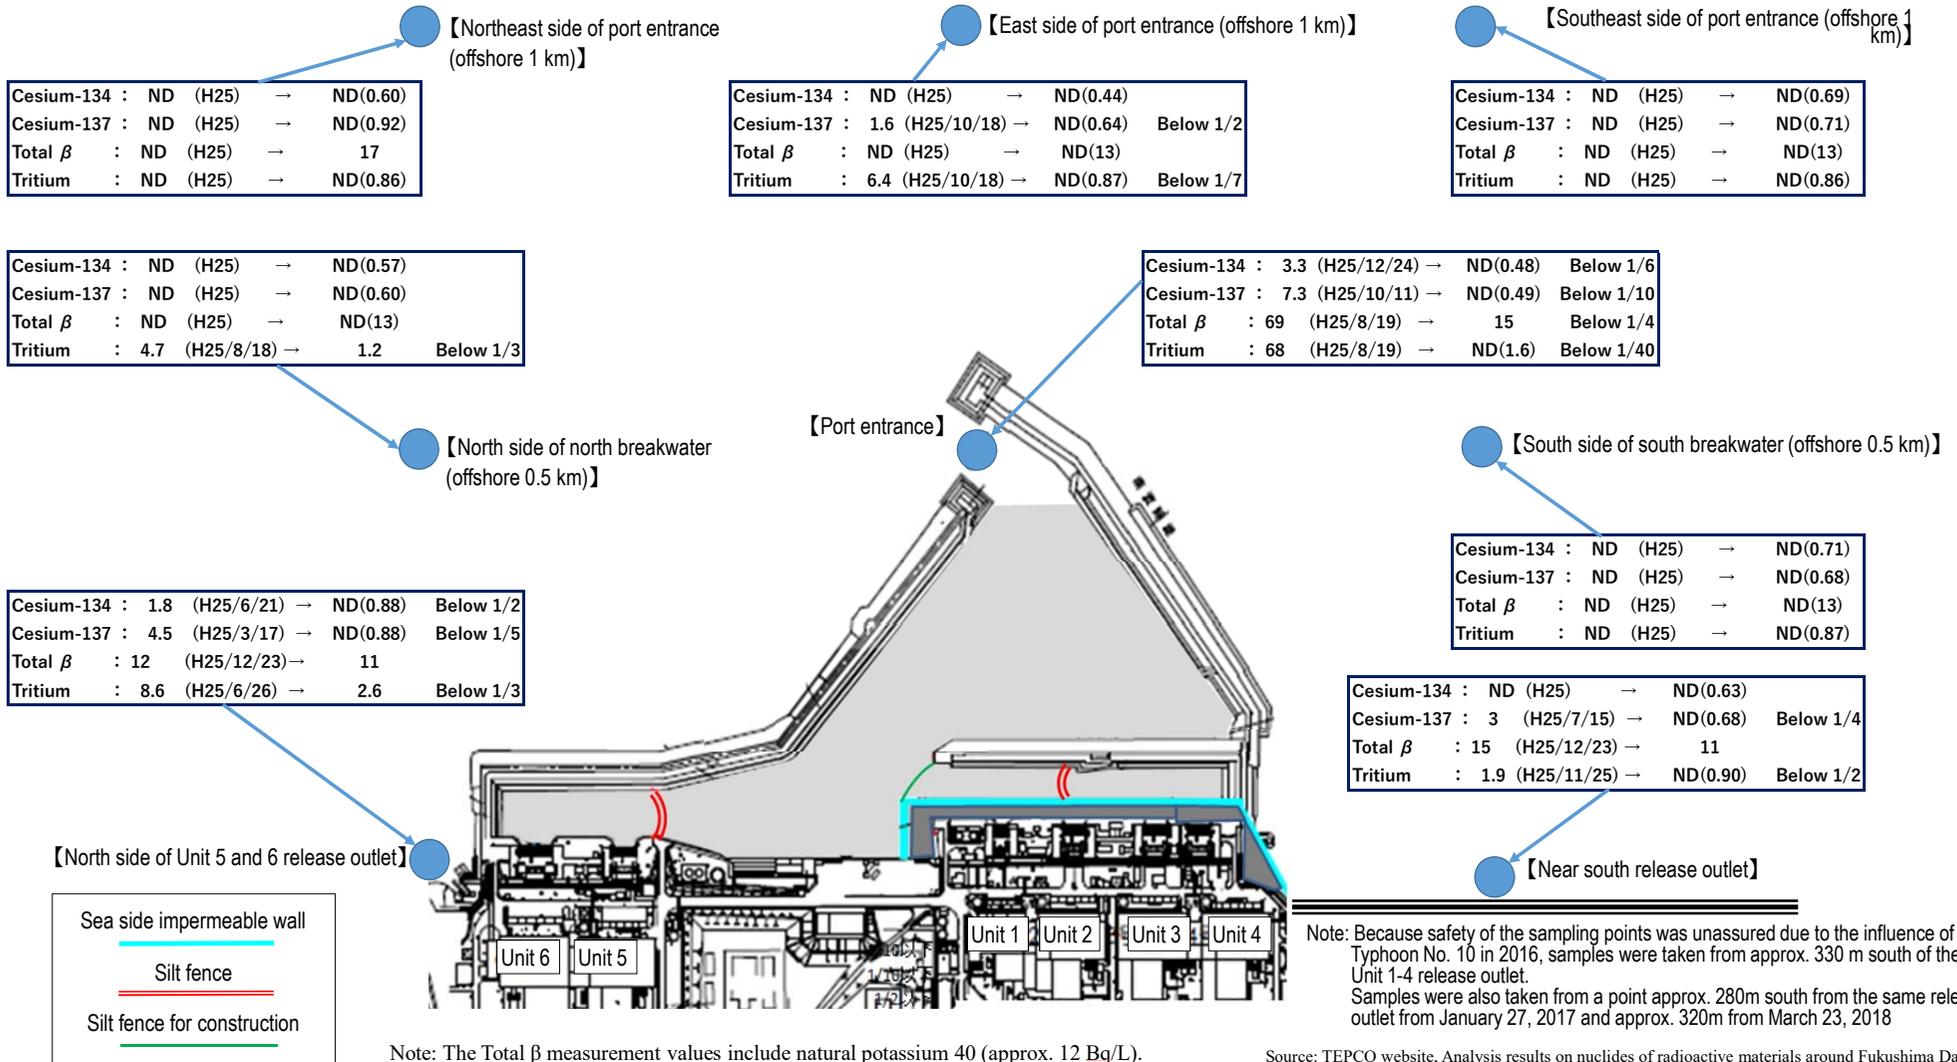
Summary of TEPCO data as of November 24, 2020

Note: The Total β measurement values include natural potassium 40 (approx. 12 Bq/L). They also include the contribution of yttrium 90, which radioactively balance strontium 90.

Note: Because safety of the sampling points was unassured due to the influence of Typhoon No. 10 in 2016, samples were taken from approx. 330 m south of the Unit 1-4 release outlet. Samples were also taken from a point approx. 280m south from the same release outlet from January 27, 2017 and approx. 320m from March 23, 2018

Legal discharge limit	WHO Guidelines for Drinking Water Quality
Cesium-134	60	10
Cesium-137	90	10
Strontium-90 (strongly correlate with Total β)	30	10
Tritium	60,000	10,000

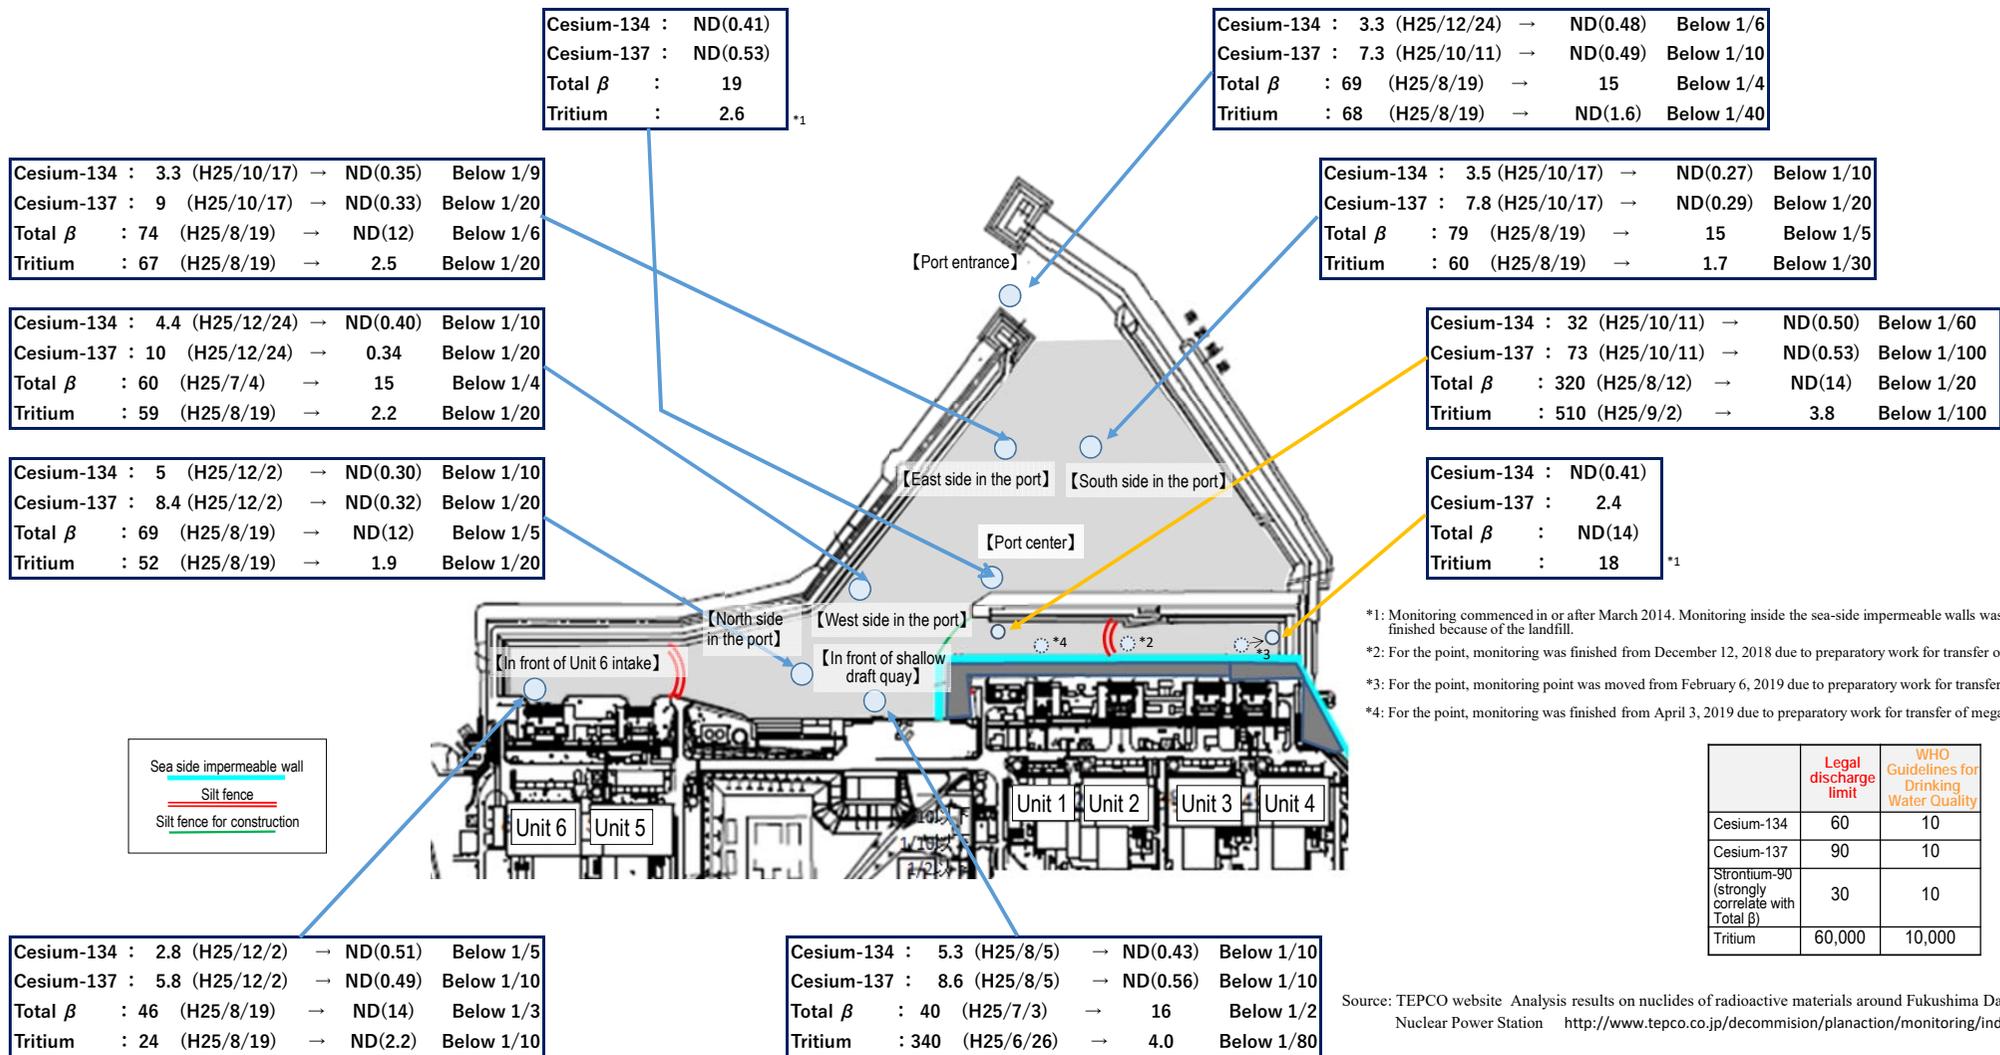
Summary of TEPCO data as of November 24, 2020

Note: The Total β measurement values include natural potassium 40 (approx. 12 Bq/L). They also include the contribution of yttrium 90, which radioactively balance strontium 90.

*1: Monitoring commenced in or after March 2014. Monitoring inside the sea-side impermeable walls was finished because of the landfill.
 *2: For the point, monitoring was finished from December 12, 2018 due to preparatory work for transfer of mega float.
 *3: For the point, monitoring point was moved from February 6, 2019 due to preparatory work for transfer of mega float.
 *4: For the point, monitoring was finished from April 3, 2019 due to preparatory work for transfer of mega float.

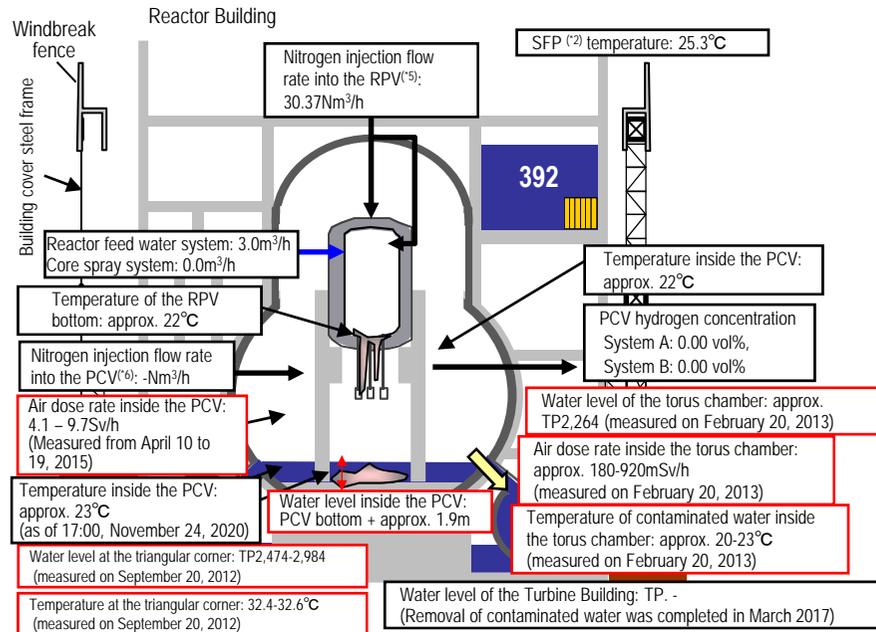
Air dose rate inside the Reactor Building:
 Max. 5,150mSv/h (1F southeast area) (measured on July 4, 2012)

* Indices related to the plant are values as of 11:00, November 25, 2020

Investigations inside PCV	1st (Oct 2012)	2nd (Apr 2015)	3rd (Mar 2017)
	- Acquiring images - Measuring air temperature and dose rate - Measuring water level and temperature - Sampling contaminated water - Installing permanent monitoring instrumentation	- Confirming the status of PCV 1st floor - Acquiring images - Measuring air temperature and dose rate - Replacing permanent monitoring instrumentation	- Confirming the status of PCV 1st basement floor - Acquiring images - Measuring air temperature and dose rate - Sampling deposit - Replacing permanent monitoring instrumentation
Leakage points from PCV	- PCV vent pipe vacuum break line bellows (identified in May 2014) - Sand cushion drain line (identified in November 2013)

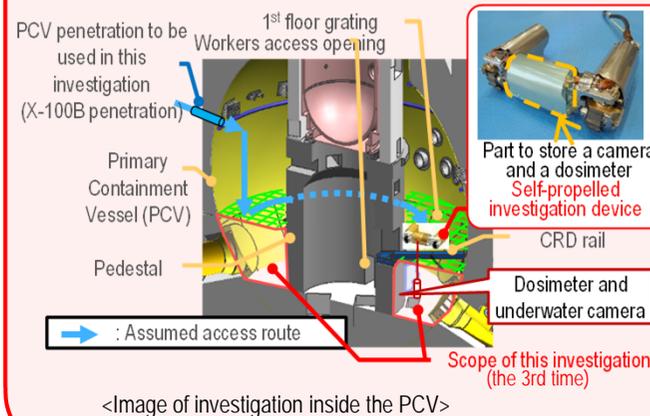
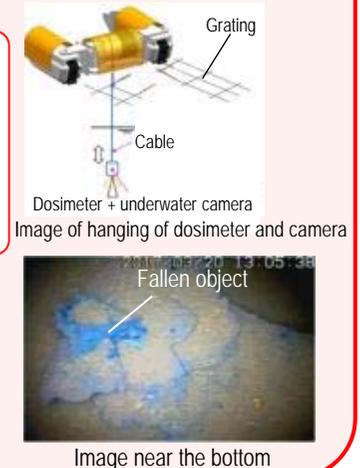
[Investigative outline]

- In April 2015, a device, which entered the inside of the PCV through a narrow access opening (bore: ϕ 100 mm), collected information such as images and airborne dose inside the PCV 1st floor.
- In March 2017, the investigation using a self-propelled investigation device, conducted to inspect the spreading of debris to the basement floor outside the pedestal, took images of the PCV bottom status for the first time. The status inside the PCV will continue to be examined based on the collected image and dose data.

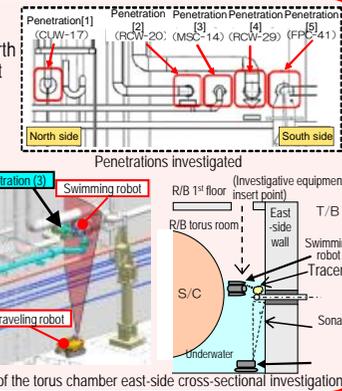
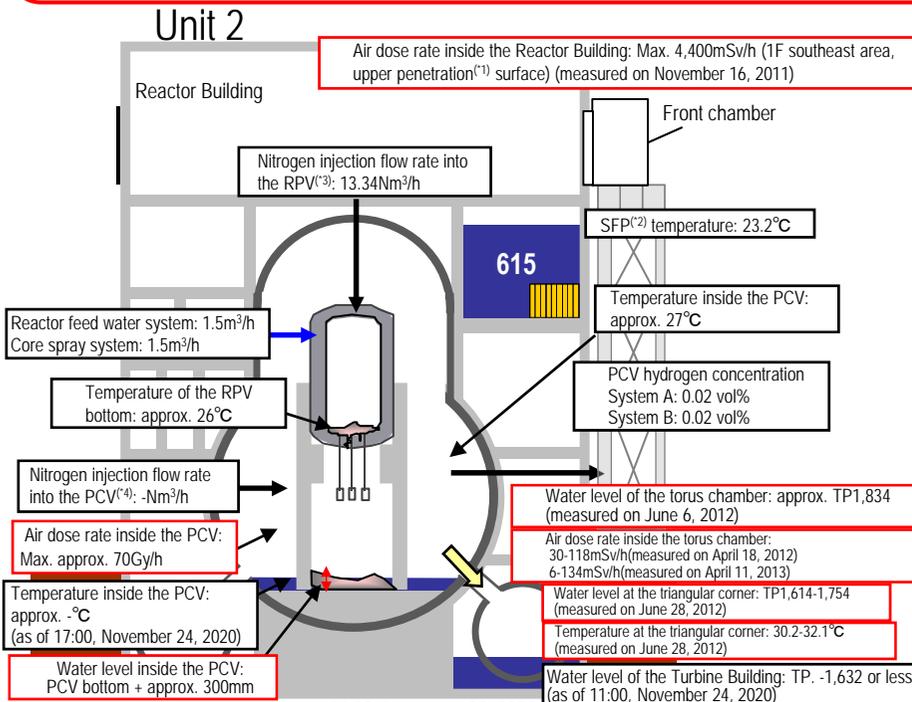
Investigative results on torus chamber walls

- July 2014, the torus chamber walls were investigated (on the north and the east-side walls) using equipment specially developed for that purpose (a swimming robot and a floor traveling robot).
- At the east-side wall pipe penetrations (five points), "the status" and "existence of flow" were checked.
- A demonstration using the above two types of underwater wall investigative equipment showed how the equipment could check the status of penetration.
- Regarding Penetrations 1 - 5, the results of checking the sprayed tracer (5) by camera showed no flow around the penetrations. (Investigation by the swimming robot)
- Regarding Penetration 3, a sonar check showed no flow around the penetrations. (Investigation by the floor traveling robot)

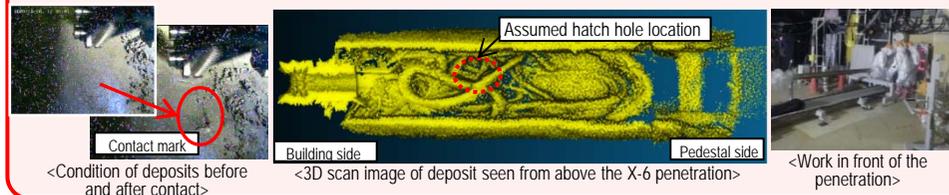
- On October 28, 2020, as a preparatory stage of the PCV internal investigation and the trial retrieval, a contact investigation into deposits inside the penetration (X-6 penetration) was conducted. In this investigation, a guide pipe incorporating an investigative unit inserted into the penetration. By the contact, it was confirmed that deposits inside the penetration did not deform and unstuck.

- On October 30, 2020, a 3D scan investigation was conducted, measuring deposits by the 3D scan sensor mounted on the top of the investigative unit. Information obtained in the investigation will be utilized in the mockup test of the equipment to remove deposits inside the X-6 penetration.

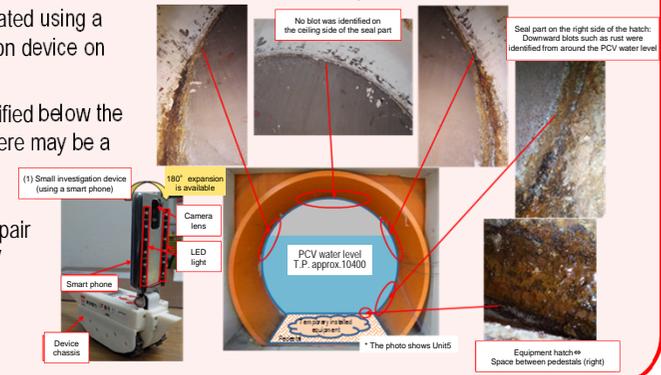
Investigative results into the Unit 3 PCV equipment hatch using a small investigation device

- As part of the investigation into the PCV to facilitate fuel debris retrieval, the status around the Unit 3 PCV equipment hatch was investigated using a small self-traveling investigation device on November 26, 2015.
- Given blots such as rust identified below the water level inside the PCV, there may be a leakage from the seal to the extent of bleeding. Methods to investigate and repair the parts, including other PCV penetrations with a similar structure, will be considered.

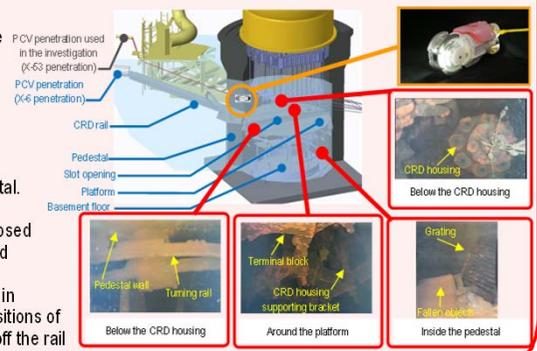
- Analysis of image data obtained in the investigation identified damage to multiple structures and the supposed core internals. Consideration about fuel removal based on the obtained information will continue.

- Videos obtained in the investigation were reproduced in 3D. Based on the reproduced images, the relative positions of the structures, such as the rotating platform slipping off the rail with a portion buried in deposits, were visually understood.

- For the purpose of confirming the status inside the PCV, an investigation device was inserted into the PCV from X-53 penetration on October 20 and 22, 2015 to obtain images, data of dose and temperature and sample contaminated water. No damage was identified on the structure and walls inside the PCV and the water level was almost identical with the estimated value. In addition, the dose inside the PCV was confirmed to be lower than in other Units.

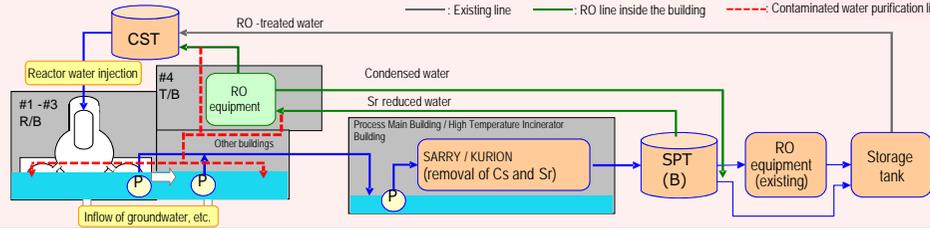
- To reduce the risk of contaminated-water leakage, the circulation loop was shortened by installing a reverse osmosis (RO) device in the Unit 4 Turbine Building within the circulation loop, comprising the transfer of contaminated water, water treatment and injection into the reactors. Operation of the installed RO device started from October 7 and 24-hour operation started from October 20. Installation of the new RO device inside the building shortened the circulation loop from approx. 3 to 0.8 km.

* The entire length of contaminated water transfer pipes is approx. 2.1km, including the transfer line of surplus water to the upper heights (approx. 1.3km).

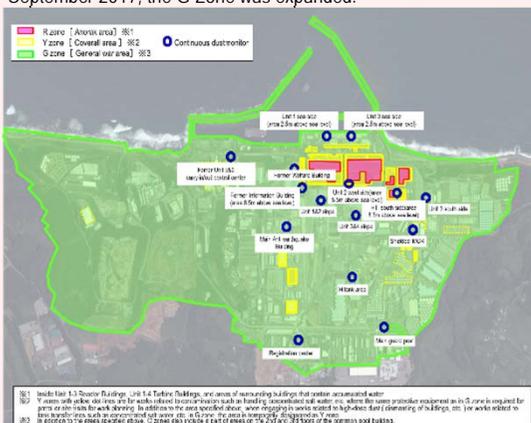
Optimization of radioactive protective equipment
Based on the progress of measures to reduce environmental dosage on site, the site is categorized into two zones: highly contaminated area around Unit 1-4 buildings, etc. and other areas to optimize protective equipment according to each category aiming at improving safety and productivity by reducing load during work.
From March 2016, limited operation started. From March and September 2017, the G Zone was expanded.

R zone (Anorak area)	Y zone (Coverall area)	G zone (General wear)	
Full-face mask 	Full-face or half-face masks *1, *2 	Disposable disposable mask 	
Anorak on coverall Or double coveralls 	Coverall 	General*3 	Dedicated on-site wear

*1 For works in buildings including water-treatment facilities (multi-nuclide removal equipment, etc.) (excluding site visits), wear a full-face mask.
 *2 For works in tank areas containing concentrated salt water or Sr-treated water (excluding works not handling concentrated salt water, etc., patrol, on-site investigation for work planning, and site visits) and works related to tank transfer lines, wear a full-face mask.
 *3 Specified light works (patrol, monitoring, delivery of goods brought from outside, etc.)
