## Main decommissioning work and steps

Fuel removal from the spent fuel pool was completed on December 22 2014 at Unit 4 and February 28 2021 at Unit 3. Trial fuel debris retrieval at Unit 2 commenced from September 10 2024 and a milestone of the Mid-and-Long-Term Roadmap "Commencing fuel debris retrieval at the first Unit" was achieved.

## Unit 2 Progress of fuel debris trial retrieval

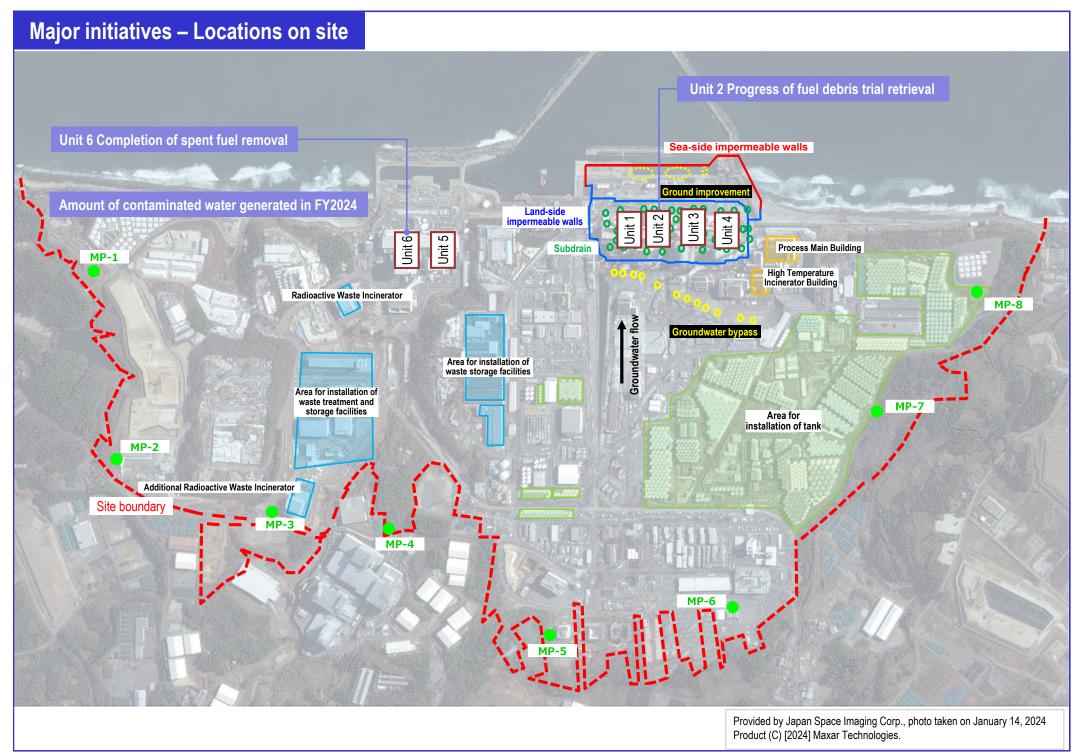
Spent fuel removal from Unit 6

Among 1884 fuel assemblies (1456 spent fuel and 428 nonirradiated fuel) stored in the Unit 6 Reactor Building, removal of 1456 spent fuel assemblies to the common pool commenced in August 2022 and was completed on April 16 2025.

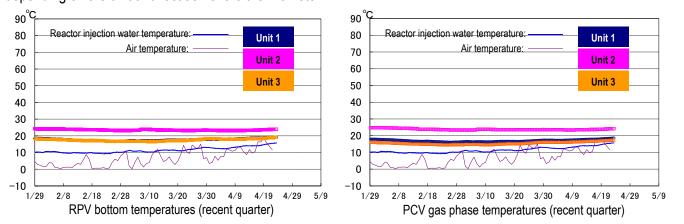
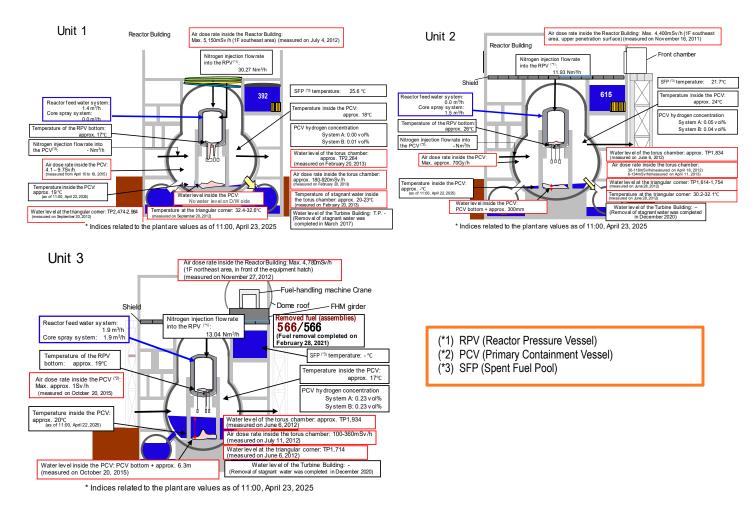
Through continuous reactor cooling by water injection, the temperatures of the Reactor Pressure Vessel (RPV) bottom and the Primary Containment Vessel (PCV) gas phase were maintained as shown below for recent, though they varied depending on the unit and location of the thermometer.

- \*1 The trend graphs show part of the temperature data measured at multiple points.
- \*2 A part of data could not be measured due to maintenance and inspection of the facility and other work.

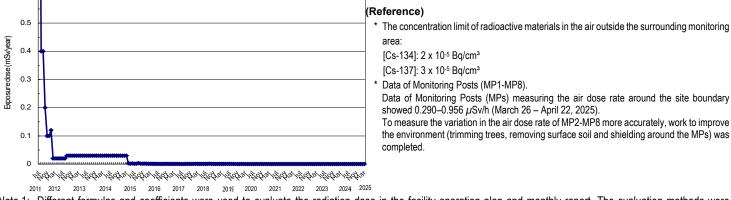
As of March 2025, the concentration of radioactive materials newly released from Reactor Building Units 1-4 into the air and measured at the site boundary was evaluated at approx.  $1.1 \times 10^{-11}$  Bq/cm³ and  $1.1 \times 10^{-11}$  Bq/cm³ for Cs-134 and -137 respectively, while the radiation exposure dose due to the release of radioactive materials there was less than 0.00004 mSv/year.

- Note 1: Different formulas and coefficients were used to evaluate the radiation dose in the facility operation plan and monthly report. The evaluation methods were integrated in September 2012. As the fuel removal from the spent fuel pool (SFP) commenced for Unit 4, the radiation exposure dose from Unit 4 was added to the items subject to evaluation since November 2013. The evaluation has been changed to a method considering the values of continuous dust monitors since FY2015, with data to be evaluated monthly and announced the following month.

- Note 2: Radiation dose was calculated using the evaluation values of release amount from Units 1-4 and Units 5 and 6. The radiation dose of Unit 5 and 6 was evaluated based on expected release amount during operation until September 2019 but the evaluation method was reviewed and changed to calculate based on the actual measurement results of Units 5 and 6 from October.

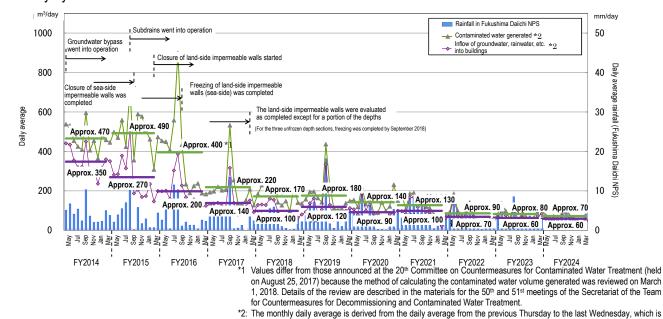
Figure 1: Changes in contaminated water generated and inflow of groundwater and rainwater into buildings

calculated based on the data measured at 7:00 on every Thursday

- > Status of contaminated water generated
  - Multi-layered contaminated water management measures, including land-side impermeable walls and subdrains, have stabilized the groundwater at a low level and the increased contaminated water generated during rainfall is being suppressed by repairing damaged portions of building roofs facing onsite. Through these measures, the generation of contaminated water has been suppressed and reduced from approx. 540 m³/day (in May 2014) before implementing measures to approx. 70 m³/day (in FY2024). It was confirmed that the milestone of "suppressing the amount of contaminated water generated to 100 m³/day or less during average rainfall within FY2025," which was achieved in FY2023, has been maintained in FY2024.

- Measures will proceed to further reduce the amount of contaminated water generated and suppress to approx. 50-70 m<sup>3</sup>/day by FY2028.

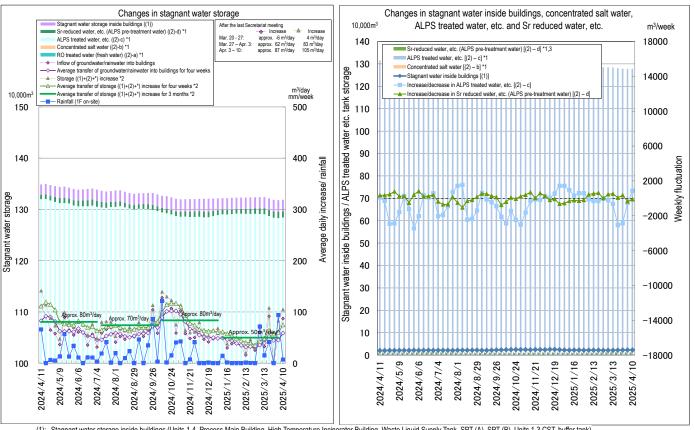
Figure 3: Status of stagnant water storage

## As of April 10, 2025

- (1): Stagnant water storage inside buildings (Units 1-4, Process Main Building, High Temperature Incinerator Building, Waste Liquid Supply Tank, SPT (A), SPT (B), Units 1-3 CST, buffer tank)

- Units 1-4 tank storage ([(2)-a RO-treated water (fresh water)] + [(2)-b Concentrated salt water] + [(2)-c ALPS treated water, etc.] + [(2)-d Sr-reduced water, etc.] + ((2)-d Sr-reduced water, etc.) Water amount from tank bottom to water-level gauge 0% (DS)

- To reduce the risks of strontium-reduced water, treatment using existing, additional and high-performance multinuclide removal system is underway. Up until April 10, 2025, approx. 951,000 m³ had been treated.
- Storage status of stagnant water and amount of ALPS treated water, etc. stored in tanks
- The volume of ALPS treated water, etc. was approx. 1,280,828 m<sup>3</sup> as of April 10, 2025.
- The total volume of ALPS treated water discharged into the sea since the discharge commenced on August 24, 2023, was approx. 86,144 m³ as of the completion of the seventh discharge in FY2024.

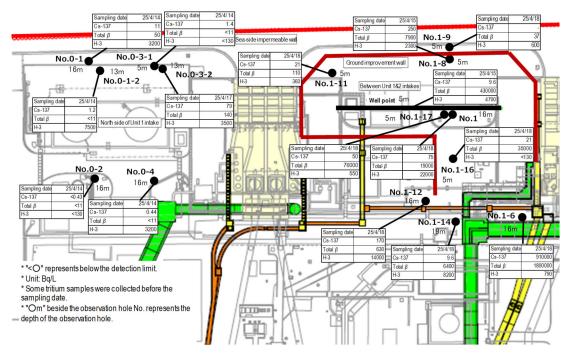
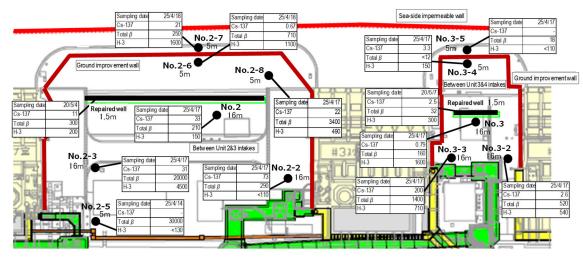
Figure 4: Groundwater concentration on the Turbine Building east side

<Unit 1 intake north side, between Unit 1 and 2 intakes>

<Between Unit 2 and 3 intakes, between Unit 3 and 4 intakes>

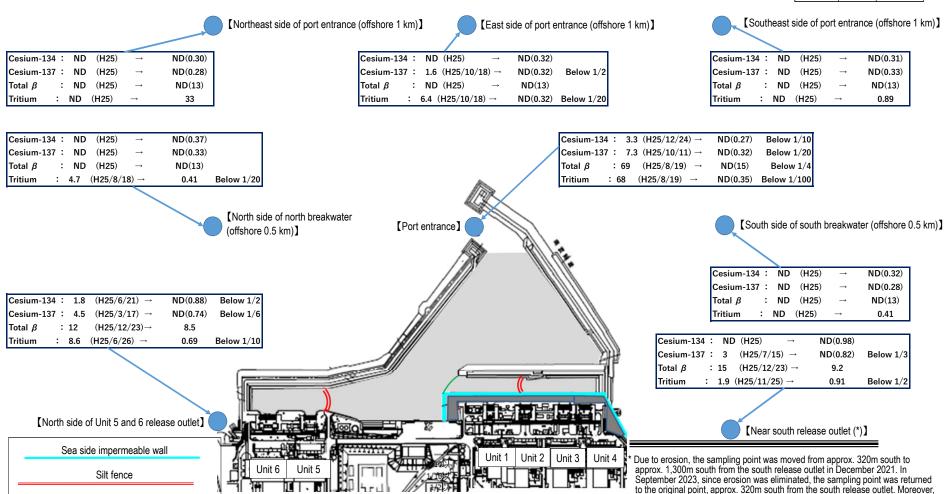
Silt fence for construction

Note: The Total  $\beta$  measurement value is the total radioactivity concentration of radioactive materials that emit  $\beta$ -ray (Potassium-40, Cesium-137, Strontium-90, progeny nuclide Yttrium-90, etc.). In

general, approx. 12 Bg/L of natural nuclide Potassium-40 is included in seawater.

due to erosion, the sampling point has been moved again to approx. 1,300m south from the south release outlet since June 11, 2024.
