Main works and steps for decommissioning

Fuel removal from Unit 4 SFP had been completed. Preparatory works to remove fuel from Unit 1-3 SFP and fuel debris (Note 1) removal are ongoing.

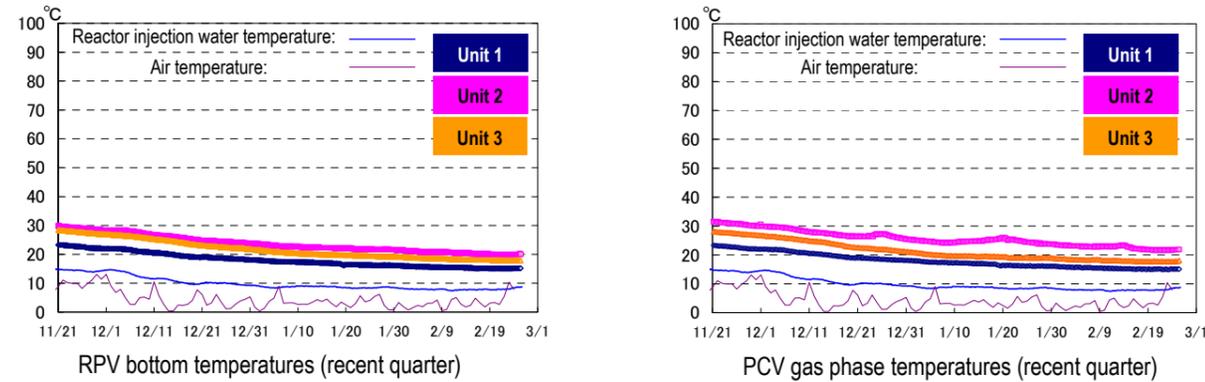
Through continuous reactor cooling by water injection, the temperatures of the Reactor Pressure Vessel (RPV) bottom and the Primary Containment Vessel (PCV) gas phase have been maintained within the range of approx. 10 to 35°C for the past month, though they vary depending on the unit and location of the thermometer.

* The trend graphs show part of the temperature data measured at multiple points.

◆ The temperatures of the Reactor Pressure Vessel (RPV) and the Primary Containment Vessel (PCV) of Units 1-3 have been maintained within the range of approx. 10-35°C^{*1} for the past month. There was no significant change in the density of radioactive materials newly released from Reactor Buildings in the air^{*2}. It was evaluated that the comprehensive cold shutdown condition had been maintained.

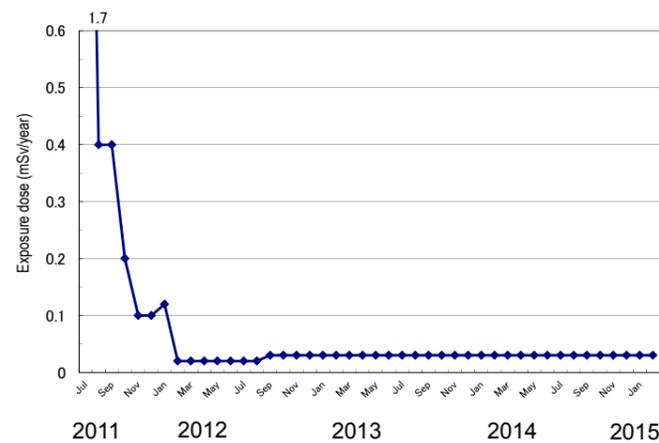
Annual radiation dose at site boundaries by radioactive materials (cesium) released from Reactor Building Units

The density of radioactive materials newly released from Reactor Building Units 1-4 in the air measured at site boundaries was evaluated at approx. 1.4×10^{-9} Bq/cm³ for both Cs-134 and -137. The radiation exposure dose due to the release of radioactive materials was 0.03 mSv/year (equivalent to approx. 1/70 of the annual radiation dose by natural radiation (annual average in Japan: approx. 2.1 mSv/year)) at the site boundaries.

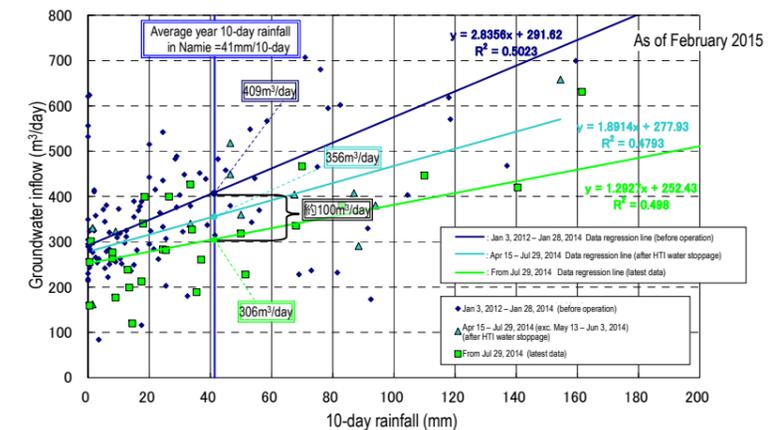
Figure 1: Analytical results of inflow into buildings

- It was confirmed that the groundwater inflow into the buildings had decreased by approx. 100m³/day based on the evaluation data to date through measures such as the groundwater bypass and water stoppage of the High Temperature Incinerator Building (HTI) (see Figure 1).

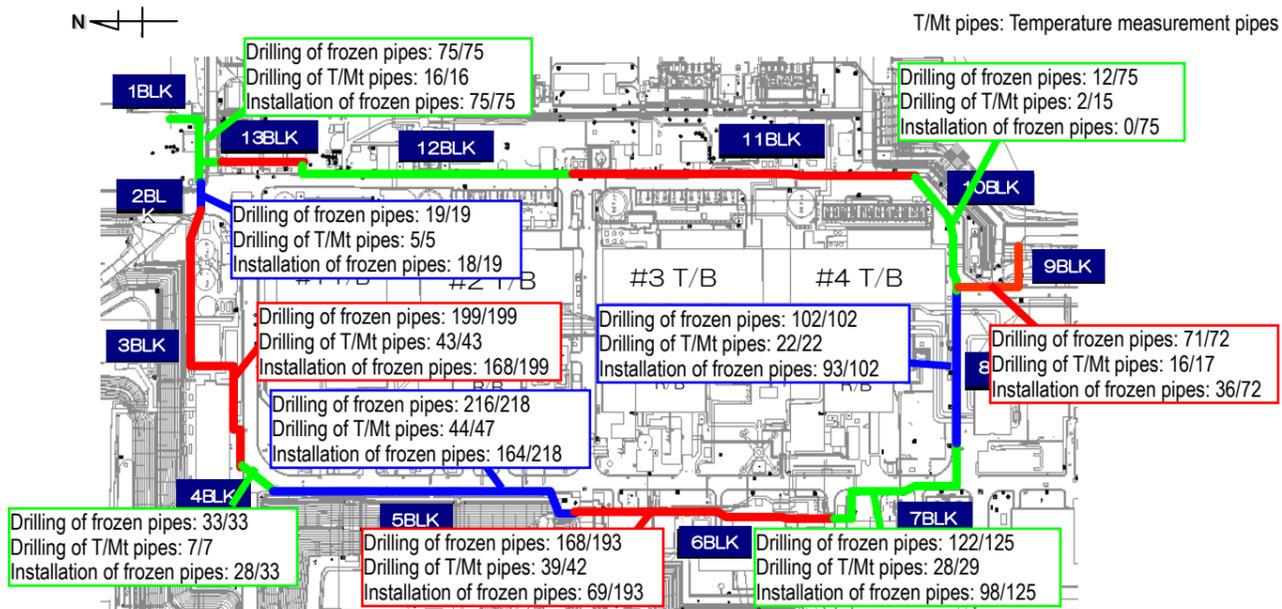
Figure 2: Drilling status for frozen-soil impermeable walls and installation of frozen pipes

- To facilitate the installation of land-side impermeable walls surrounding Units 1-4 (a subsidy project of the Ministry of Economy, Trade and Industry), drilling to place frozen pipes commenced (from June 2, 2014). As of February 24, drilling at 1,225 points (approx. 97%, for frozen pipes: 1,005 of 1,036 points, for temperature-measurement pipes: 220 of 228 points) and installation of frozen pipes at 749 of 1,036 points (approx. 72%) had been completed (see Figure 2). Regarding brine pipes, installation of the slope 35m aquifer (approx. 93%) and the 10m aquifer mountain side (approx. 32%) had been completed.

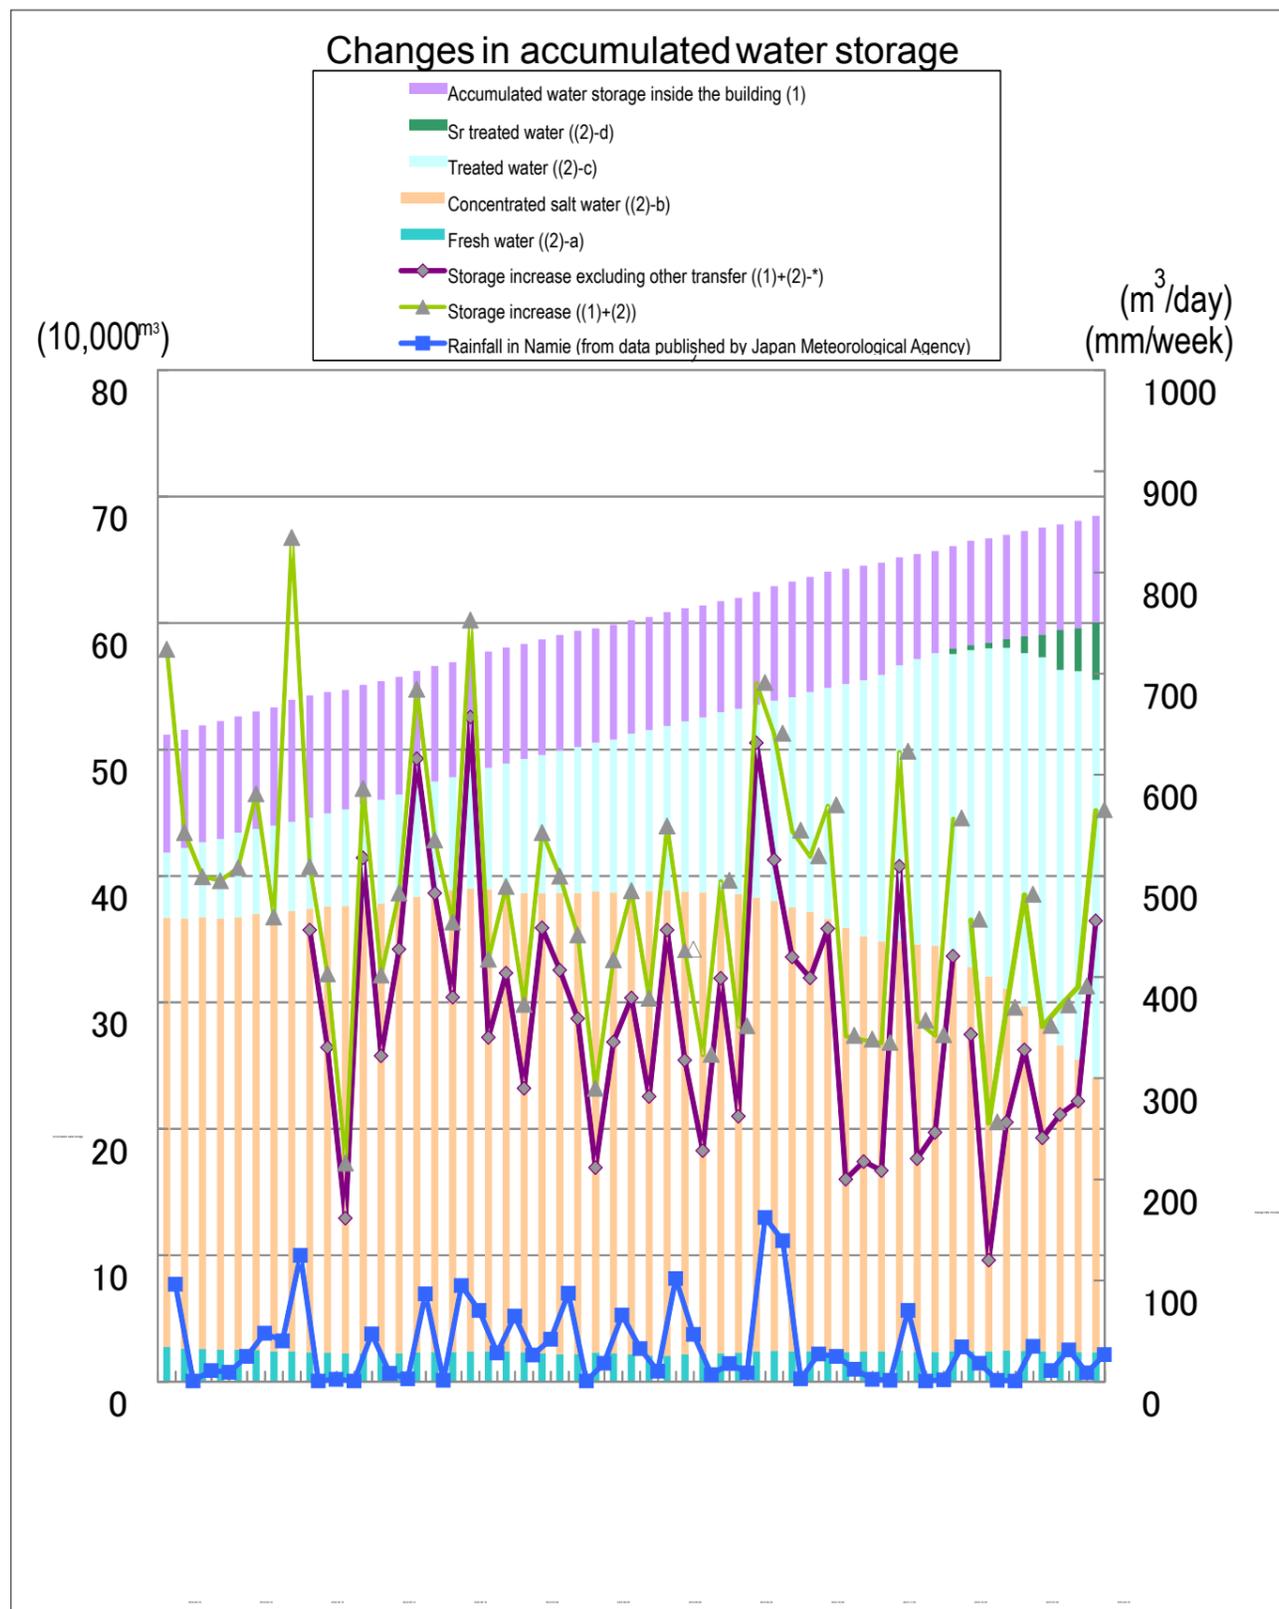
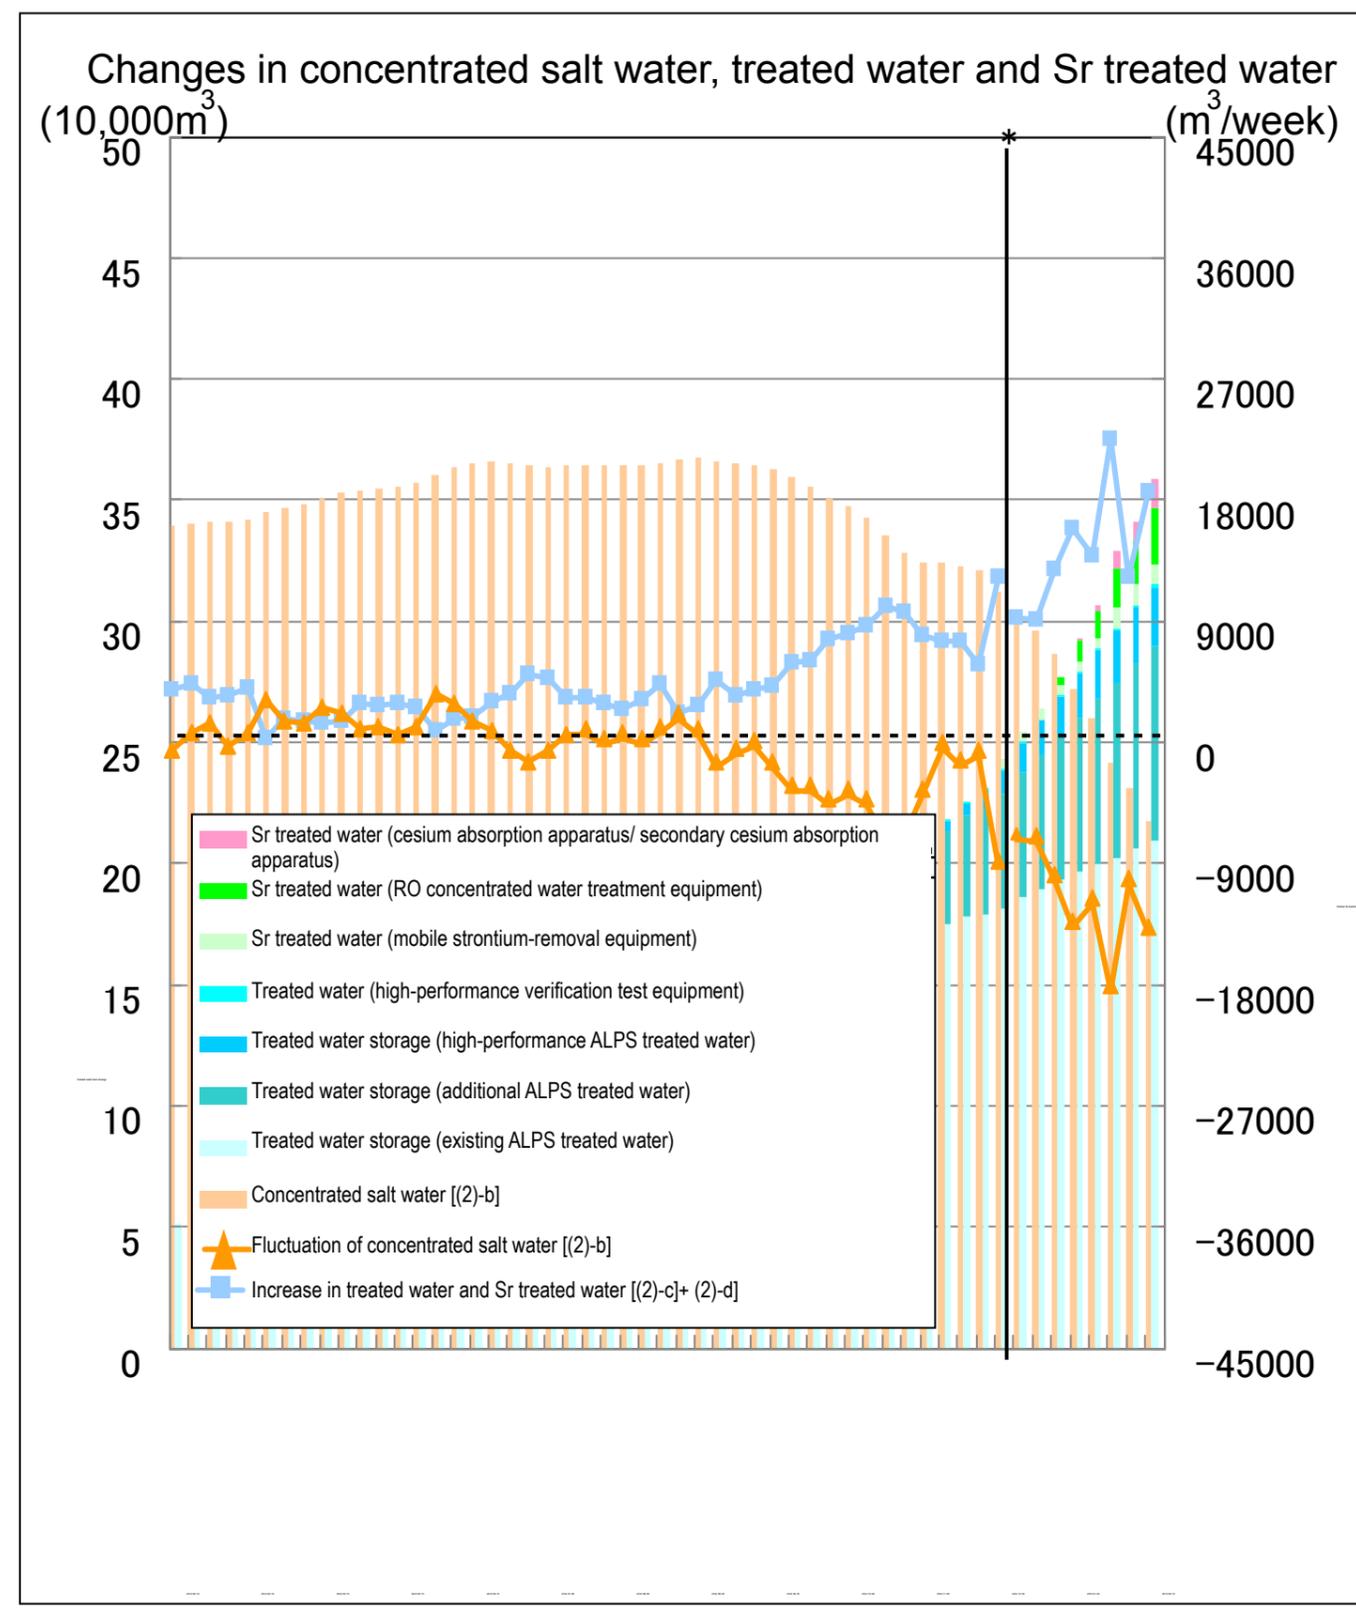
Figure 3: Status of accumulated water storage

* Since January 1, 2015, data collection days have been changed (from Tuesdays to Thursdays)

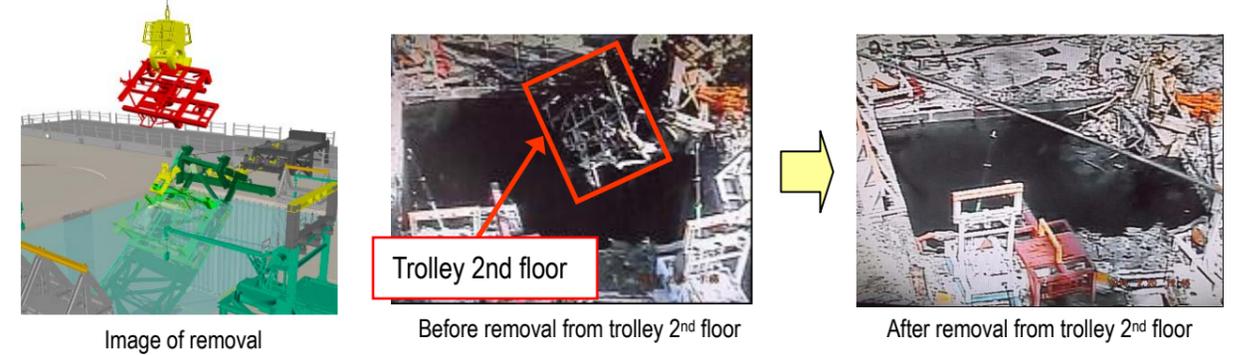
Figure 8: Status of rubble removal from Unit 3 spent fuel pool

- During rubble removal inside the spent fuel pool, the console and overhanging pedestal of a fuel-handling machine, which were scheduled for removal, fell (August 29, 2014) and the work was therefore suspended. On December 17, 2014, the rubble removal work resumed. Removal from the fuel-handling machine trolley 2nd floor was completed (February 20) and additional cover panels were installed (February 21 and 23). After completing preparation, removal from the walkway and other parts will commence.

Toward fuel removal from Unit 3 SFP, large rubble within the pool is being removed.

Though removal of large rubble within Unit 3 SFP had been suspended since the fall of rubble in August 2013, it has been resumed since December 2014 after implementing additional fall-prevention measures.

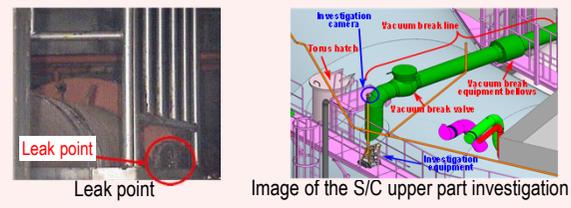
Investigation in the leak point detected in the upper part of Unit 1 Suppression Chamber (S/C^(*))

Investigation in the leak point detected in the upper part of Unit 1 S/C from May 27, 2014 from one expansion joint cover among the lines installed there. As no leakage was identified from other parts, specific methods will be examined to halt the flow of water and repair the PCV.

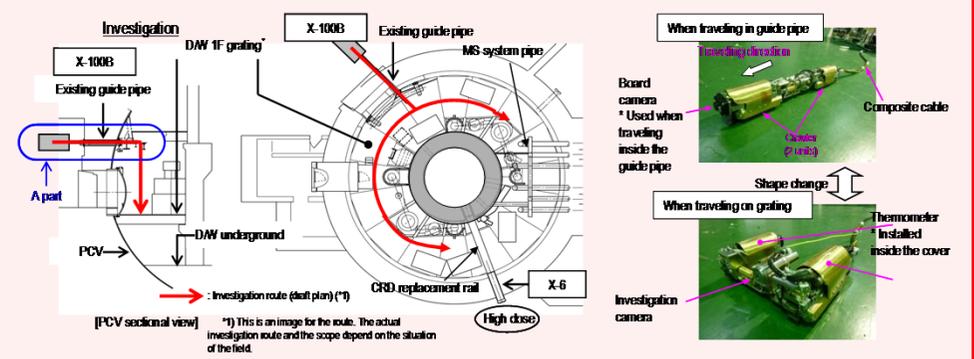
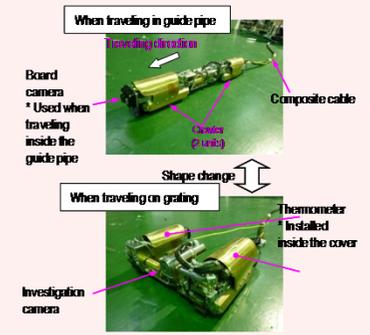
Status of equipment development toward investigating inside the PCV

Prior to removing fuel debris, to check the conditions inside the Primary Containment Vessel (PCV), including the location of the fuel debris, investigation inside the PCV is scheduled.

- [Investigative outline]
- Inserting equipment from Unit 1 X-100B penetration⁽⁵⁾ to investigate in clockwise and counter-clockwise directions.
- [Status of investigation equipment development]
- Crawler-type equipment with a shape-changing structure which allows it to enter the PCV from the narrow access entrance (bore: φ100mm) and stably move on the grating is currently under development. A field demonstration is scheduled for the 1st half of FY2015.

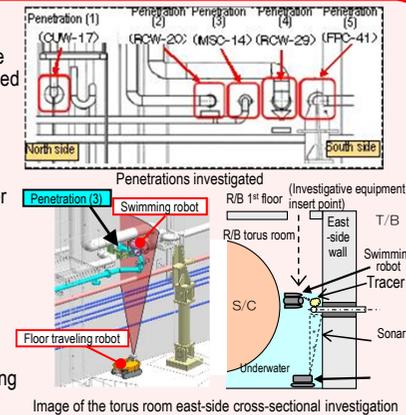
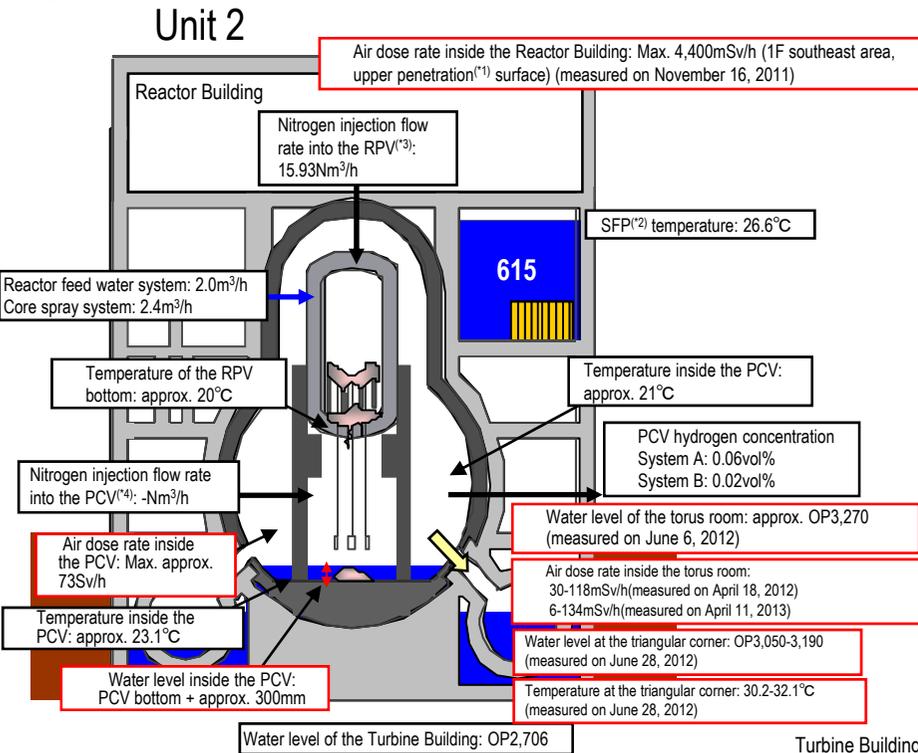
Investigative results on torus room walls

- The torus room walls were investigated (on the north side of the east-side walls) using equipment specially developed for that purpose (a swimming robot and a floor traveling robot).
- At the east-side wall pipe penetrations (five points), "the status" and "existence of flow" were checked.
- A demonstration using the above two types of underwater wall investigative equipment showed how the equipment could check the status of penetration.
- Regarding Penetrations 1 - 5, the results of checking the sprayed tracer (*) by camera showed no flow around the penetrations. (investigation by the swimming robot)
- Regarding Penetration 3, a sonar check showed no flow around the penetrations. (investigation by the floor traveling robot)

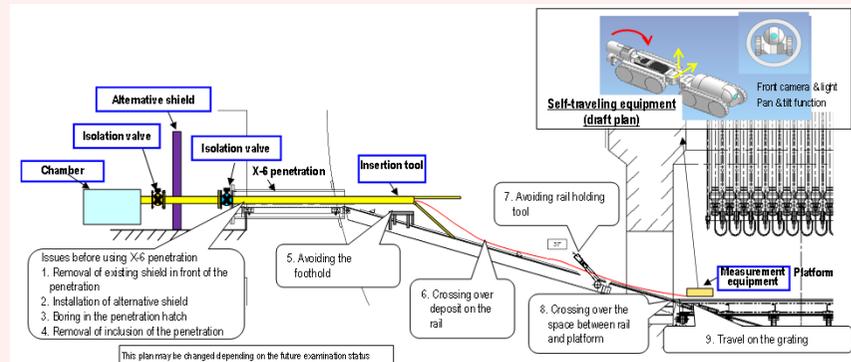
- Based on issues confirmed by the CRD rail status investigation conducted in August 2013, the investigation method and equipment design are currently being examined. A demonstration is scheduled in the field in the 1st half of FY2015.

Investigative issues inside the PCV and equipment configuration (draft plan)

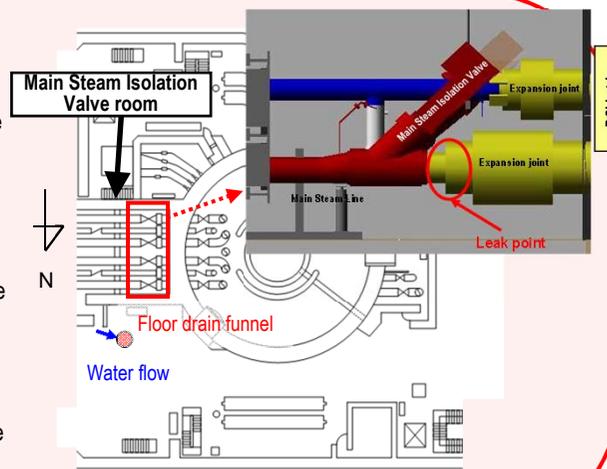
From April 23, 2014, image data has been acquired by camera and the radiation dose measured via pipes for measurement instrumentation, which connect the air-conditioning room on the Reactor Building 2nd floor with the Main Steam Isolation Valve Room on the 1st floor. On May 15, 2014, water flow from the expansion joint of one Main Steam Line was detected.

This is the first leak from PCV detected in Unit 3. Based on the images collected in this investigation, the leak volume will be estimated and the need for additional investigations will be examined. The investigative results will also be utilized to examine water stoppage and PCV repair methods.

Outline of the water-flow status

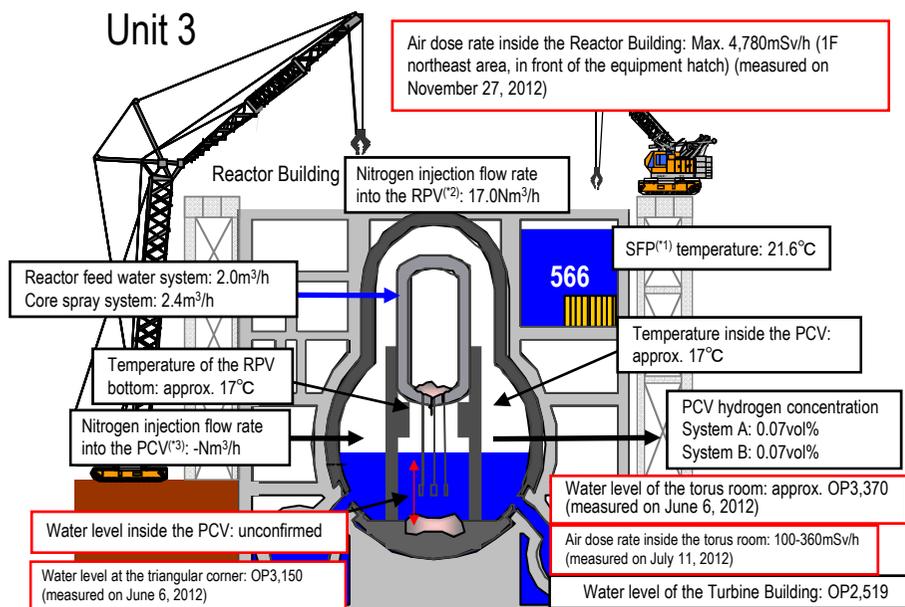
Robot for investigating the contamination status (gamma camera mounted)

Unit 3

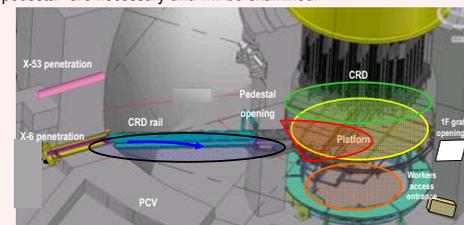
- (2) Investigation plan following the investigation of X-53 penetration
 - Based on the measurement values of hydraulic head pressure inside the PCV, X-6 penetration may decline. It is estimated that access to X-6 penetration is difficult.

- For access from another penetration, approaches such as "further downsizing the equipment" or "moving in water to access the pedestal" are necessary and will be examined.

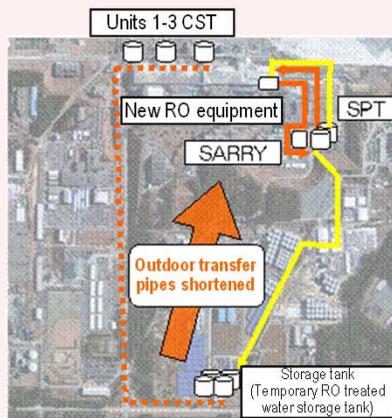
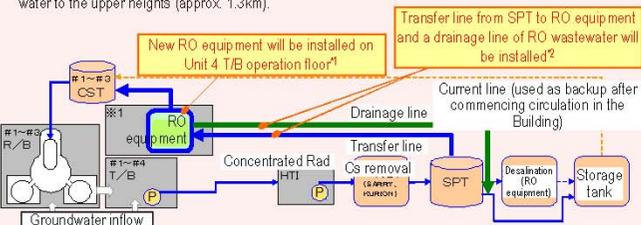
Work to improve the reliability of the circulation water injection cooling system and pipes to transfer accumulated water.

- Operation of the reactor water injection system using Unit 3 CST as a water source commenced (from July 5, 2013). Compared to the previous systems, in addition to the shortened outdoor line, the reliability of the reactor water injection system was enhanced, e.g. by increasing the amount of water-source storage and enhancing durability.
- By newly installing RO equipment inside the Reactor Building by the 1st half of 2015, the reactor water injection loop (circulation loop) will be shortened from approx. 3km to approx. 0.8km*.
- * The entire length of contaminated water transfer pipes is approx. 2.1km, including the transfer line of surplus water to the upper heights (approx. 1.3km).

*1 Unit 4 TB operation floor is one of the installation proposals, which will be determined after further examination based on the work environment.
 *2 A detailed line configuration will be determined after further examination.

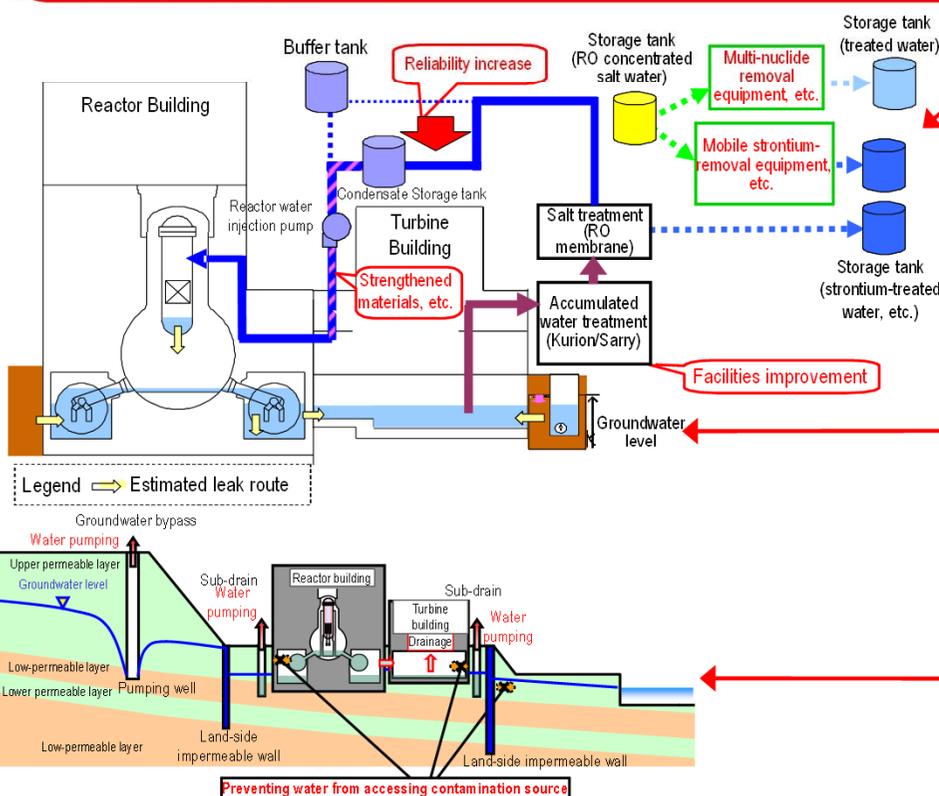
Toward treatment of all contaminated water

Regarding contaminated water treatment by multi-nuclide removal equipment (ALPS), etc. it is difficult to reach the initially anticipated performance due to technical reason. It is estimated that treatment of the entire amount of contaminated water would be in May 2015. Specific time of the completion will be announced by mid-March. Efforts will continue to improve treatment capability aiming to reduce risks as soon as possible.

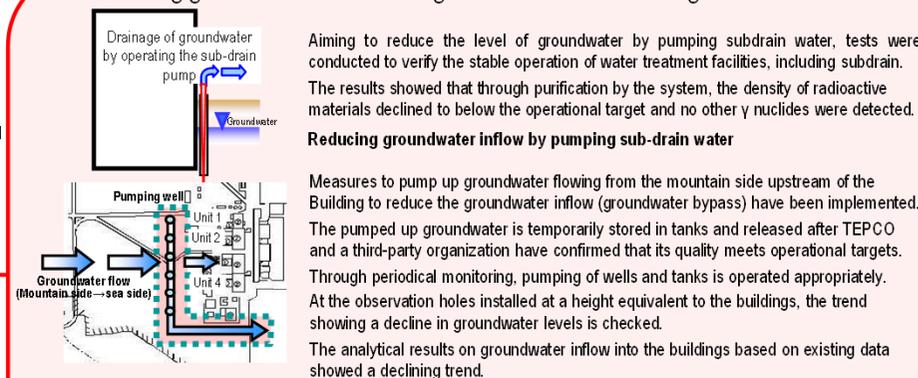
Preventing groundwater from flowing into the Reactor Buildings

Via a groundwater bypass, reduce the groundwater level around the Building and groundwater inflow into the Building

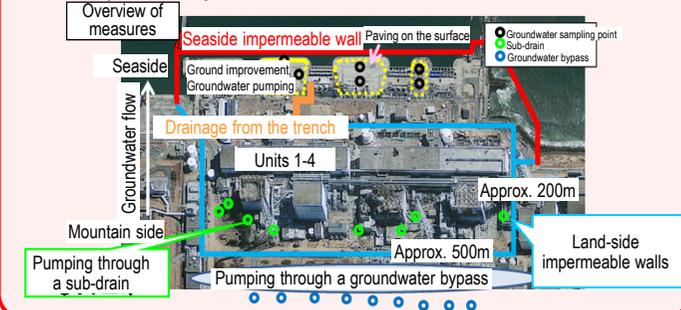
- Unit 2: November 25 to December 18, 2014 - tunnel sections were filled with cement-based materials. February 24, 2015 - filling of the Vertical Shafts commenced.

- Unit 3: February 5, 2015 - filling of tunnel sections commenced.
 - Unit 4: February 14, 2015 - filling of tunnel sections commenced.
