Main works and steps for decommissioning

Summary of TEPCO data as of November 22

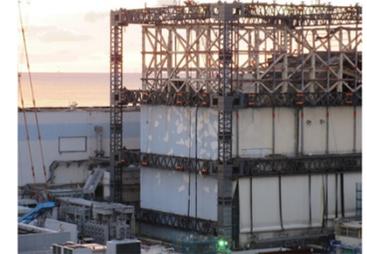
Dismantling of the building cover started in July 2015 and dismantling of wall panel was completed in November 2016. The work is being conducted steadily, with anti-scattering measures fully implemented and the density of radioactive materials monitored.

(Dismantling of Unit 1 building cover wall panels)
