## Main decommissioning works and steps

All fuel has been removed from Unit 4 SFP and preparatory work to remove fuel from Unit 1-3 SFP and fuel debris (Note 1) retrieval is ongoing.

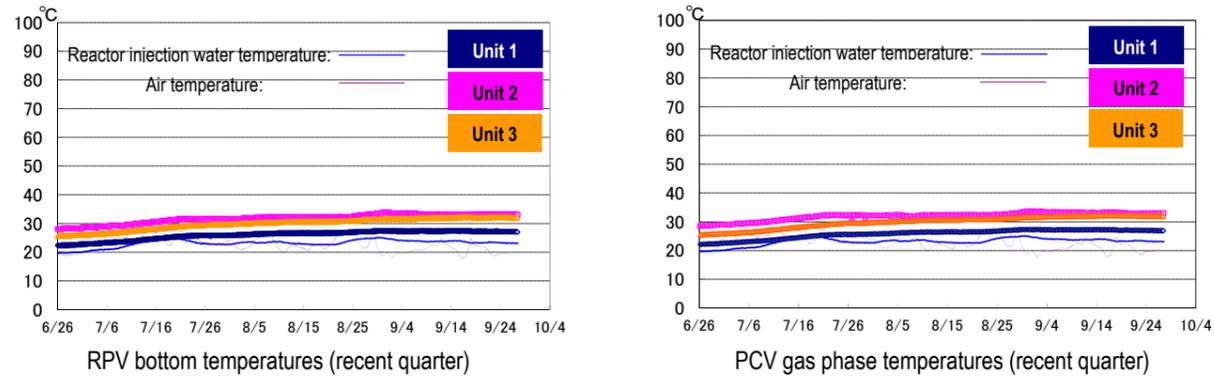
Through continuous reactor cooling by water injection, the temperatures of the Reactor Pressure Vessel (RPV) bottom and the Primary Containment Vessel (PCV) gas phase were maintained within the range of approx. 25 to 35°C for the past month, though it varied depending on the unit and location of the thermometer.

\* The trend graphs show part of the temperature data measured at multiple points.

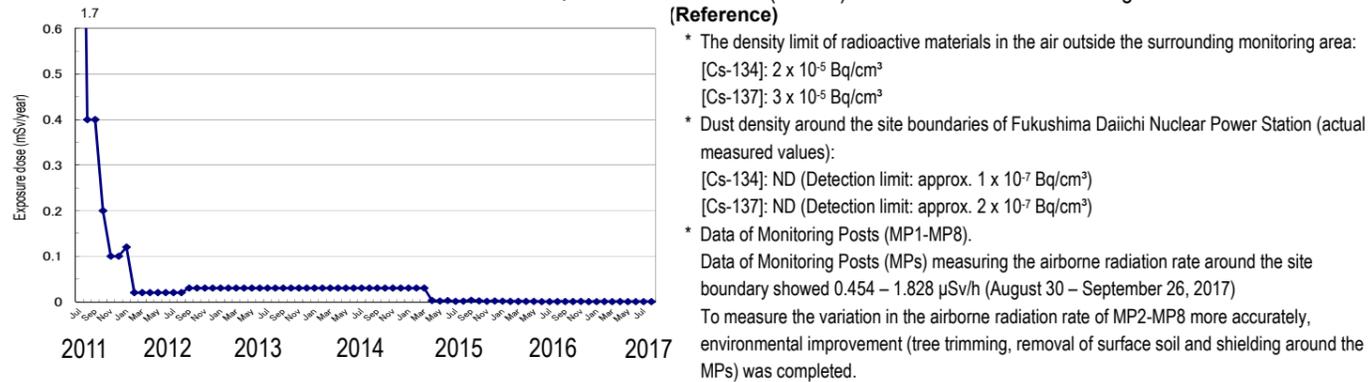
Annual radiation dose at site boundaries by radioactive materials (cesium) released from Reactor Building Units 1-4

As of August 2017, the density of radioactive materials newly released from Reactor Building Units 1-4 in the air and measured at the site boundary was evaluated at approx.  $1.5 \times 10^{-12}$  Bq/cm<sup>3</sup> for Cs-134 and  $3.7 \times 10^{-12}$  Bq/cm<sup>3</sup> for Cs-137, while the radiation exposure dose due to the release of radioactive materials there was less than 0.00021 mSv/year.

Note: Different formulas and coefficients were used to evaluate the radiation dose in the facility operation plan and monthly report. The evaluation methods were integrated in September 2012. As the fuel removal from the spent fuel pool (SFP) commenced for Unit 4, the radiation exposure dose from Unit 4 was added to the items subject to evaluation since November 2013. The evaluation has been changed to a method considering the values of continuous dust monitors since FY2015, with data to be evaluated monthly and announced the following month.

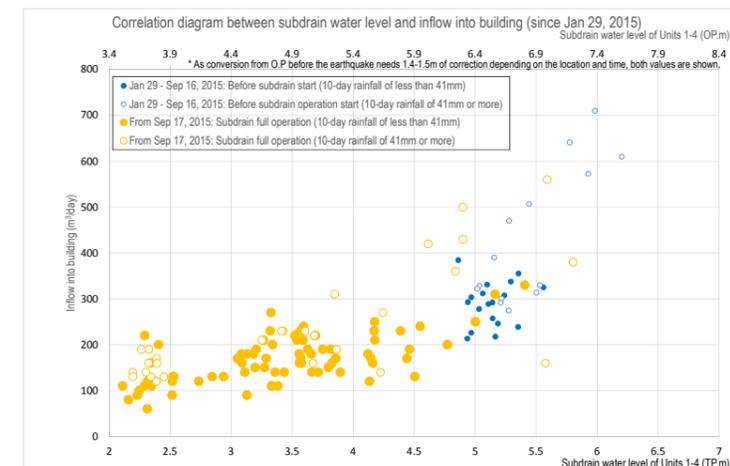
Figure 1: Correlation between inflow such as groundwater and rainwater into buildings and the water level of Unit 1-4 subdrains

- Since the subdrains went into operation, the inflow into buildings tended to decline to fewer than 150 m<sup>3</sup>/day when the subdrain water level declined below T.P. 3.0 m, while the inflow increased during rainfall.

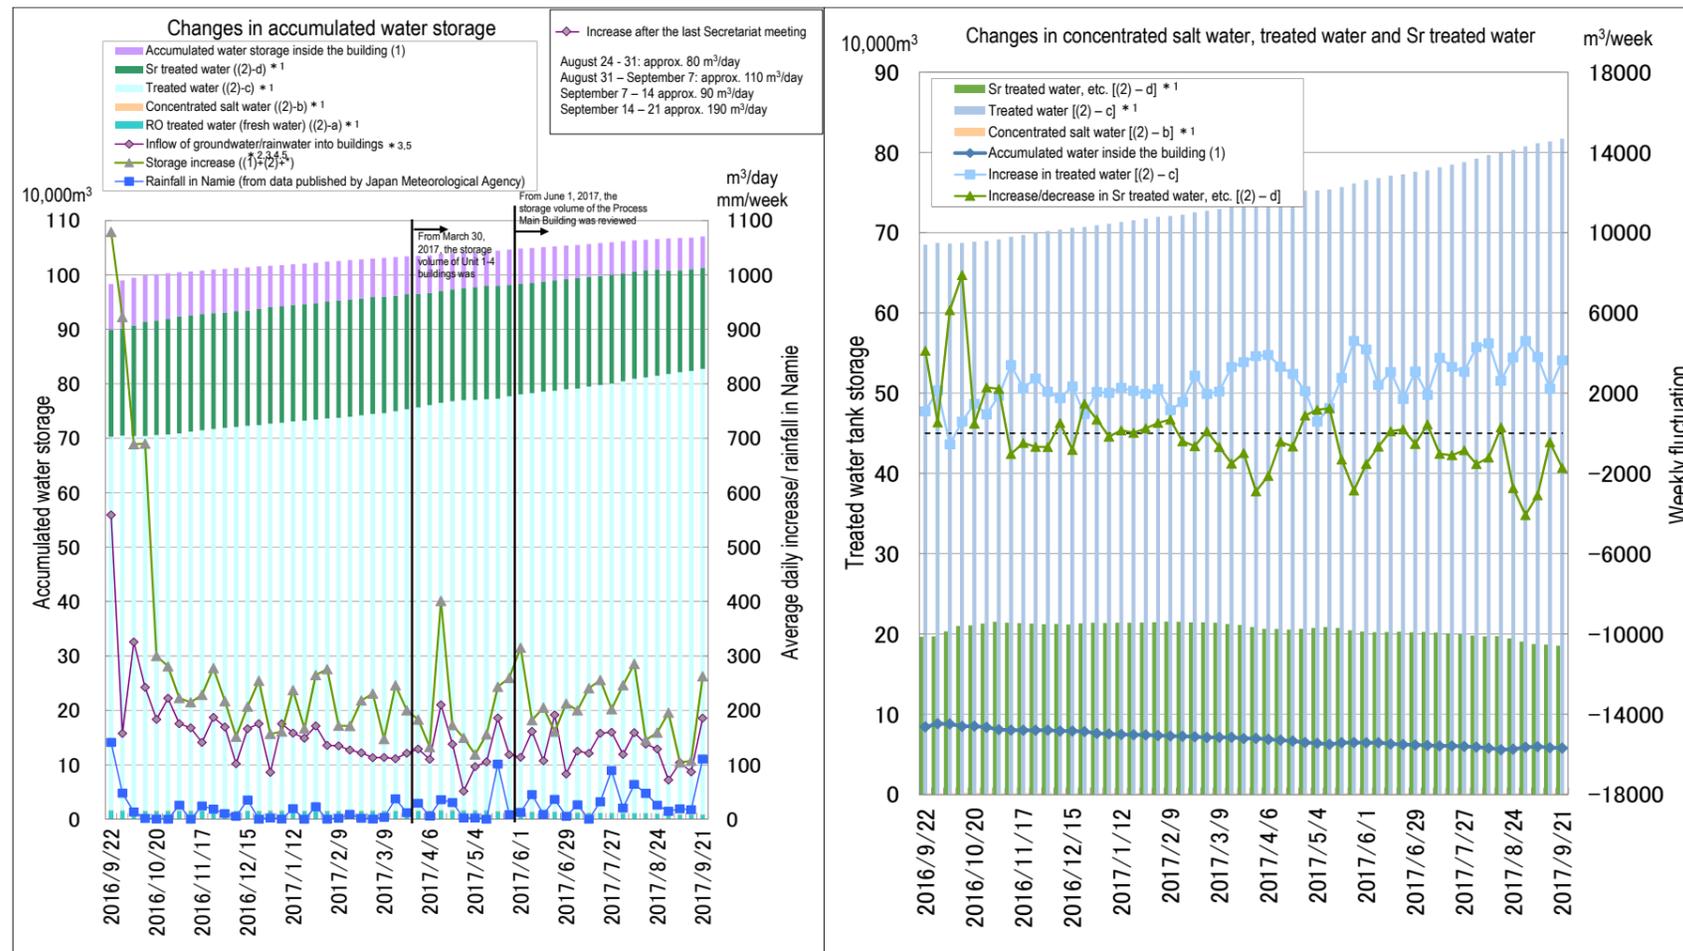
Figure 3: Status of accumulated water storage

As of September 21, 2017

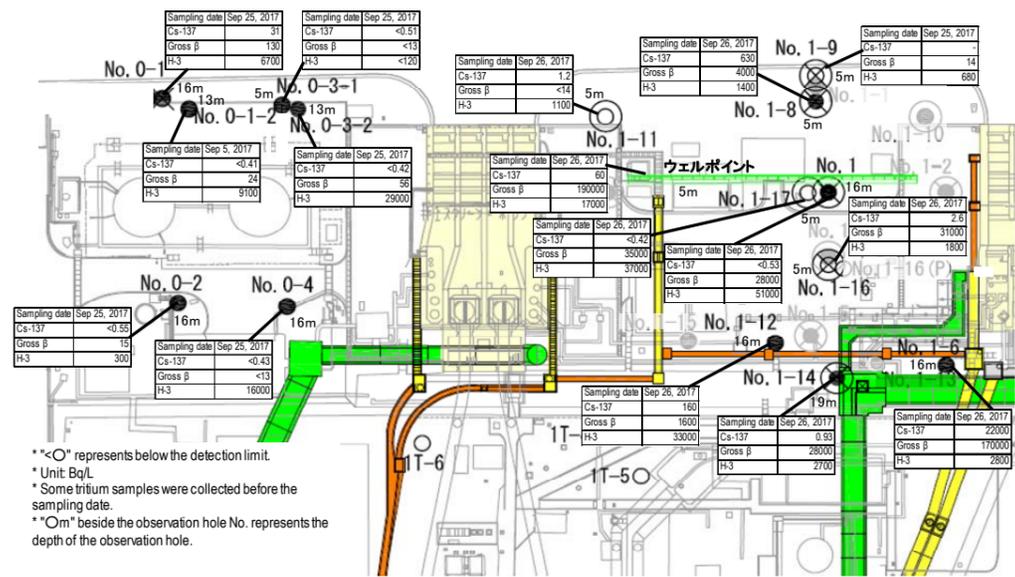
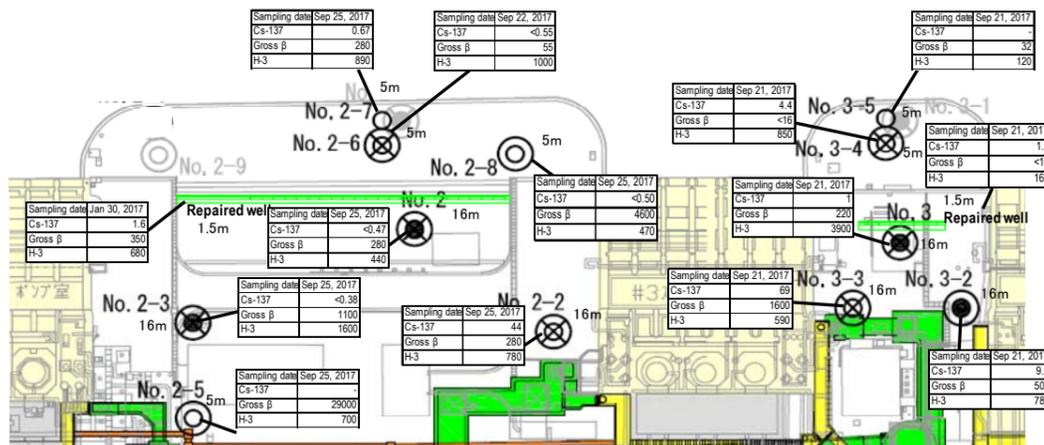
Figure 4: Groundwater density on the Turbine Building east side

<Unit 1 intake north side, between Unit 1 and 2 intakes>

<Between Unit 2 and 3 intakes, between Unit 3 and 4 intakes>

- around 500 Bq/L, it has increased to 2,000 Bq/L since November 2016, then declined and currently stands at around 1,000 Bq/L. Though the density of gross  $\beta$  radioactive materials at the same groundwater Observation Hole had been increasing from 10,000 to 80,000 Bq/L since November 2016, it increased to 80,000 Bq/L, then has been declining and currently stands at around 30,000 Bq/L. Since December 18, 2013, pumping of groundwater continued (at the well point between the Unit 2 and 3 intakes: December 18, 2013 - October 13, 2015; at the repaired well: from October 14, 2015).

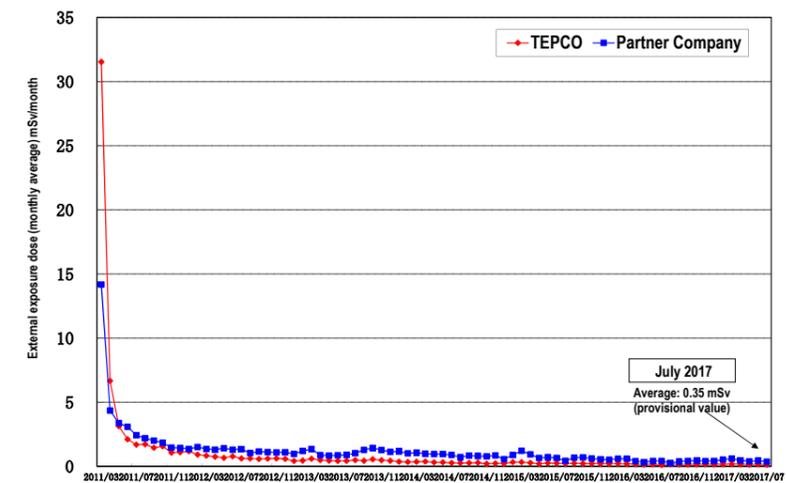
Figure 7: Changes in monthly individual worker exposure dose (monthly average exposure dose since March 2011)

- The monthly average exposure dose of workers remained at approx. 0.81 mSv/month during FY2014, approx. 0.59 mSv/month during FY2015 and approx. 0.39 mSv/month during FY2016. (Reference: Annual average exposure dose 20 mSv/year  $\approx$  1.7 mSv/month)

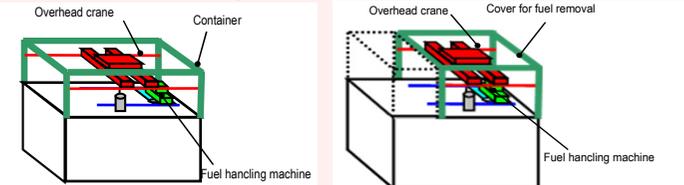
Examination of the following two plans continues: Plan 1 to share a container for removing fuel assemblies and debris from the pool; and Plan 2 to install a dedicated cover for fuel removal from the pool.

Image of Plan 1

Image of Plan 2

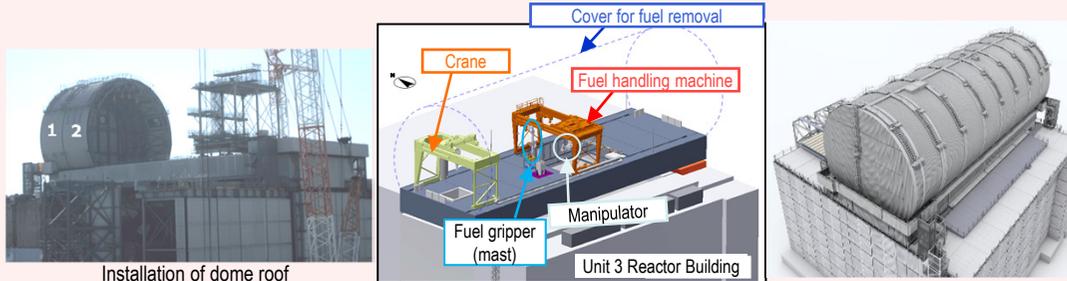
Measures to reduce dose on the Reactor Building top floor (decontamination, shields) were completed in December 2016. Installation of a cover for fuel removal and a fuel-handling machine is underway from January 2017.

Installation of dome roof  
(September 26)

Image of entire fuel handling facility inside the cover

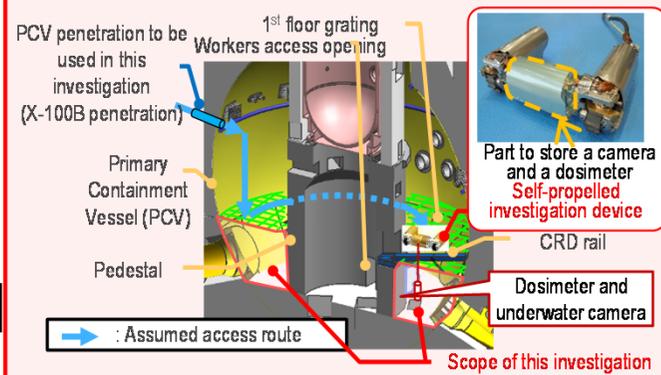
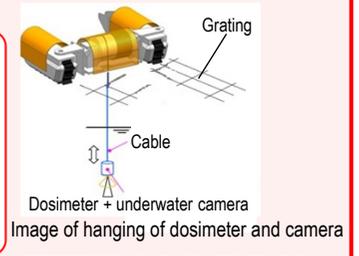
<Image of investigation inside the PCV>

- In April 2015, a device, which entered the inside of the PCV through a narrow access opening (bore:  $\phi$  100 mm), collected information such as images and airborne dose inside the PCV 1st floor.
- In March 2017, the investigation using a self-propelled investigation device, conducted to inspect the spreading of debris to the basement floor outside the pedestal, took images of the PCV bottom status for the first time. The status inside the PCV will continue to be examined based on the collected image and dose data.

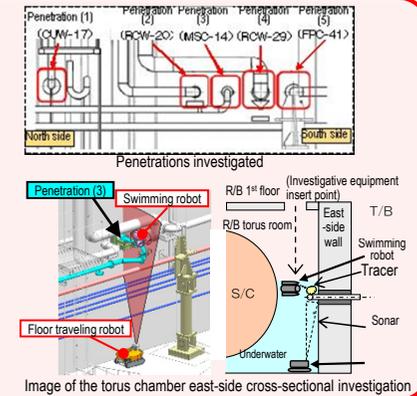
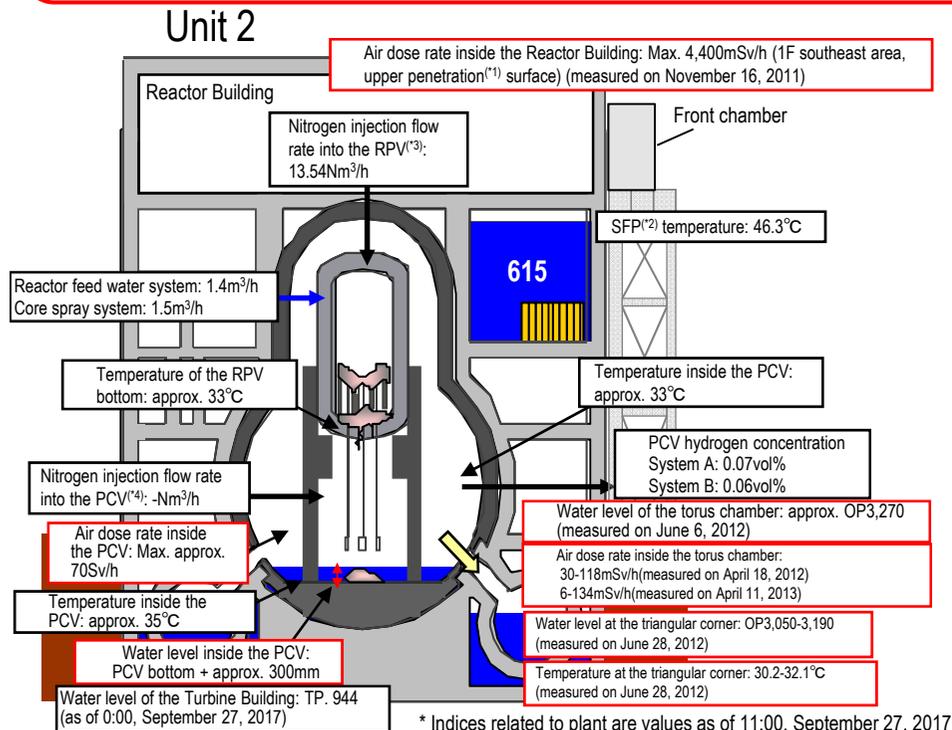
- The torus chamber walls were investigated (on the north side of the east-side walls) using equipment specially developed for that purpose (a swimming robot and a floor traveling robot).
- At the east-side wall pipe penetrations (five points), "the status" and "existence of flow" were checked.
- A demonstration using the above two types of underwater wall investigative equipment showed how the equipment could check the status of penetration.
- Regarding Penetrations 1 - 5, the results of checking the sprayed tracer (\*) by camera showed no flow around the penetrations. (investigation by the swimming robot)
- Regarding Penetration 3, a sonar check showed no flow around the penetrations. (investigation by the floor traveling robot)

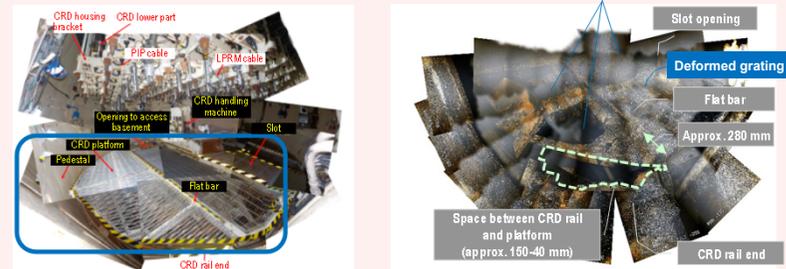
Scope of investigation inside the PCV

- As manufacturing of shields necessary for dose reduction around X-6 penetration was completed, a hole was made in December 2016 at the PCV penetration from which a robot will be injected.
- On January 26 and 30, 2017, a camera was inserted from the PCV penetration to inspect the status of the CRD replacement rail on which the robot will travel. On February 9, deposit on the access route of the self-propelled investigative device was removed and on February 16, the inside of the PCV was investigated using the device.
- The results of this series of investigations confirmed fallen and deformed gratings and a quantity of deposit inside the pedestal. The evaluation results of the collected information will be utilized in considering the policy for fuel debris removal.

(Reference) Inside the Unit 5 pedestal

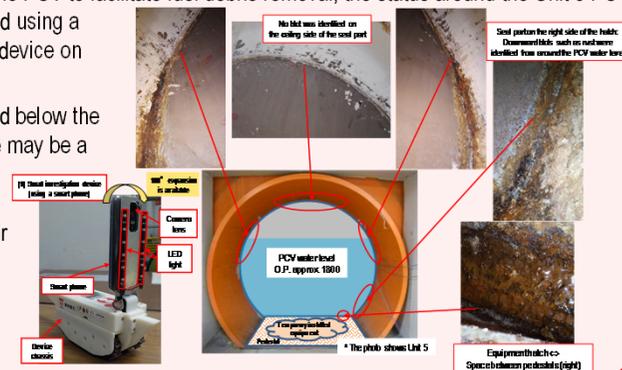
- As part of the investigation into the PCV to facilitate fuel debris removal, the status around the Unit 3 PCV equipment hatch was investigated using a small self-traveling investigation device on November 26, 2015.
- Given blots such as rust identified below the water level inside the PCV, there may be a leakage from the seal to the extent of bleeding. Methods to investigate and repair the parts, including other PCV penetrations with a similar structure, will be considered.

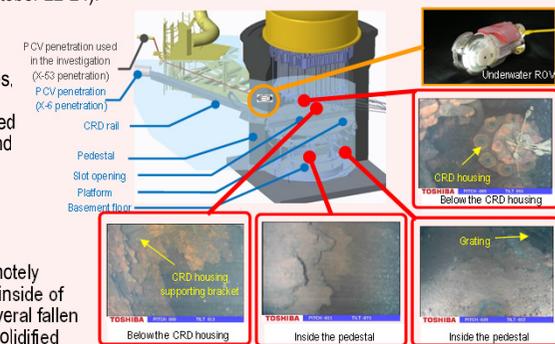
Status inside the pedestal

- In July 2017, the inside of the PCV was investigated using the underwater ROV (remotely operated underwater vehicle) to inspect the inside of the pedestal. The investigation identified several fallen obstacles and deposits, such as supposed solidified molten materials and grating, inside the pedestal.

- Image data collected in the investigation will be analyzed to identify the detailed status inside the pedestal.

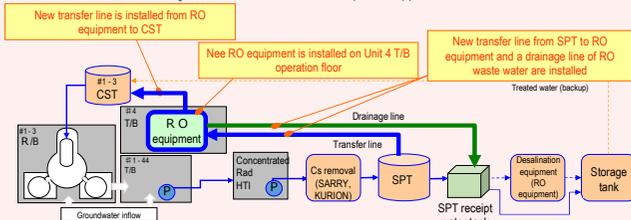
- Operation of the reactor water injection system using Unit 3 Condensate Storage Tank (CST) as a water source commenced (from July 5, 2013). Compared to the previous systems, the reliability of the reactor water injection system was enhanced, e.g. by increasing the amount of water-source storage and enhancing durability.
- To reduce the risk of contaminated-water leakage, the circulation loop was shortened by installing a reverse osmosis (RO) device in the Unit 4 Turbine Building within the circulation loop, comprising the transfer of contaminated water, water treatment and injection into the reactors. Operation of the installed RO device started from October 7 and 24-hour operation started from October 20. Installation of the new RO device inside the building shortened the circulation loop from approx. 3 to 0.8 km.

\* The entire length of contaminated water transfer pipes is approx. 2.1km, including the transfer line of surplus water to the upper heights (approx. 1.3km).

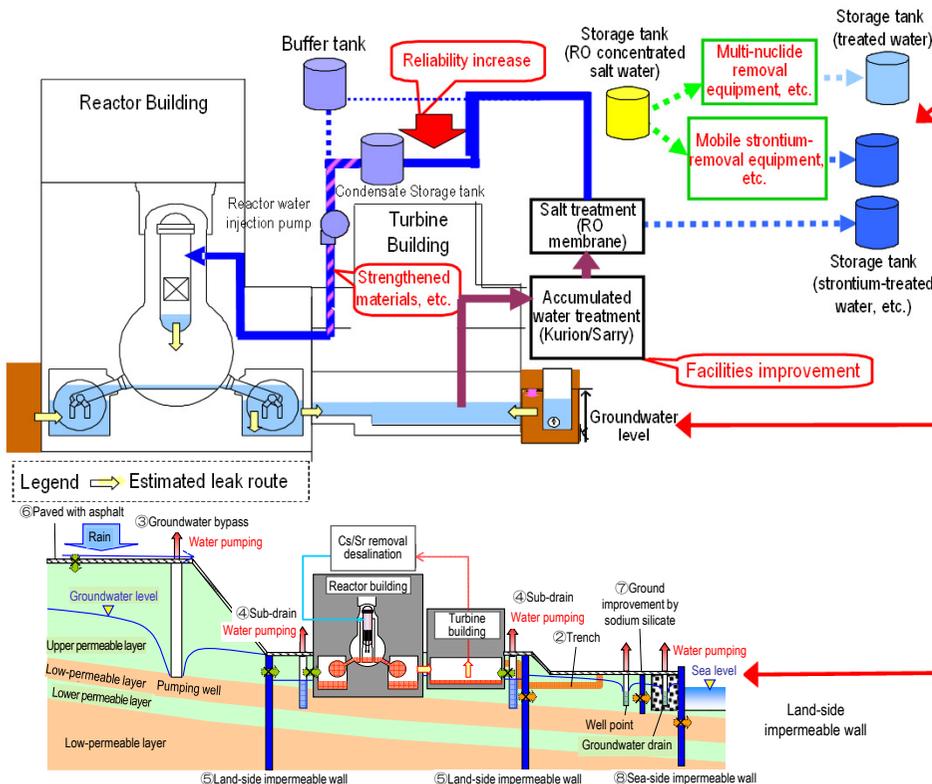
Contaminated water (RO concentrated salt water) is being treated using seven types of equipment including the multi-nuclide removal equipment (ALPS). Treatment of the RO concentrated salt water was completed on May 27, 2015, with the exception of the remaining water at the tank bottom. The remaining water will be treated sequentially toward dismantling the tanks.

The strontium-treated water from other facilities than the multi-nuclide removal equipment will be re-purified in the multi-nuclide removal equipment to further reduce risks.
