Main decommissioning work and steps

All fuel had been removed from Unit 4 SFP by December 22, 2014. Work continues toward fuel removal and debris (Note 1) retrieval from Units 1-3.

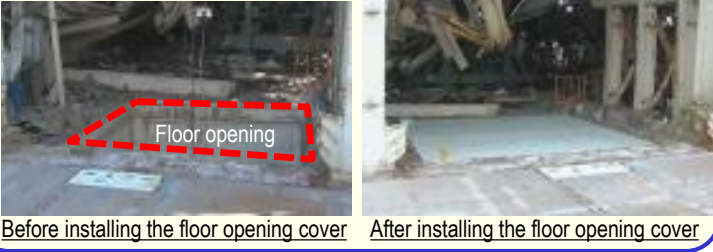
Completion of floor opening cover installed to protect Unit 1 SFP

Toward the protection of the spent fuel pool (SFP) to secure an access route from the west work floor and prevent the falling of small rubble from the operating floor during the work, the floor opening was covered by March 6, 2019. Following the covering, removal of small rubble in the east-side area around the SFP started from March 18, 2019.

Before installing the floor opening cover After installing the floor opening cover

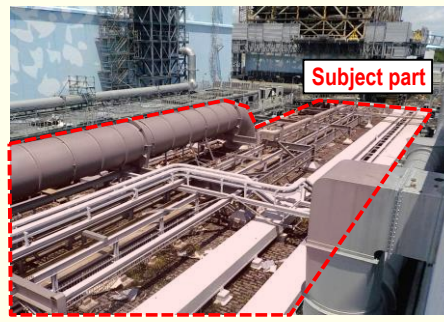
As measures to improve the environment around the Unit 2, pipes, roof blocks, etc. of the Turbine Building shed extension, the Reactor Building shed extension and the Unit 1/2 waste treatment building, to which contamination sources are attached, will be removed. The work began with Turbine Building shed extension from March 25, 2019.

Condition of the Turbine Building shed extension

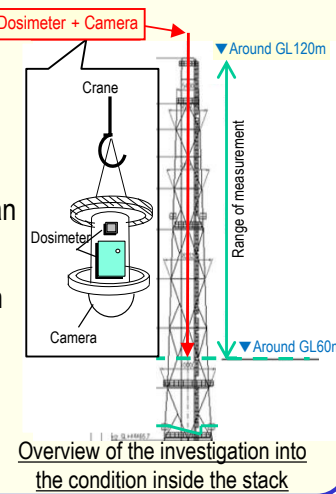
Investigation into the condition inside the Unit 1/2 exhaust stack

Toward dismantling of the Unit 1/2 exhaust stack, the demonstration test of the dismantling equipment STEP 3 (verification of work procedures) will be completed in early April, 2019. To check the condition inside the stack, etc., an investigation before actual work will start from early April using a dedicated large crane for dismantling the exhaust stack. The investigation will include measuring the radiation dose inside the stack and checking obstacles there using a camera. The dismantling equipment will be transferred to the site and assembled to start dismantling from mid-May.

- To check the condition inside the stack, etc., an investigation before actual work will start from early April 2019 using a dedicated large crane for dismantling the exhaust stack. The investigation will include measuring radiation dose inside the stack and checking obstacles there using a camera.

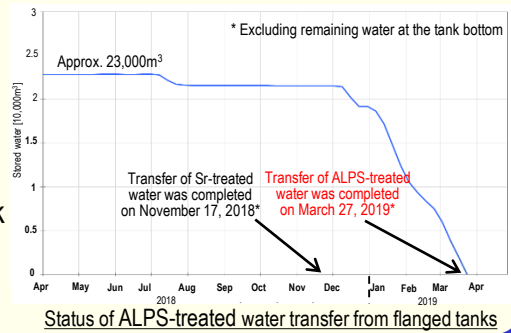
Completion of ALPS-treated water transfer from flanged tanks

Transfer of ALPS-treated water stored in flanged tanks to more reliable welded-joint tanks was completed on March 27, 2019, which meant that the milestone specified in the Mid-and-Long-Term Roadmap "welded-joint tanks are used to store the entire amount of water purified by the purification systems within FY2018" was achieved. By this transfer, the risk of leakage from flanged tanks was significantly reduced.

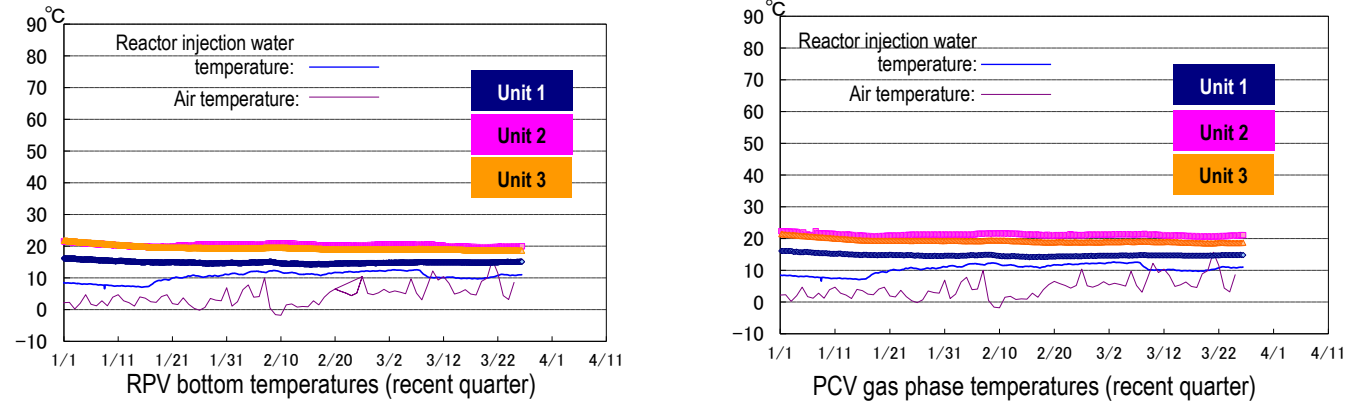
Through continuous reactor cooling by water injection, the temperatures of the Reactor Pressure Vessel (RPV) bottom and the Primary Containment Vessel (PCV) gas phase were maintained within the range of approx. 15 to 25°C for the past month, though varied depending on the unit and location of the thermometer.

* The trend graphs show part of the temperature data measured at multiple points.

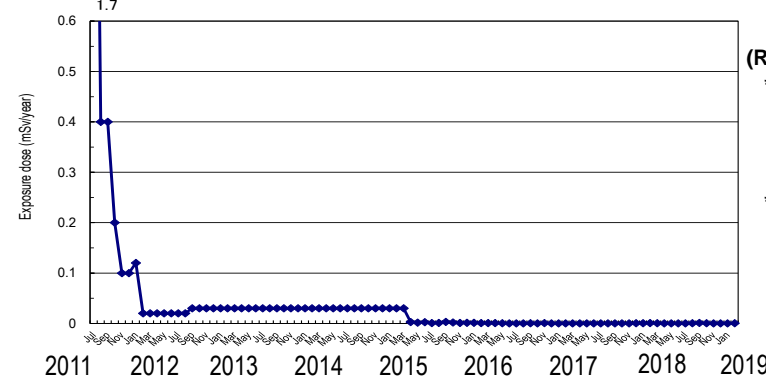
As of February 2019, the density of radioactive materials newly released from Reactor Building Units 1-4 into the air and measured at the site boundary was evaluated at approx. 5.0×10^{-12} Bq/cm³ for Cs-134 and 3.5×10^{-11} Bq/cm³ for Cs-137, while the radiation exposure dose due to the release of radioactive materials there was less than 0.00047 mSv/year.

Annual radiation dose at site boundaries by radioactive materials (cesium) released from Reactor Building Units 1-4

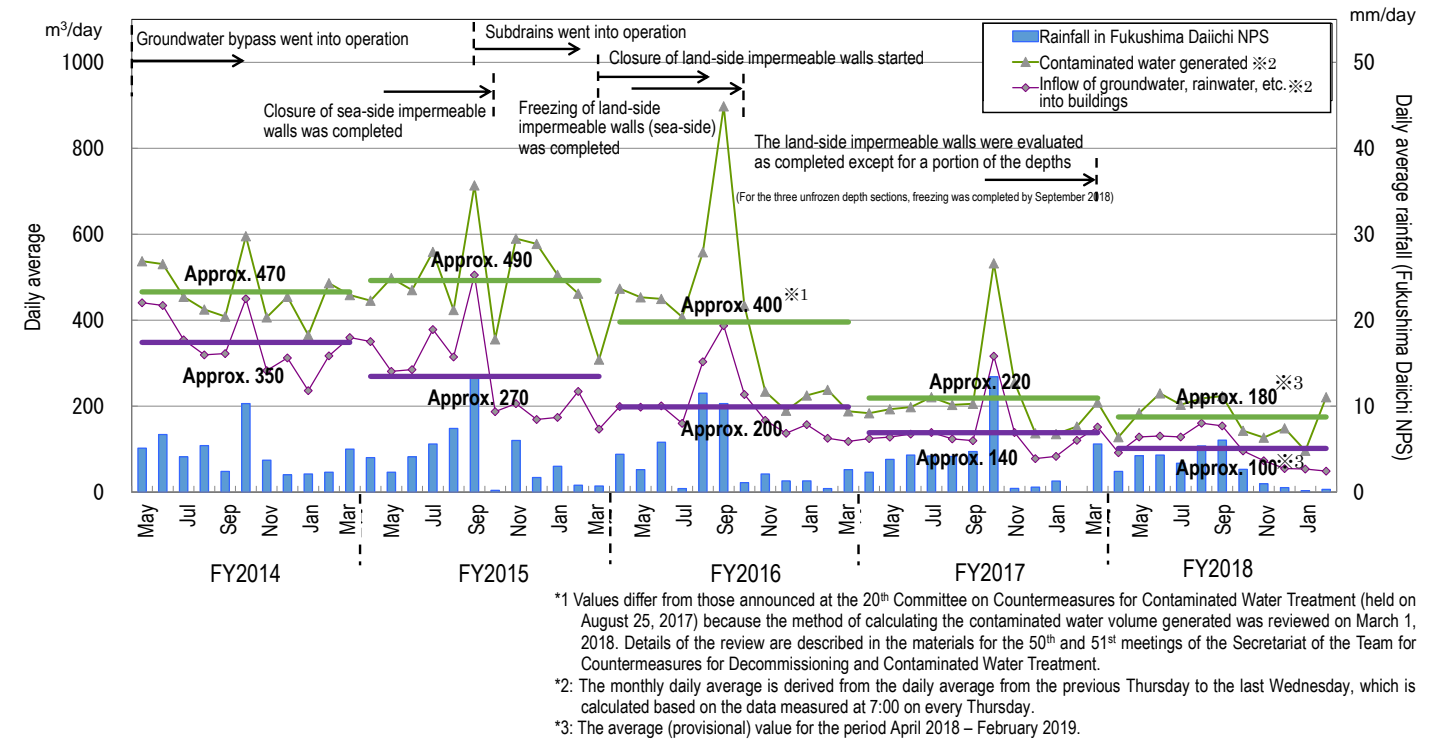
- Following the steady implementation of “isolation” measures (groundwater bypass subdrains, frozen walls, etc.), the inflow reduced from approx. 470 m³/day (the FY2014 average) when the measures were first launched to approx. 220 m³/day (the FY2017 average), though it varied depending on rainfall, etc.
- Measures will continue to further reduce the volume of contaminated water generated.

*1 Values differ from those announced at the 20th Committee on Countermeasures for Contaminated Water Treatment (held on August 25, 2017) because the method of calculating the contaminated water volume generated was reviewed on March 1, 2018. Details of the review are described in the materials for the 50th and 51st meetings of the Secretariat of the Team for Countermeasures for Decommissioning and Contaminated Water Treatment.
 *2: The monthly daily average is derived from the daily average from the previous Thursday to the last Wednesday, which is calculated based on the data measured at 7:00 on every Thursday.
 *3: The average (provisional) value for the period April 2018 – February 2019.

Figure 1: Changes in contaminated water generated and inflow of groundwater, rainwater, etc. into buildings

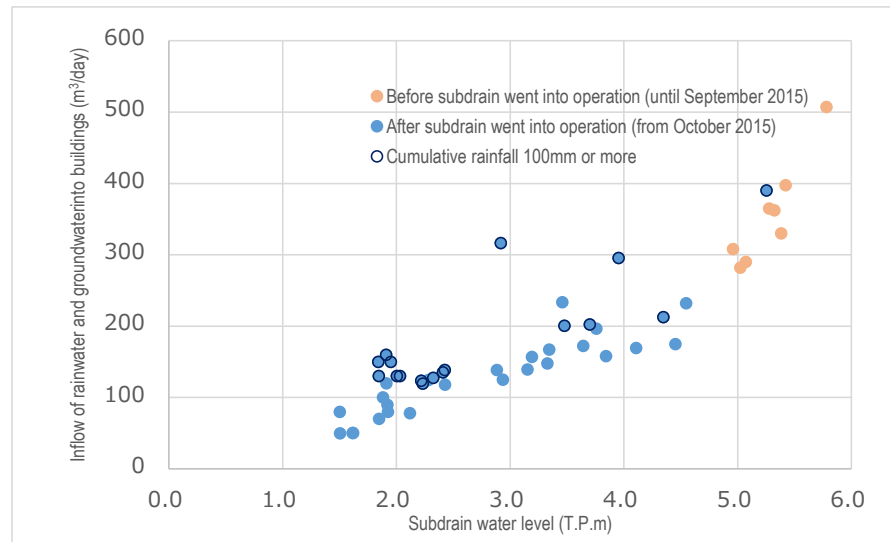
- To eliminate the need to suspend water pumping while cleaning the subdrain transfer pipe, the pipe will be duplicated. Installation of the pipe and ancillary facilities was completed.
- Since the subdrains went into operation, the inflow into buildings tended to decline to under 150 m³/day when the subdrain water level declined below T.P. 3.0 m, but increased during rainfall.

Figure 2: Correlation between inflow such as groundwater and rainwater into buildings and the water level of Unit 1-4 subdrains

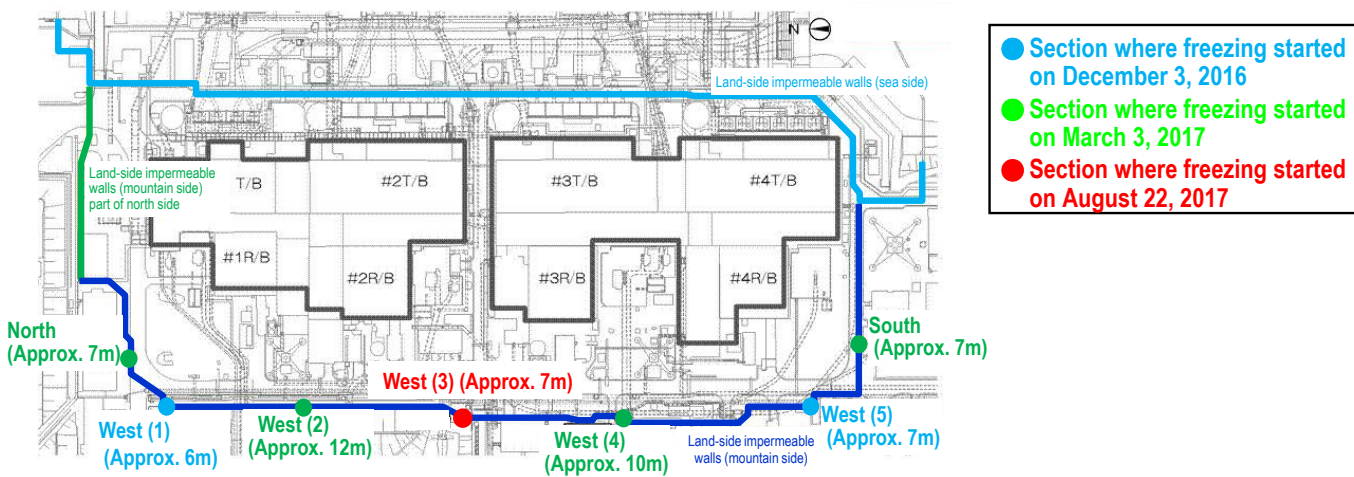
- In March 2018, the land-side impermeable walls were considered completed, except for a portion of the depth, based on a monitoring result showing that the underground temperature had declined below 0°C in almost all areas, while on the mountain side, the difference between the inside and outside increased to approx. 4-5 m. Multi-layered contaminated water management measures, including subdrains and facing, have kept the groundwater level stable. Consequently, a water-level management system to isolate the buildings from groundwater was considered to have been established. The Committee on Countermeasures for Contaminated Water Treatment, held on March 7, clearly recognized the effect of the land-side impermeable walls in shielding the groundwater and evaluated that the land-side impermeable walls had allowed a significant reduction in the amount of contaminated water generated.

Figure 3: Closure of part of the land-side impermeable walls (on the mountain side)

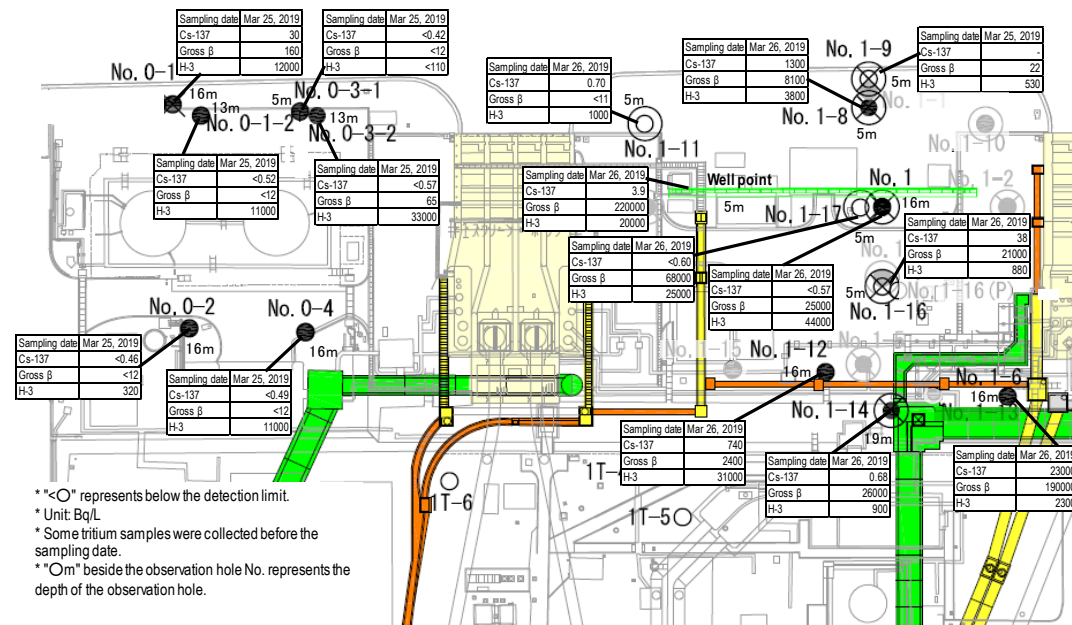
Figure 5: Groundwater density on the Turbine Building east side

- The density of gross β radioactive materials at No. 1-12 had been decreasing from around 800 Bq/L since September 2018 to around 200 Bq/L. It has since been increasing, and currently stands at around 2,400 Bq/L. Since August 15, 2013, pumping of groundwater continued (at the well point between the Unit 1 and 2 intakes: August 15, 2013 – October 13, 2015 and from October 24; at the repaired well: October 14 - 23, 2015).

- The H-3 density at No. 2-5 had been increasing from around 1,200 Bq/L since December 2018, and currently stands at around 2,400 Bq/L. The density of gross β radioactive materials at the same point had been increasing from around 30,000 Bq/L since December 2018, and currently stands at around 80,000 Bq/L. Since December 18, 2013, pumping of groundwater continued (at the well point between the Unit 2 and 3 intakes: December 18, 2013 - October 13, 2015; at the repaired well: from October 14, 2015).

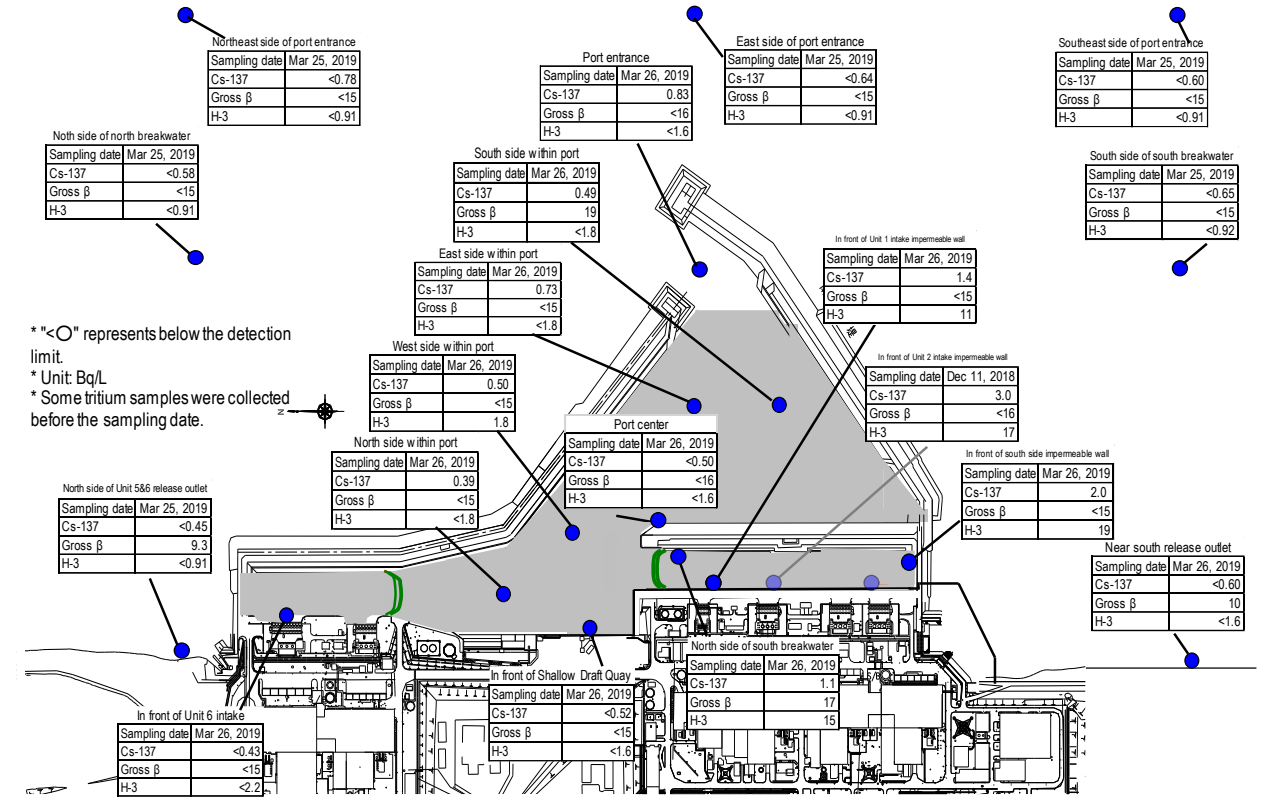
Figure 6: Seawater density around the port

- Regarding the radioactive materials in seawater in the Unit 1-4 intake open channel area, densities have remained below the legal discharge limit except for the increase in Cs-137 and Sr-90 during rain. They have also been declining following the completed installation and the connection of steel pipe sheet piles for the sea-side impermeable walls. The density of Cs-137 has been increasing since January 25, 2017, when a new silt fence was installed to accommodate the relocation.

- Regarding the radioactive materials in seawater in the area within the port, densities have remained below the legal discharge limit, except for the increase in Cs-137 and Sr-90 during rain. They have been below the level of those in the Unit 1-4 intake open channel area and have been declining following the completed installation and connection of steel pipe sheet piles for the sea-side impermeable walls.
- Regarding the radioactive materials in seawater in the area outside the port, densities of Cs-137 and Sr-90 have been declining, but remained unchanged following the completed installation and the connection of steel pipe sheet piles for the sea-side impermeable walls.

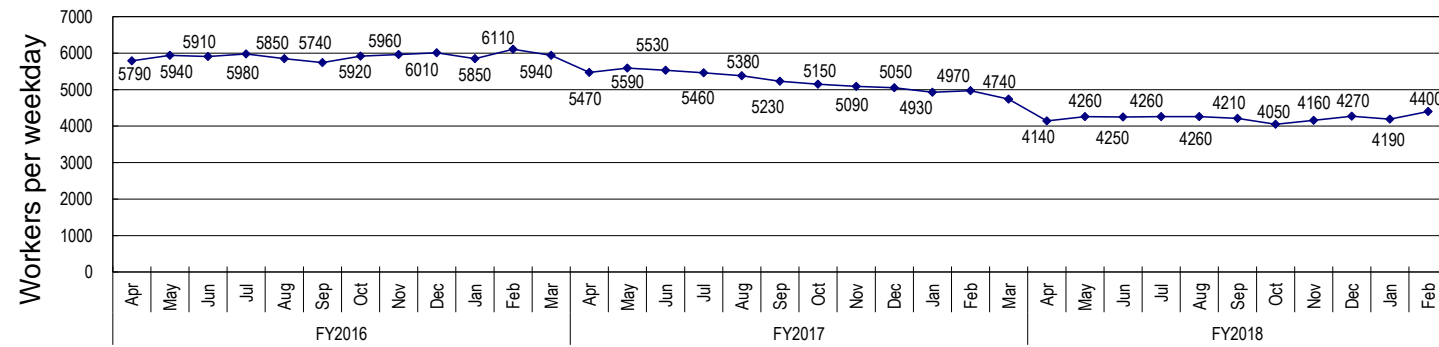
Figure 7: Changes in the average number of workers per weekday for each month since FY2016 (actual values)

- It was confirmed with the prime contractors that the estimated manpower necessary for the work in April 2019 (approx. 4,300 per day: TEPCO and partner company workers) would be secured at present. The average numbers of workers per day per month (actual values) were maintained, with approx. 4,000 to 6,200 since FY2016 (see Figure 7).

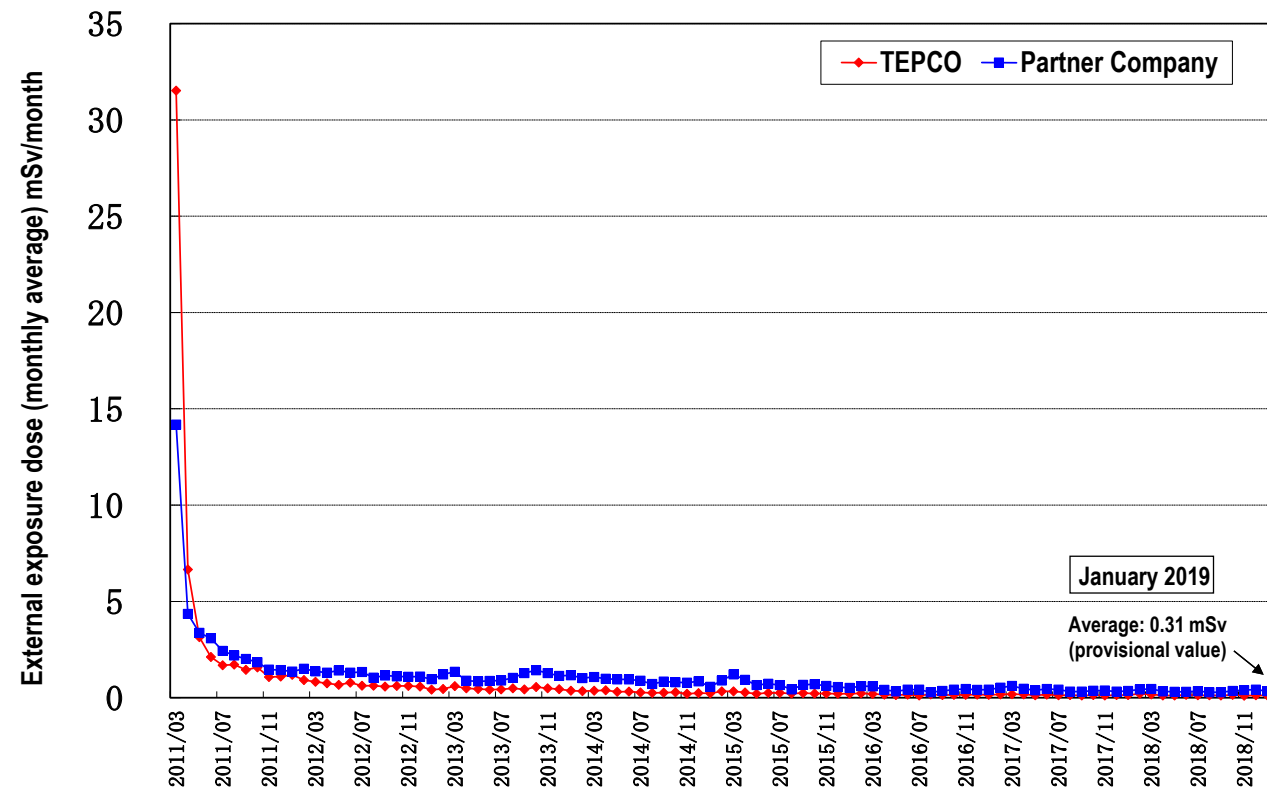
Figure 8: Changes in monthly individual worker exposure dose (monthly average exposure dose since March 2011)

- The monthly average exposure dose of workers remained at approx. 0.59 mSv/month during FY2015, approx. 0.39 mSv/month during FY2016 and approx. 0.36 mSv/month during FY2017. (Reference: Annual average exposure dose 20 mSv/year \doteq 1.7 mSv/month)

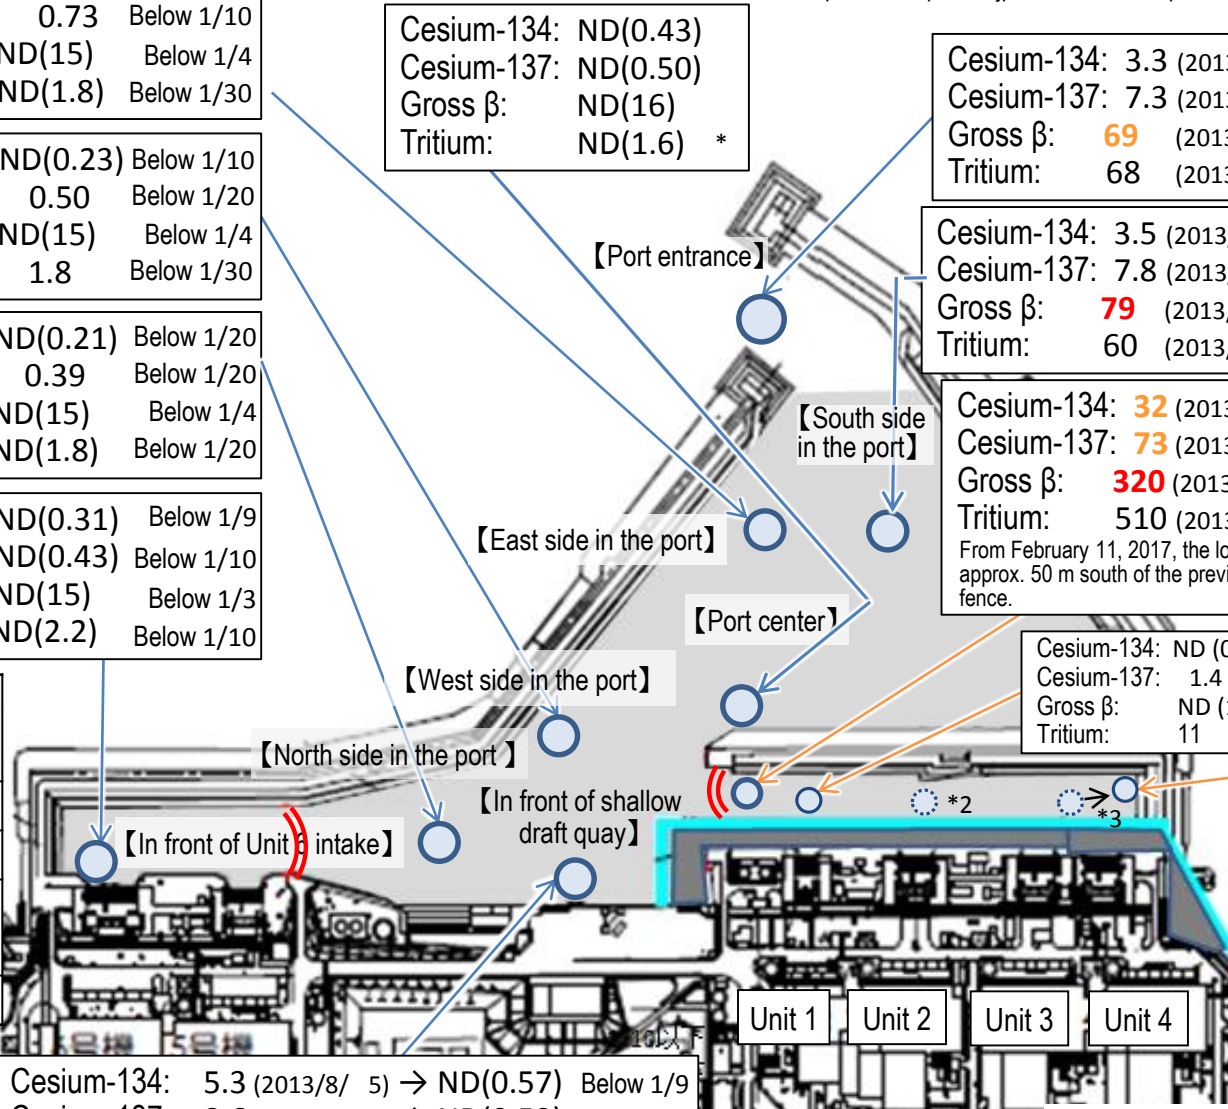
Cesium-134: 5.3 (2013/8/ 5) → ND(0.57) Below 1/9
Cesium-137: 8.6 (2013/8/ 5) → ND(0.52) Below 1/10
Gross β: **40** (2013/7/ 3) → ND(15) Below 1/2
Tritium: 340 (2013/6/26) → ND(1.6) Below 1/200

Note: The gross β measurement values include natural potassium 40 (approx. 12 Bq/L). They also include the contribution of yttrium 90, which radioactively balance strontium 90.

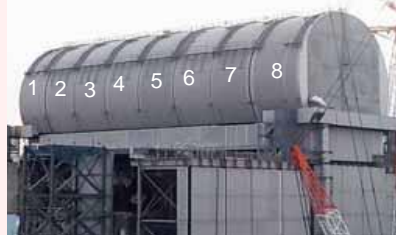
Installation of dome roof (February 21)

Prior to the installation of a cover for fuel removal, removal of large rubble from the spent fuel pool was completed in November 2015. To ensure safe and steady fuel removal, training of remote control was conducted at the factory using the actual fuel-handling machine which will be installed on site (February – December 2015). Measures to reduce dose on the Reactor Building top floor (decontamination, shields) were completed in December 2016. Installation of a cover for fuel removal and a fuel-handling machine is underway from January 2017. Installation of the fuel removal cover was completed on February 23, 2018. Toward fuel removal, the rubble retrieval training inside the pool, which was scheduled in conjunction with fuel removal training, started from March 15, 2019, and the process is being reviewed to start fuel removal within April 2019.

As measures to reduce the dose on the Reactor Building operating floor, decontamination and installation of shields were completed in June and December 2016, respectively. Installation of a fuel removal cover started in January 2017, and installation of all dome roofs was completed in February 2018.

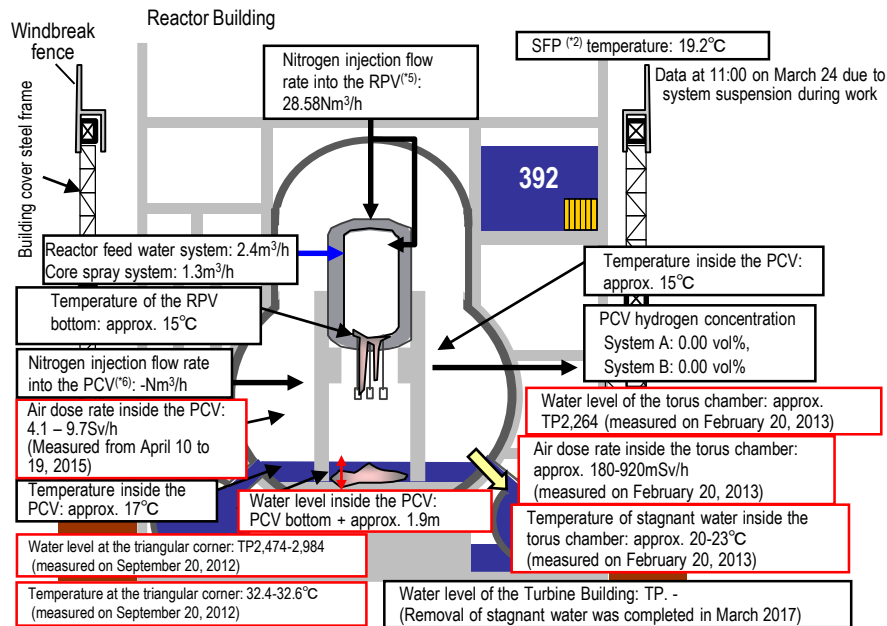
Unit 1

Air dose rate inside the Reactor Building:
Max. 5,150mSv/h (1F southeast area) (measured on July 4, 2012)

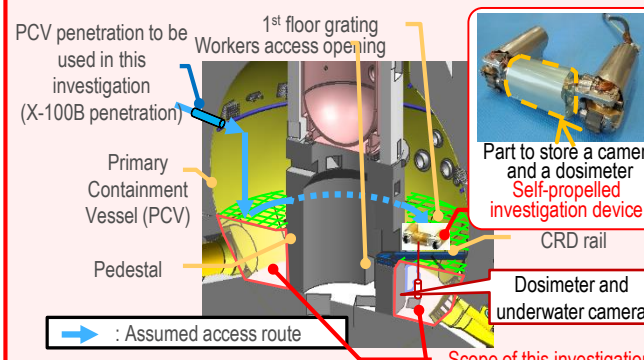
<Image of investigation inside the PCV>

- In April 2015, a device, which entered the inside of the PCV through a narrow access opening (bore: ϕ 100 mm), collected information such as images and airborne dose inside the PCV 1st floor.
- In March 2017, the investigation using a self-propelled investigation device, conducted to inspect the spreading of debris to the basement floor outside the pedestal, took images of the PCV bottom status for the first time. The status inside the PCV will continue to be examined based on the collected image and dose data.

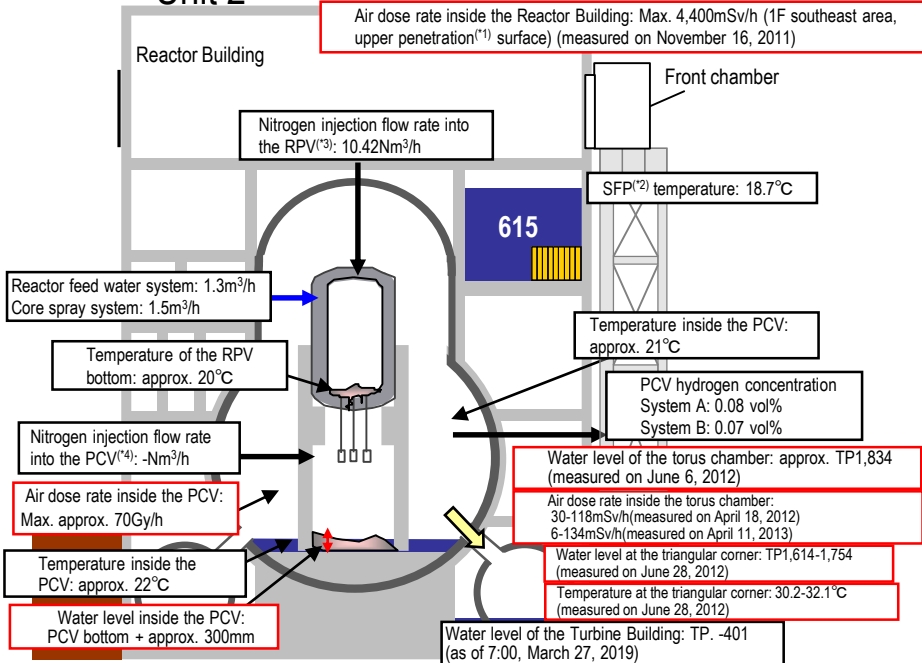
Unit 2

Investigations inside PCV	1st (Jan 2012)	- Acquiring images - Measuring air temperature
	2nd (Mar 2012)	- Confirming water surface - Measuring water temperature - Measuring dose rate
	3rd (Feb 2013 - Jun 2014)	- Acquiring images - Sampling stagnant water - Measuring water level - Installing permanent monitoring instrumentation
	4th (Jan - Feb 2017)	- Acquiring images - Measuring dose rate - Measuring air temperature
Leakage points from PCV	- No leakage from torus chamber rooftop - No leakage from all inside/outside surfaces of S/C

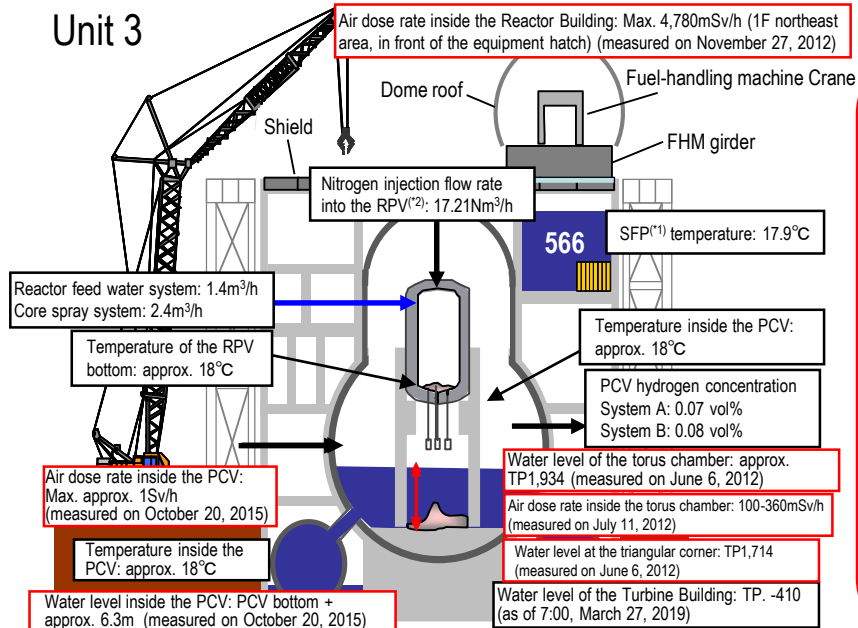
Unit 3

Investigations inside PCV	1st (Oct – Dec 2015)	- Acquiring images - Measuring air temperature and dose rate - Measuring water level and temperature - Sampling stagnant water - Installing permanent monitoring instrumentation (December 2015)
	2nd (Jul 2017)	- Acquiring images - Installing permanent monitoring instrumentation (August 2017)
Leakage points from PCV	- Main steam pipe bellows (identified in May 2014)

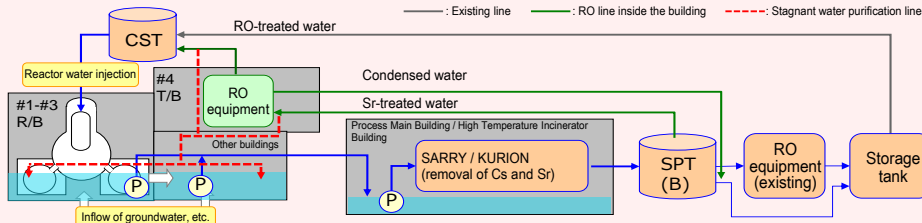
- To reduce the risk of contaminated-water leakage, the circulation loop was shortened by installing a reverse osmosis (RO) device in the Unit 4 Turbine Building within the circulation loop, comprising the transfer of contaminated water, water treatment and injection into the reactors. Operation of the installed RO device started from October 7 and 24-hour operation started from October 20. Installation of the new RO device inside the building shortened the circulation loop from approx. 3 to 0.8 km.

* The entire length of contaminated water transfer pipes is approx. 2.1km, including the transfer line of surplus water to the upper heights (approx. 1.3km).

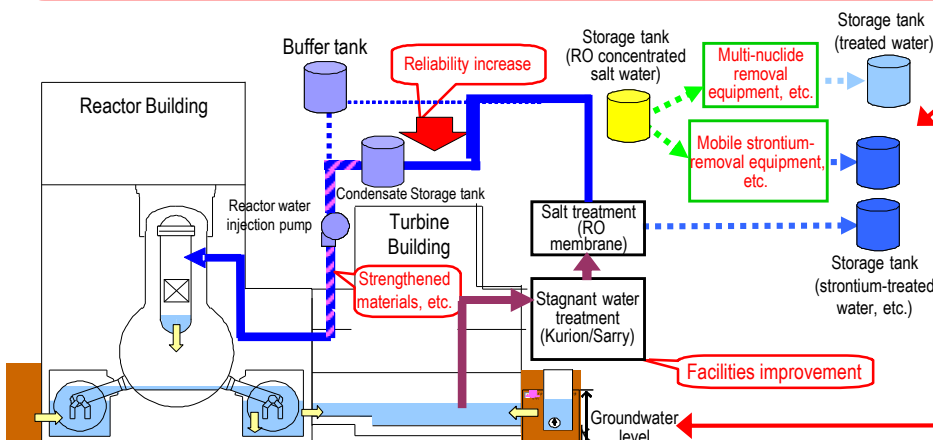
Contaminated water (RO concentrated salt water) is being treated using seven types of equipment including the multi-nuclide removal equipment (ALPS). Treatment of the RO concentrated salt water was completed on May 27, 2015, with the exception of the remaining water at the tank bottom. The remaining water will be treated sequentially toward dismantling the tanks.

The strontium-treated water from other facilities than the multi-nuclide removal equipment will be re-purified in the multi-nuclide removal equipment to further reduce risks.
