Sampling Results Regarding the Influence on the Water Leak at a Tank in the H6 Area in Fukushima Daiichi Nuclear Power Station (Around the H6 Area) Tokyo Electric Power Company

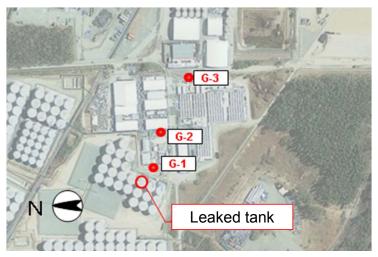
G-1	G-2	G-3
Gross β	54 <3/28>	260 <6/10>	42 <5/26>
H-3 (Approx. 12 years)	180 <4/15>	7,000 <3/24,3/25>	2,600 <5/24>

* The sampling date is provided in parentheses.
