Sampling Results Regarding the Influence on the Water Leak at a Tank in the H6 Area in Fukushima Daiichi Nuclear Power Station (Around the H6 Area) To

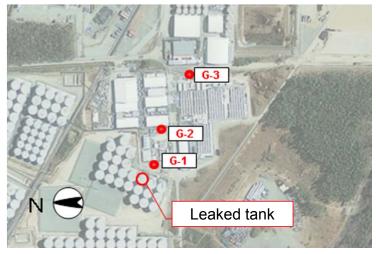
Unit: Bq/L
	Groundwater around H6 area		
	G-1	G-2	G-3
Date of Sampling		Jul 15, 2014	Jul 15, 2014
Time of sampling		8:39 AM	8:30 AM
Gross β		ND(19)	ND(19)
H-3 (Approx. 12 years)		120	360

G-1	G-2	G-3
Gross β	54 <3/28>	260 <6/10>	46 <7/7>
H-3 (Approx. 12 years)	480 <6/18>	7,000 <3/24>	2,600 <5/24>
