Ornt. Dq/L
	Seawater of the south water outlet Note (near the drainage channel exit) (T-2)	Drainage channel C OP.35 exit (C-2)	Point near the main gate in the drainage channel C Note 2 (C-0)	Point near Fureai Intersection in the drainage channel B Note 2 (B-0-1)
Date of Sampling	Mar 13, 2014	Mar 13, 2014		Mar 13, 2014
Time of sampling	8:00 AM	7:51 AM		7:31 AM
Cs-134(Approx. 2 years)	ND(1.2)	ND(17)		ND(16)
Cs-137(Approx.30 years)	ND(1.4)	ND(24)		ND(23)
Gross β	ND(18)	ND(14)		16

<Reference> The Highest Dose Until the Previous Measurement

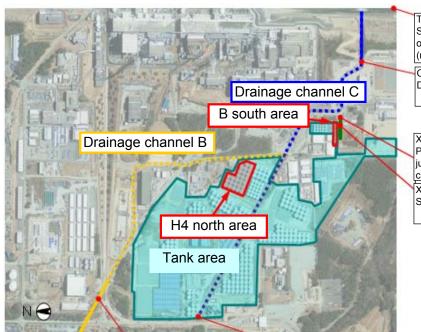
* The ducting is provided in the dot line.

B-0-1 Point near Fureai Intersection in the drainage channel B

Point near the main gate in the drainage channel C

Seawater of the south water

(near the drainage channel exit)

Drainage channel C O.P.35 exit

Point immediately short of the junction with the drainage channel C

X-2

Side ditch next to the tank
