· ·
	Seawater of the south water outlet Note 1 (near the drainage channel exit) (T-2)	Drainage channel C OP.35 exit (C-2)	Point near the main gate in the drainage channel C Note 2 (C-0)	Point near Fureai Intersection in the drainage channel B Note 2 (B-0-1)
Date of Sampling	Mar 22, 2014	Mar 22, 2014		
Time of sampling	7:45 AM	7:34 AM		
Cs-134(Approx. 2 years)	ND(1.2)	ND(18)		
Cs-137(Approx.30 years)	ND(1.0)	ND(26)		
Gross β	ND(18)	15

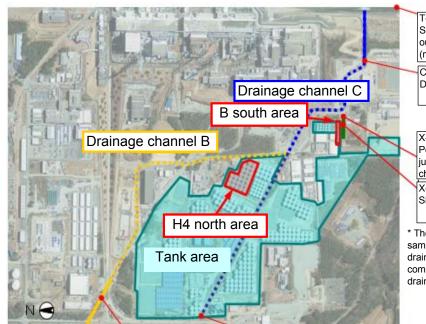
* The ducting is provided in the dot line.

B-0-1 Point near Fureai Intersection in the drainage channel B

C-0 Point near the main gate in the drainage channel C

Seawater of the south water

(near the drainage channel exit)

C-2

Drainage channel C O.P.35 exit

Point immediately short of the junction with the drainage channel C

X-2

Side ditch next to the tank

* There is no outflow from the sampling point X-1 and X-2 to the drainage channel C, since they are completely isolated from the drainage channel C.
