Thermometers Related to the Technical Specification at Unit 1 in Fukushima Daiichi NPS

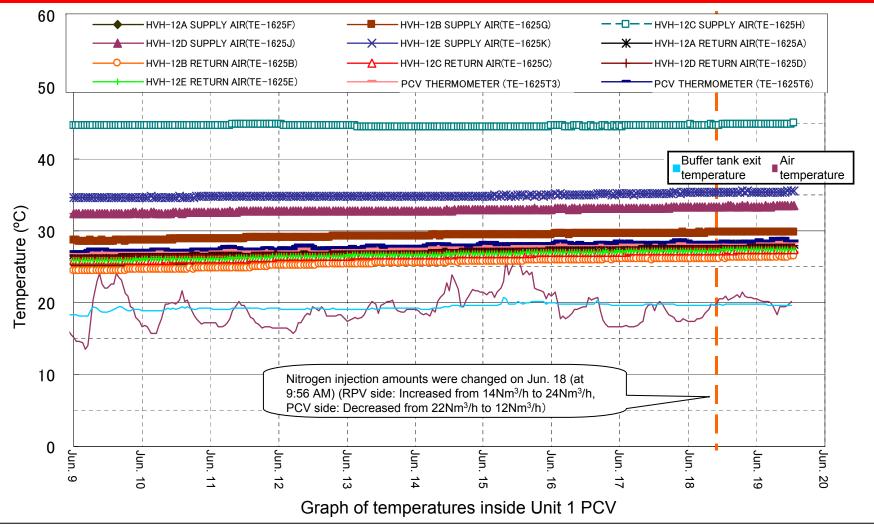
D/W HVH temperatures among temperatures inside PCV, which are monitoring parameters, have been changing within narrow ranges, and have not shown significant changes.

The other monitoring parameters (such as xenon density and hydrogen density) have not shown significant changes.
